Inspection Report

Property Address:
1234 Home Avenue
First Time Buyer GA 30084

Common Cents Home Inspection Services

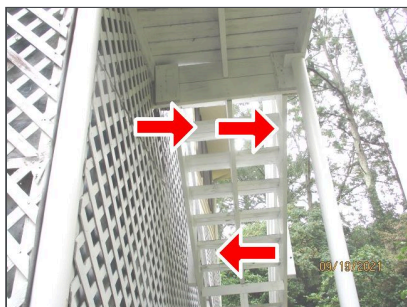
1.1 Item 1(Picture)

(1) Stairs have lateral movement. Repairs recommended.

The deck band is not attached properly to the wall or band of the home. It should have 5/8 galvanized "Lag Screws" or "Carriage Bolts" (preferred) approximately every 36 inches. I recommend a qualified contractor repair as needed (R311.5 2012)

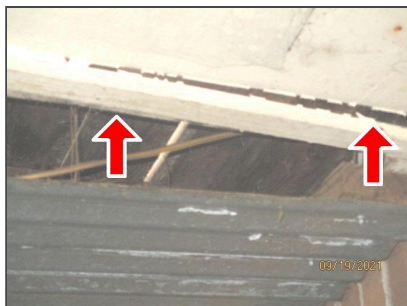
1.1 Item 2(Picture)

(2) The deck band is not attached properly to the wall or band of the home. It should have 5/8 galvanized "Lag Screws" or "Carriage Bolts" (preferred) approximately every 36 inches. I recommend a qualified contractor repair as needed (R311.5 2012)

Deck flashing detail is missing. This prevent surface water from entering the wall cavity where the assembly is bolted to the dwelling.

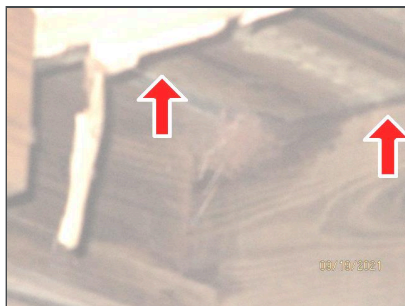
1.1 Item 3(Picture)

(3) Carpenter bee damage.

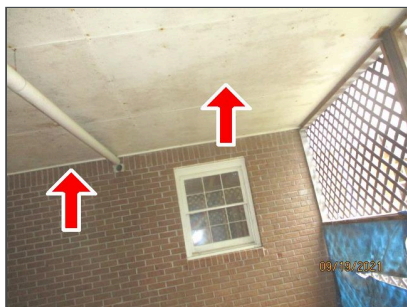
1.1 Item 5(Picture)

(4) Paint coat is failing under the sun room area. Seal, pressure wash, paint

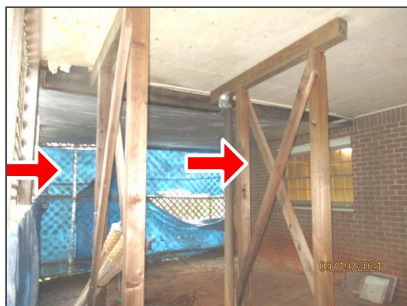
1.1 Item 6(Picture)

(5) Condition of the bracing under the deck flooring is not accessible.

4X4 bracing is original . No evidence of movement noted at the time of the inspection.

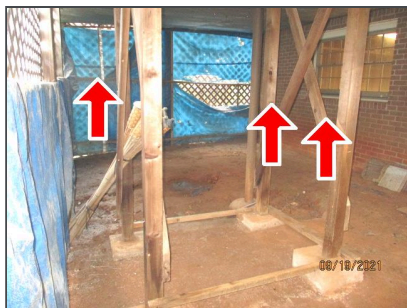
1.1 Item 7(Picture)

(6) Cross bracing 2X4 is under rated for this application.

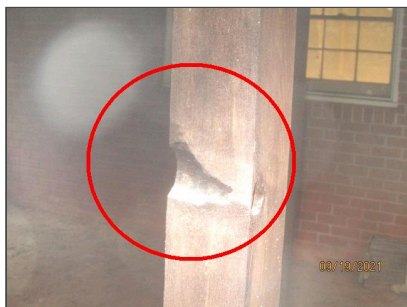
1.1 Item 8(Picture)

(7) Vertical supports are over notched. Evaluation and replacement is recommended not less than 6X6. A decking contractor or contractor whose back round and experience are known.

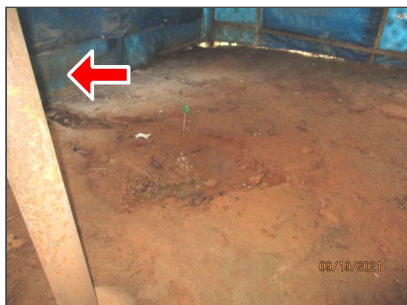
1.1 Item 9(Picture)

(8) All columns under the deck are pitting. At a minimum sand, primer and rust inhibitor coating is recommended.

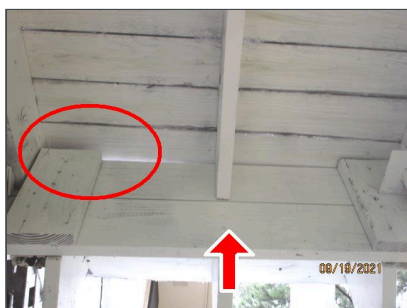
1.5 Item 1(Picture)

(1) Unlovely connection from the deck stairs to the landing. Addling joist hangers recommended.

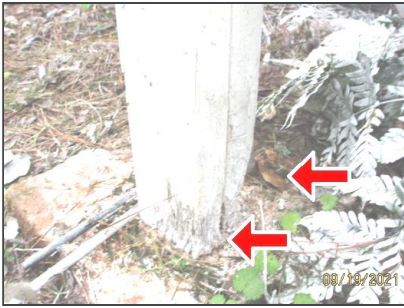
1.5 Item 2(Picture)

(2) Knee wall support post has decay and water damage. Replacement recommended.

Note: Riser plates are available for this application that prevents the post from being in contact with surface water.

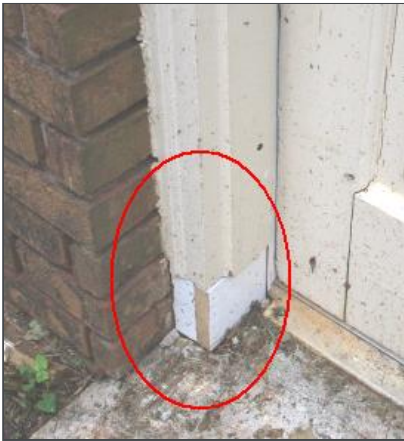
1.5 Item 3(Picture)

(3) Repairs to basement door frame have not been sealed or painted. Water intrusion noted to the interior floor.

No weather stripping exist along the bottom . Original

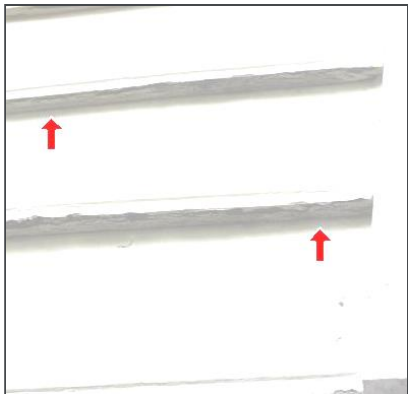
1.9 Item 5(Picture)

(4) Edges in some areas are swelling at the bottom. This indicates that the paint coat was not consistent along the bottom of the material.

Siding damage left rear corner. repair, caulk and paint coat recommended.

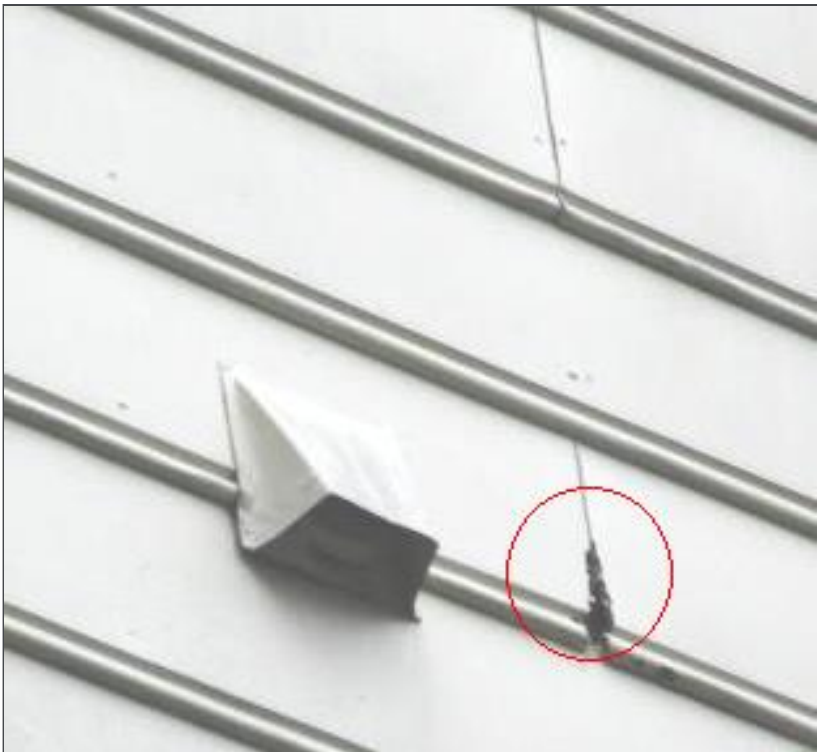
1.9 Item 8(Picture) Damaged End Joint Left Side

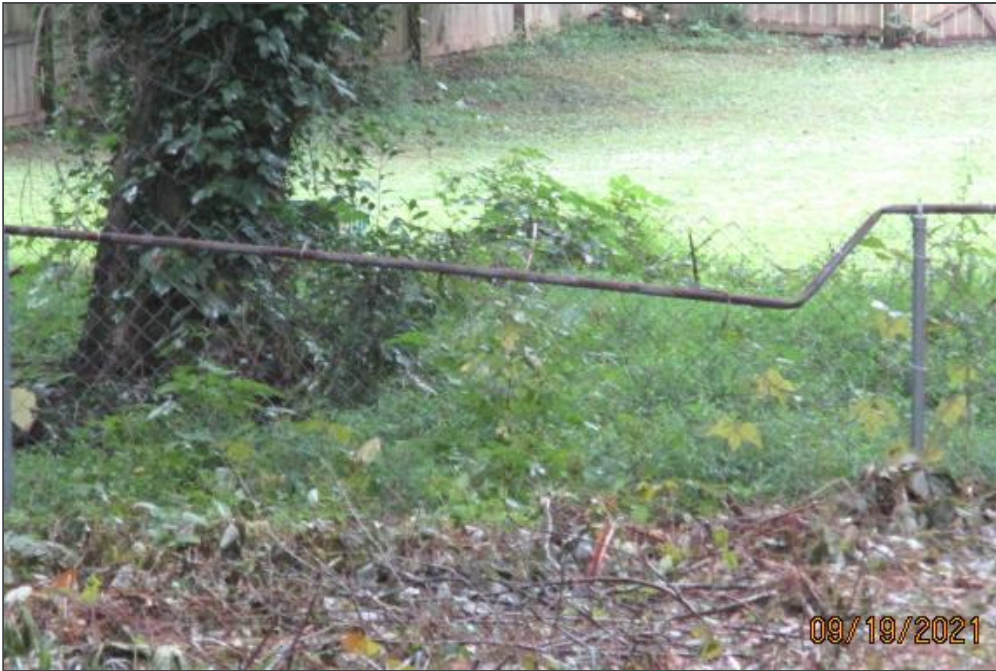
1.3 Item 1(Picture)

Damaged sections along the back left corner. Repairs recommended for improved safety.

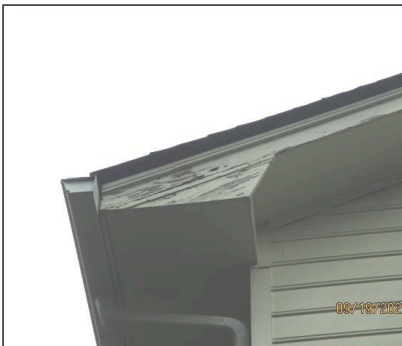
1.6 Item 1(Picture)

Chipping, peeling paint coat along the fascia.

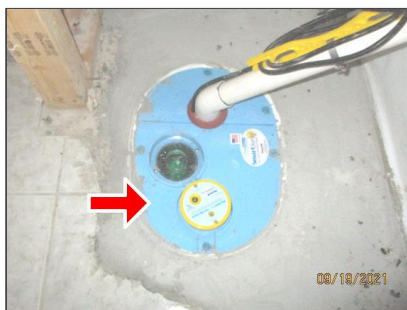
6.1 Item 2(Picture) Moisture Alarm

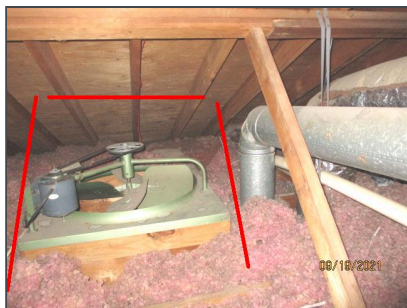
6.2 Item 1(Picture)

Whole House Fans- Failure to cover these opening creates as much heat loss as an open window during the winter season. Other options exist on line that could be beneficial.

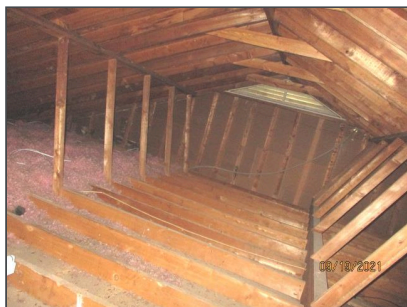
6.2 Item 3(Picture)

(2) Addittional storage over the garage is accessed via closet in the front bedroom. No decking installed.

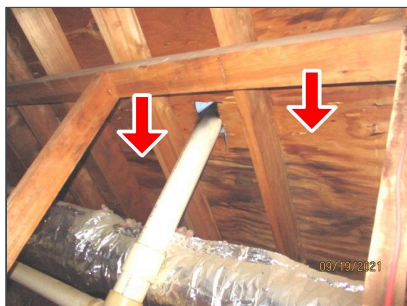
6.2 Item 4(Picture)

(3) Leak noted in the attic, back side. Appears to be old. Material was dry at the time of the inspection.

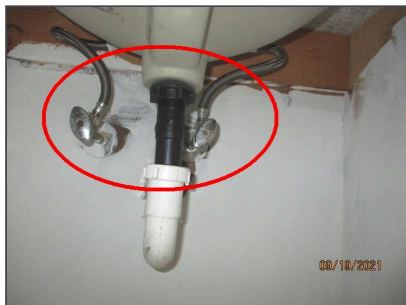
8.1.B Item 1(Picture)

Active leak at the P trap. Secure/Repair

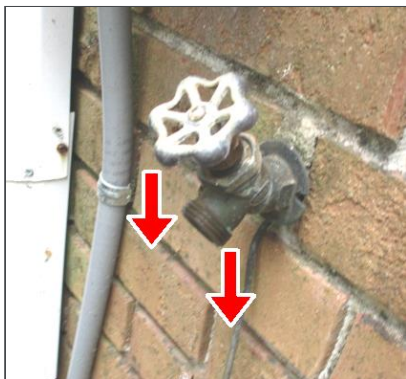
9.1 Item 1(Picture)

Back faucet at basement door has active leak. Failing stem is one option.

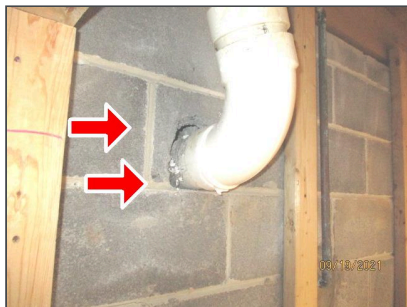
9.4 Item 1(Picture)

- (1) Use water efficiently : Average indoor water use in the typical single-family home is almost 70 gallons per person per day. Dripping faucets can waste about 2,000 gallons of water each year. Leaky toilets can waste as much as 200 gallons each day
- (2) Seal waste line penetration that exits the front cinder block wall. Expansion foam would be one option.

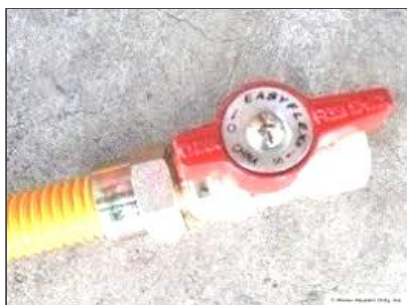
Original shut off valve requires addittional tool and effort. Code requirement in place at the time the unit was replaced.

9.6 Item 1(Picture) Quick Shut Off

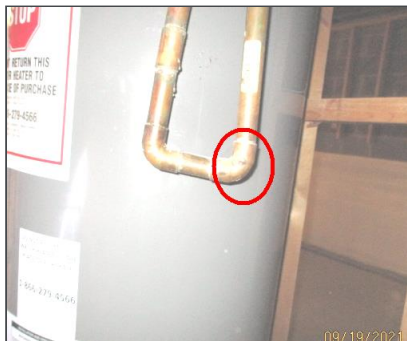
- (2) Missing drip leg at the pressure relief valve discharging vertically. This drip leg allows for condensation to drain **away from the valve** that may cause premature failure.

Ref: Discharge may not run up hill or be trapped. (2803.6.1 IRC 2012)
Code in place at the time the unit was installed.

9.7 Item 1(Picture) Missing
Drip Leg

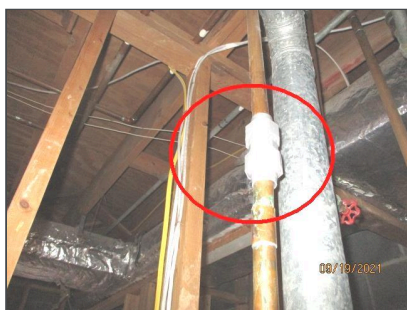
9.7 Item 3(Picture)

(4) Plastic coupling with copper material is not recommended.

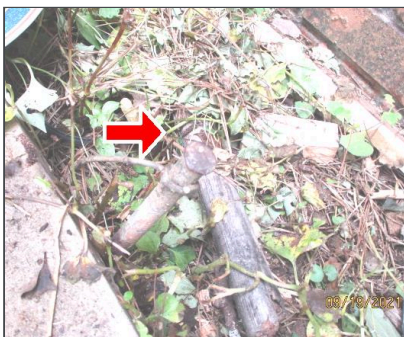
10.3 Item 1(Picture)

(2) Ground rod is not flush with or below the ground level at this phase. **Installation.** The upper end of the electrode shall be flush with or below the ground level unless the above ground end, and the grounding electrode conductor attachment are protected.

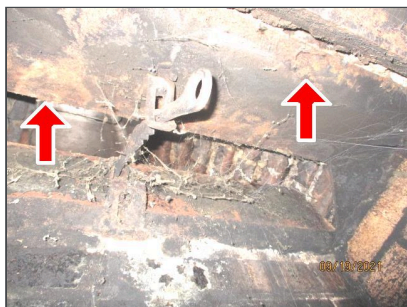
13.0 Item 1(Picture)

Damper operation function as designed. rust noted due to age and moisture intrusion over time.

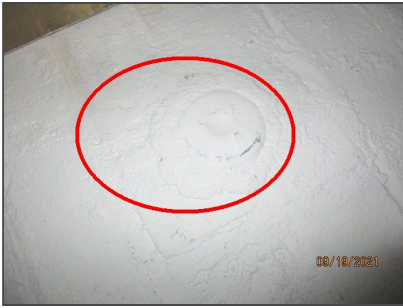
13.3 Item 1(Picture)

Gas line has been terminated and filled with caulk. No gas line visible entering the fire box.

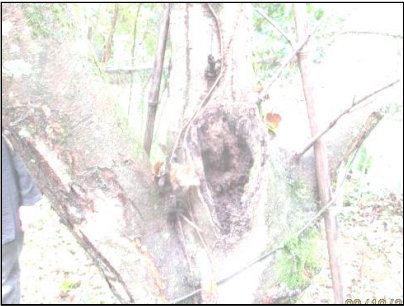
1.2 Item 1(Picture)

**1.2** (1) Right side. Tree appears with rot and decay. Removal should be expected.

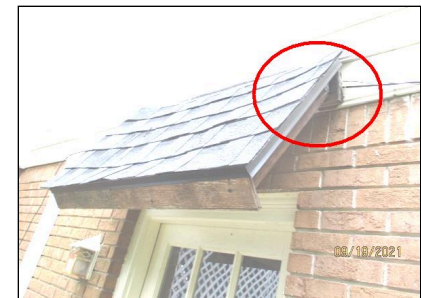
2.0 Item 1(Picture)

(2) Shed roof over basement door has failed. Lacking support and flashing at dissimilar materials. Design will require addittional bracing on both sides at a minimum.

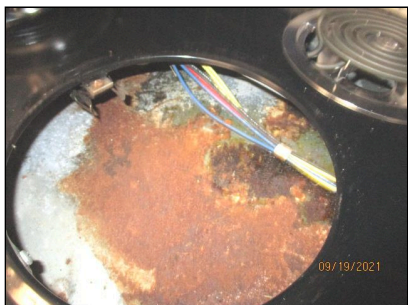
5.0 Item 1(Picture)

5.0 Appears aged equipment with progressing rust.
