# Inspection Report

## Original Modified Town Home

**Property Address:**  
Original Factory Building  
Atlanta GA 12345

<b>Date:</b> 8/5/2020	<b>Time:</b> 7:49:08 AM	<b>Report ID:</b> Town Home Modified Original
<b>Property:</b> Original Factory Building Atlanta GA 12345	<b>Customer:</b> Original Modified Town Home	<b>Real Estate Professional:</b>

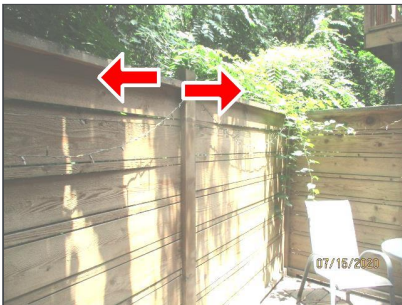
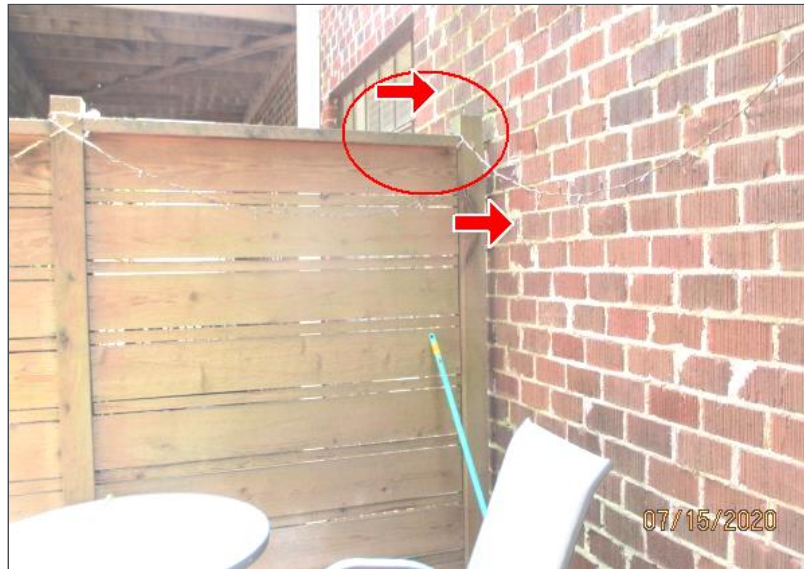
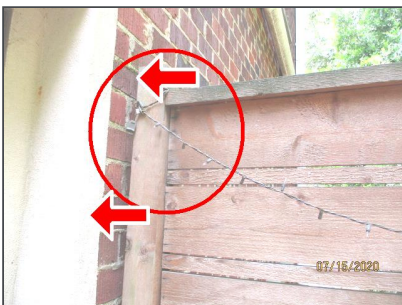
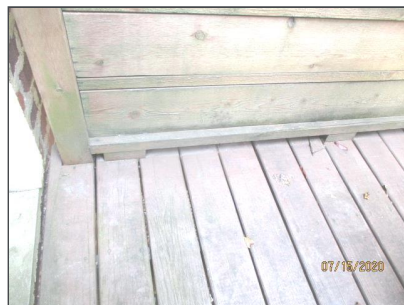
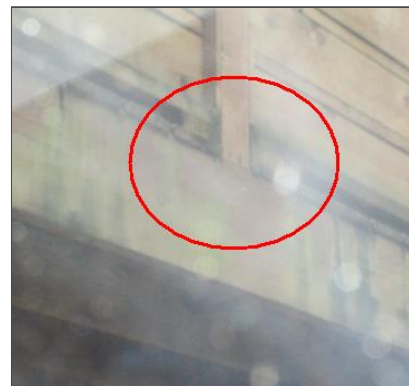
The more than 7 feet privacy fence around the perimeter of the deck has substantial lateral movement on all sides. This creates an unsafe condition.

Further evaluation of the Railing post to the deck band indicates the attachment is secure by two nails.

The railing post closest to the wall are not secured.

It could not be determined if this is the responsibility of the Home Owners Association.

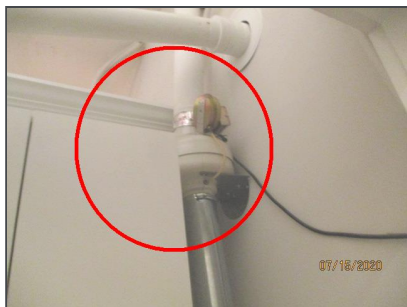
2.4 Item 1(Picture)

Electric dryer booster fan in place. Function not verified. Dryer booster fans help boost airflow through the dryer duct. ... A pressure switch senses pressure in the dryer duct run and allows power to flow to the fan. A current sensing relay senses electricity flowing to the dryer and as a result - it allows power to flow to the fan.

FUNCTION NOT VERIFIED - Unit is displaced.

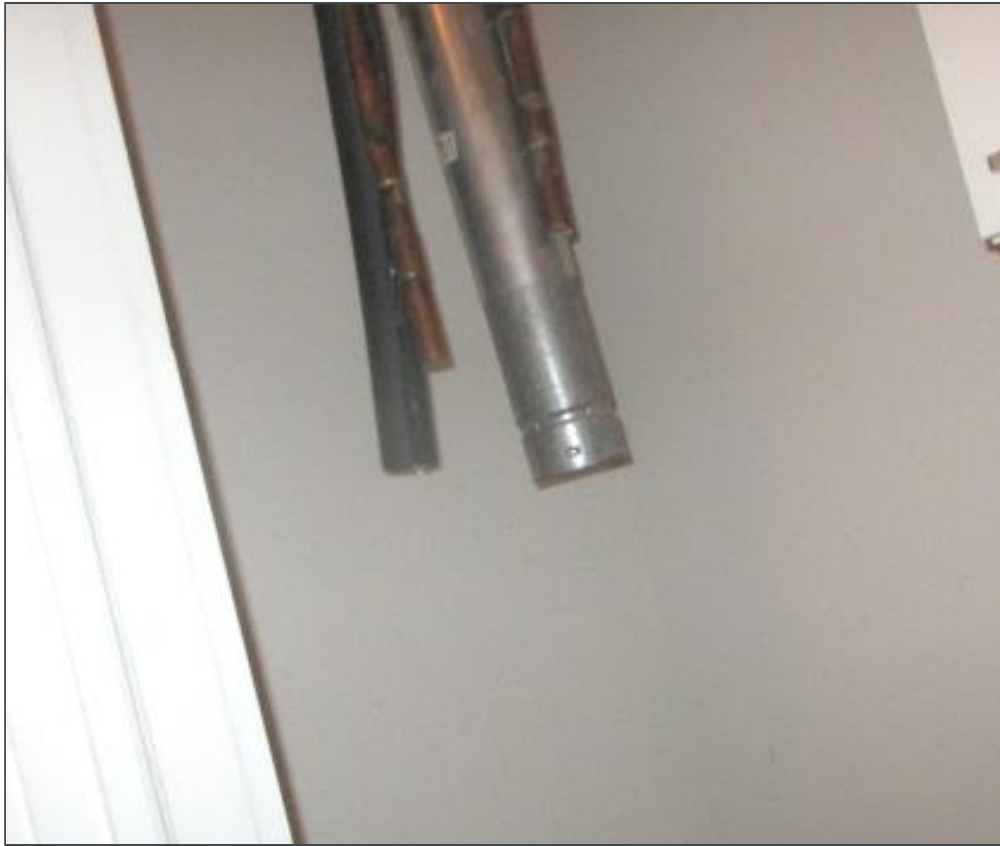
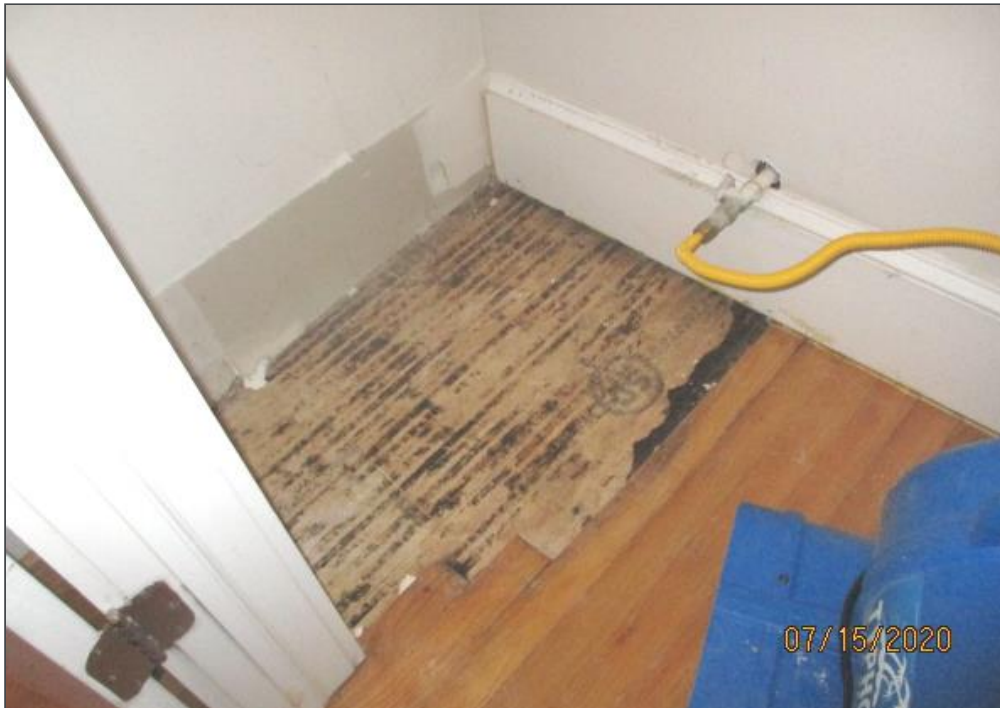
Water heater has been removed due to a leak. Water damage to the flooring extends from the hall utility closet and hall.

Replacement and repairs are pending.

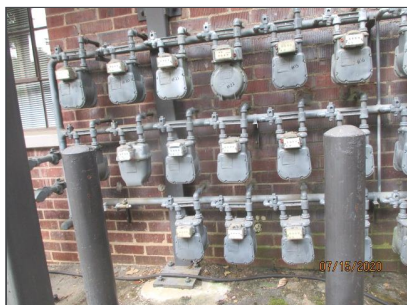
4.4 Item 1(Picture)

Gas meters are individual to the each unit. Right end of the building.

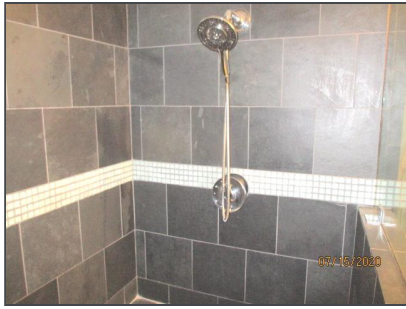
4.9 Item 1(Picture)

Hot water service not available.

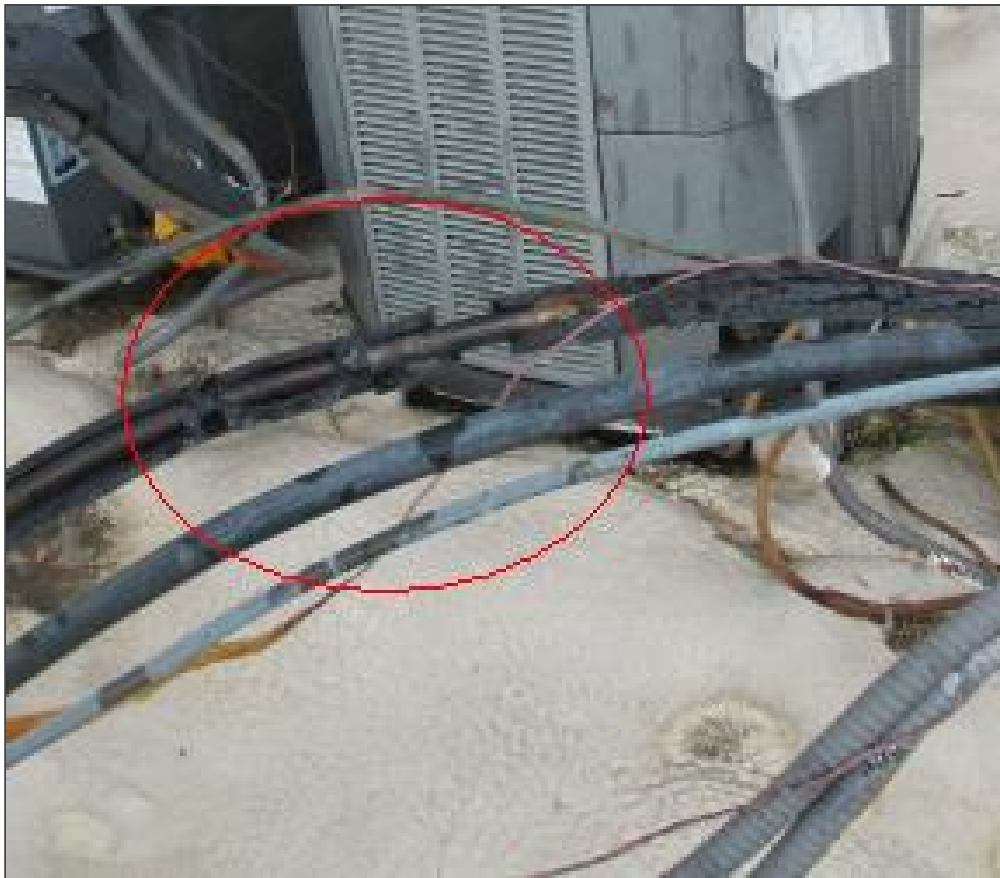
6.2 Item 1(Picture)

The foam sleeve on suction line is missing foam sleeve in area(s) at outside unit. Missing foam on suction line can cause heat gain and energy loss and condensation.

Piping and fittings for refrigerant vapor (suction) lines shall be insulated with insulation having a thermal resistivity of at least R-4. (Armor Flex- trade name)

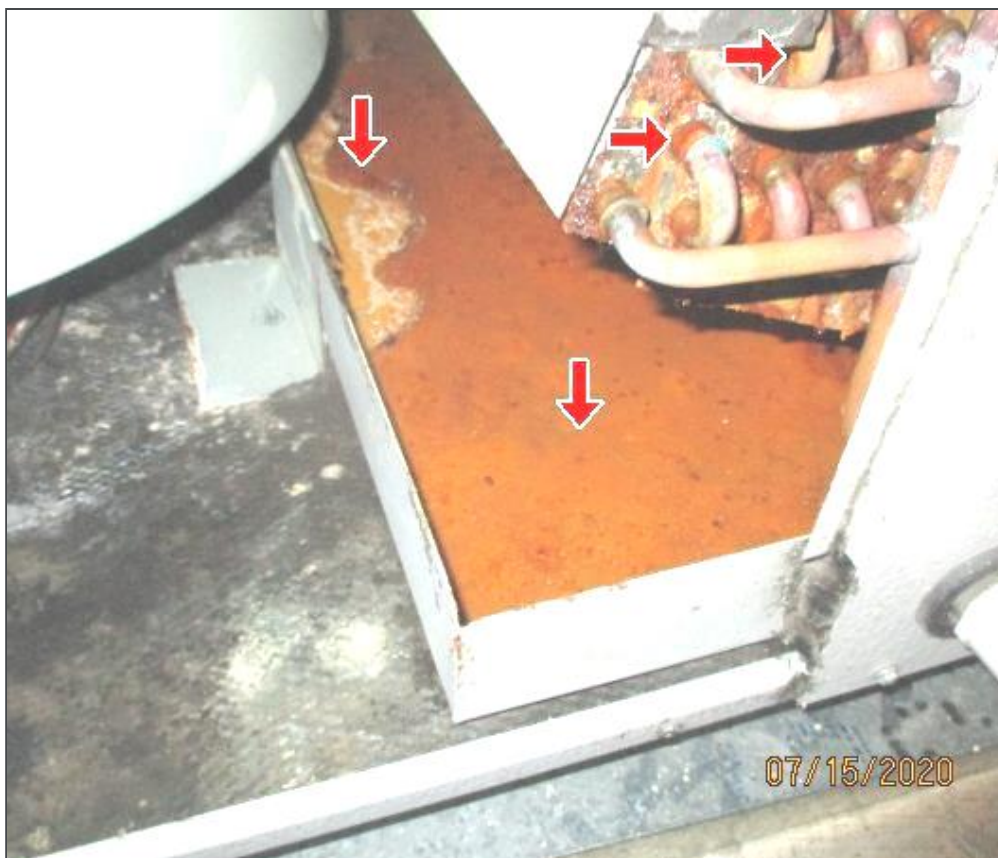
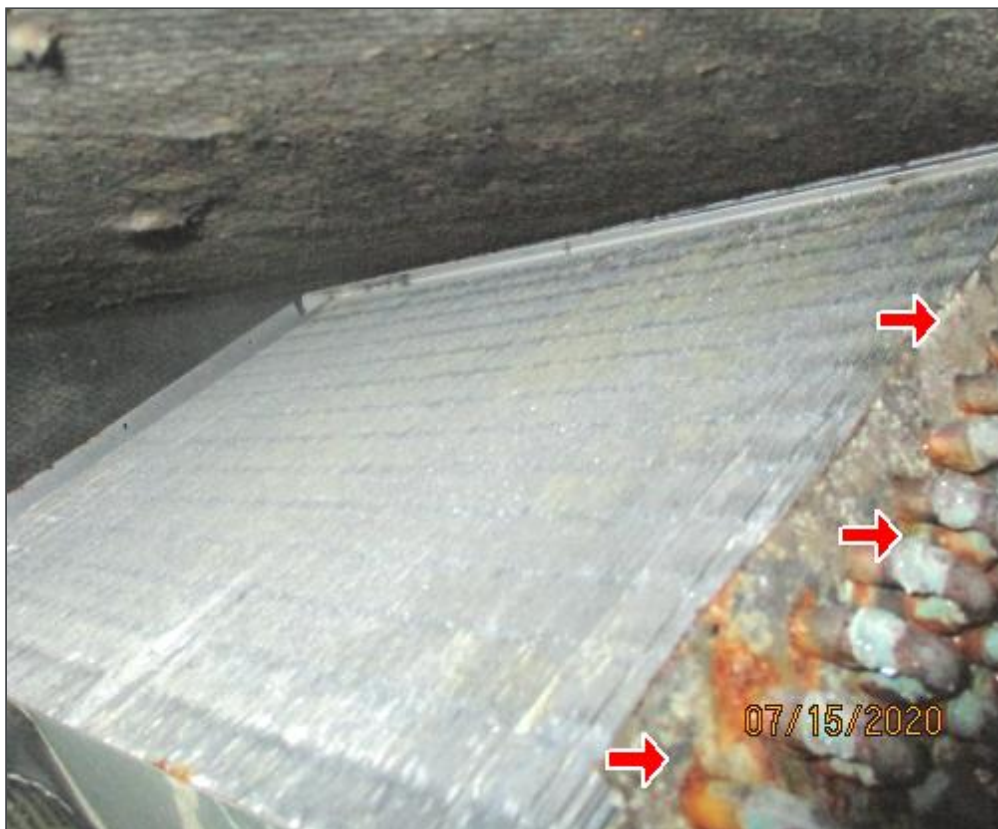
- (1) FIRST COMPANY M# 36HB0B
- (2) Interior coil appears to be failing. Rusting may indicate the condensation discharge line is clogged.

Evaluation by a licensed HVAC technician is recommended.

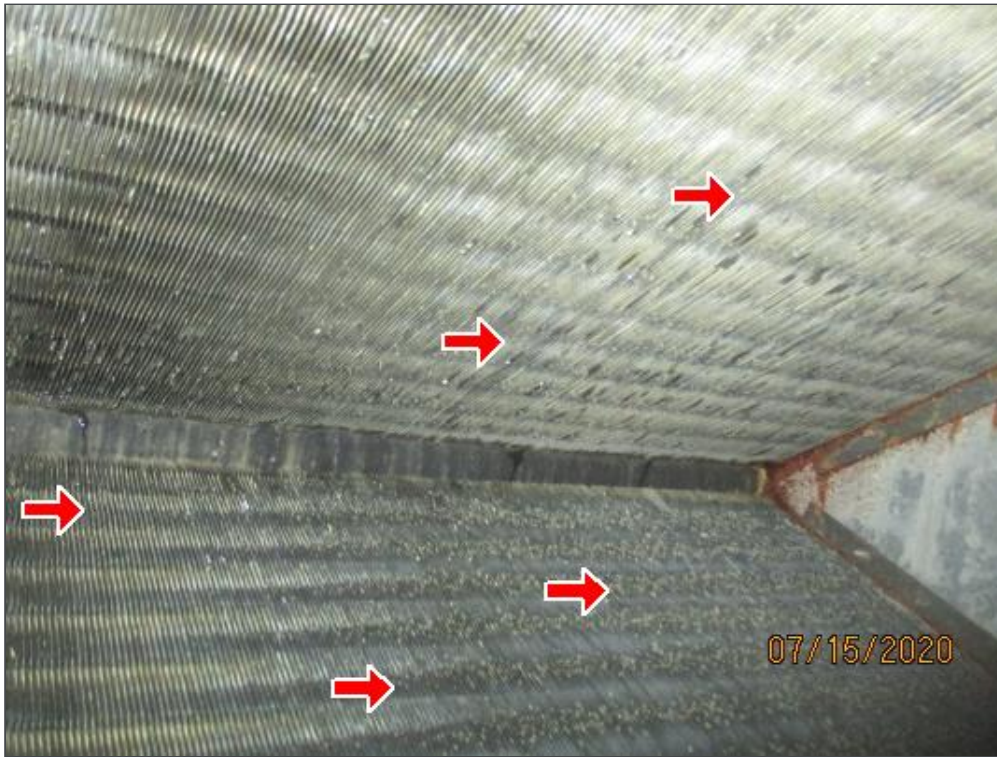
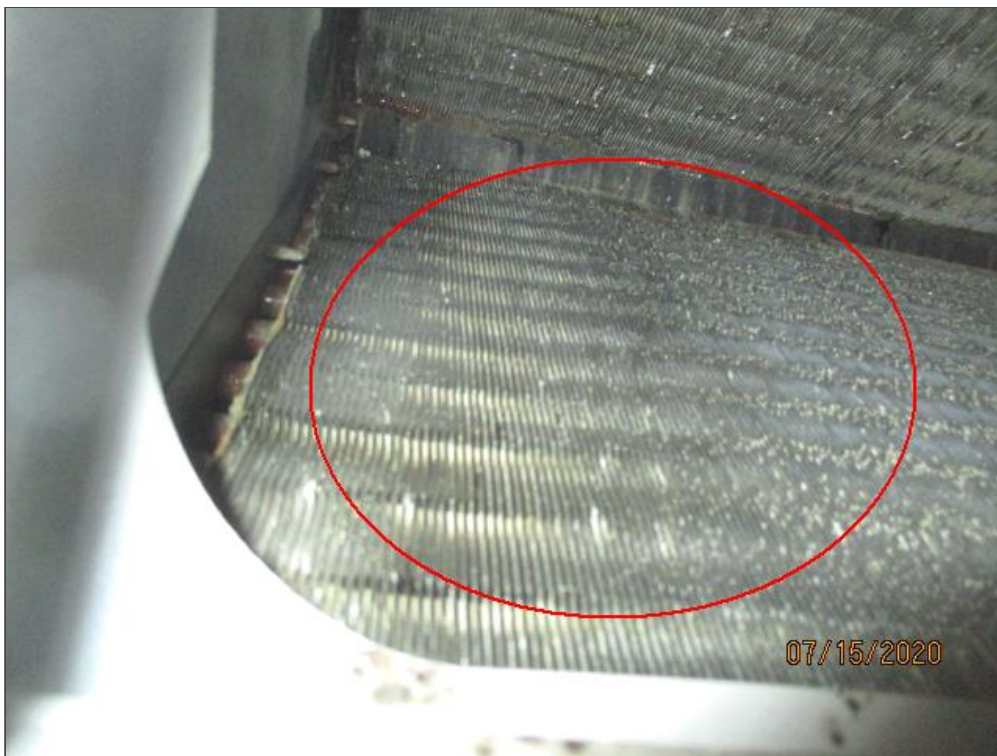
(3) Interior side of the coil is clogged more than 65% . This suggest that the unit has been operated at some point in the history without a filter.

Note: Given the location of the filter regular maintenance is difficult.

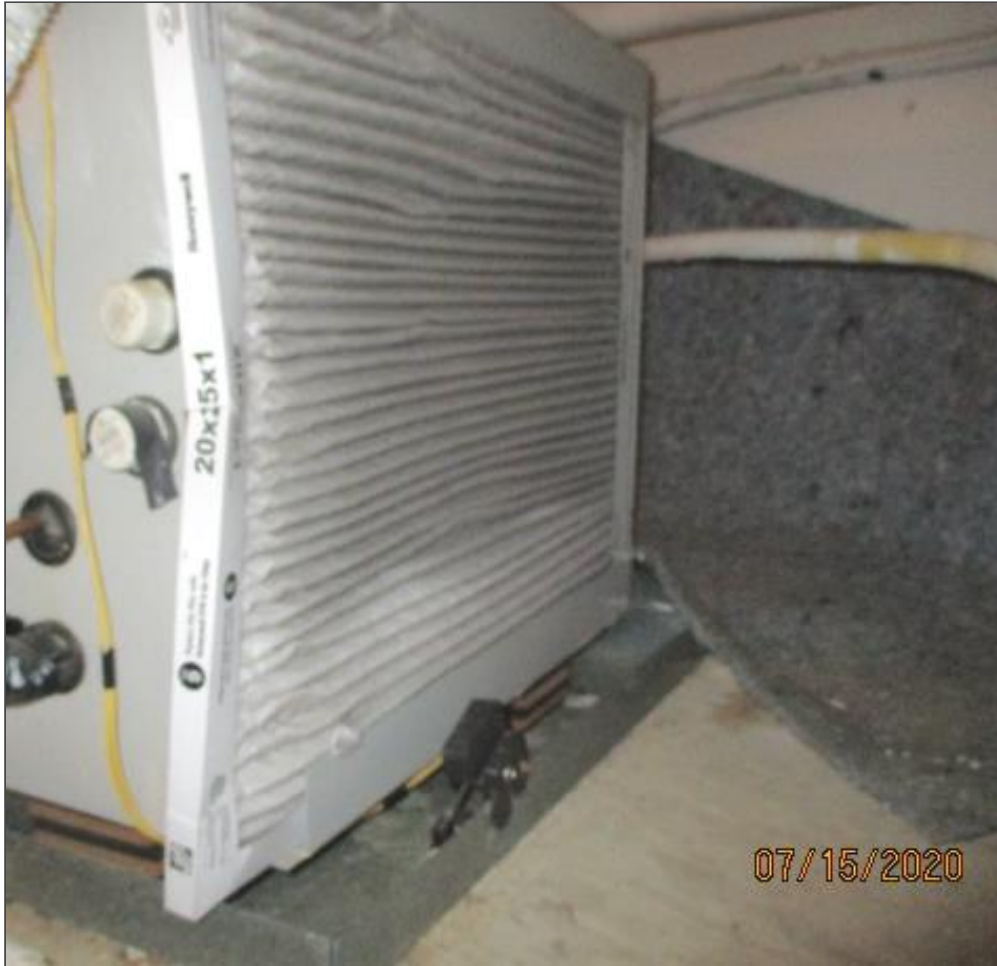
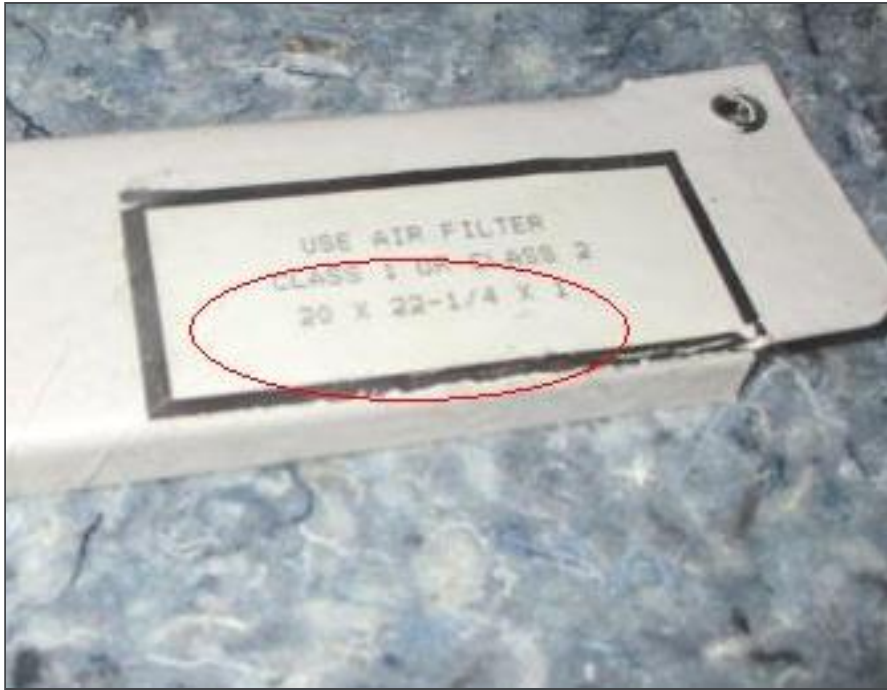
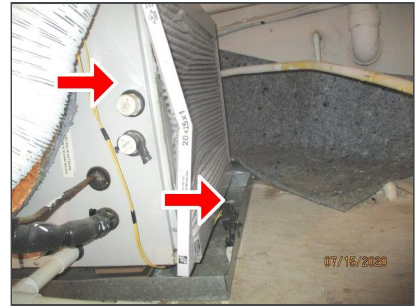
Filter is dirty and should be replaced soon. Filter is not sized. The filter wrack cover is in the area.

A better quality improves performance and quality of air cleaning. Good choices include a one inch pleated filter or larger media filter that provide more surface area. Look for filters with a higher micro particle performance rating.( 800 and up.)

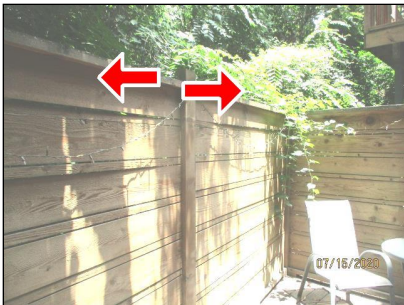
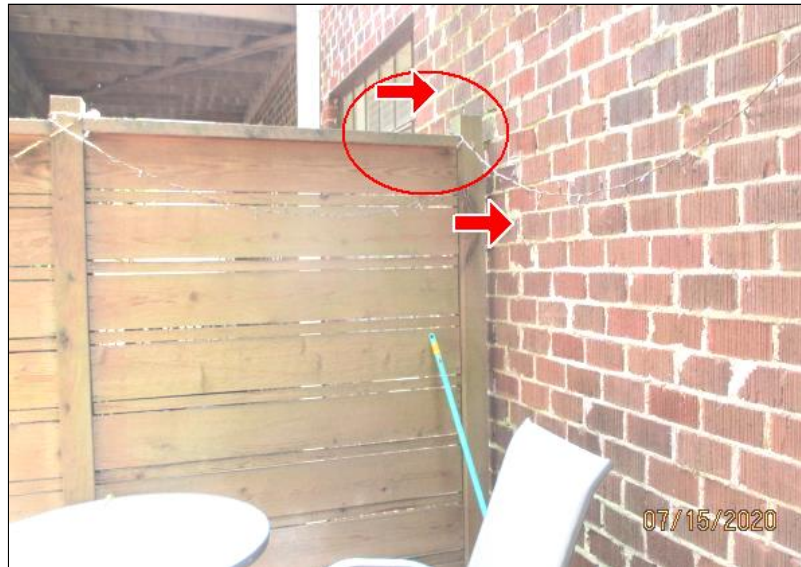
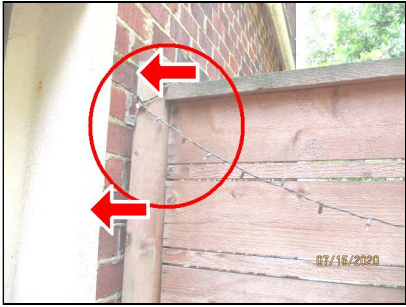
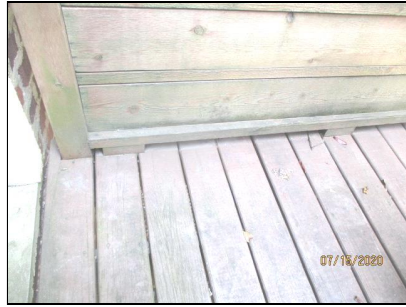
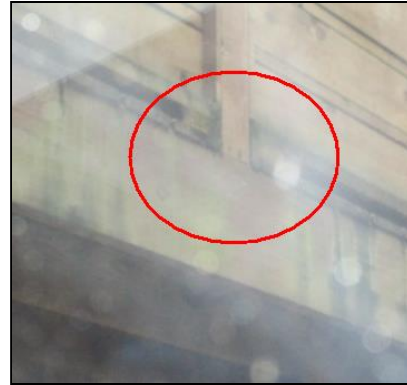
**1.0** The more than 7 feet privacy fence around the perimeter of the deck has substantial lateral movement on all sides. This creates an unsafe condition.

Further evaluation of the Railing post to the deck band indicates the attachment is secure by two nails.

The railing post closest to the wall are not secured.

It could not be determined if this is the responsibility of the Home Owners Association.

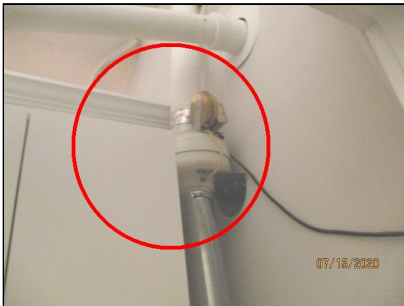
2.4 Item 1(Picture)

**2.4** Electric dryer booster fan in place. Function not verified. Dryer booster fans help boost airflow through the dryer duct. ... A pressure switch senses pressure in the dryer duct run and allows power to flow to the fan. A current sensing relay senses electricity flowing to the dryer and as a result - it allows power to flow to the fan.

FUNCTION NOT VERIFIED - Unit is displaced.

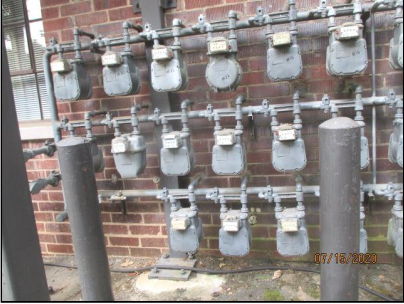
4.4 Item 1(Picture)

**4.4** Gas meters are individual to the each unit. Right end of the building.

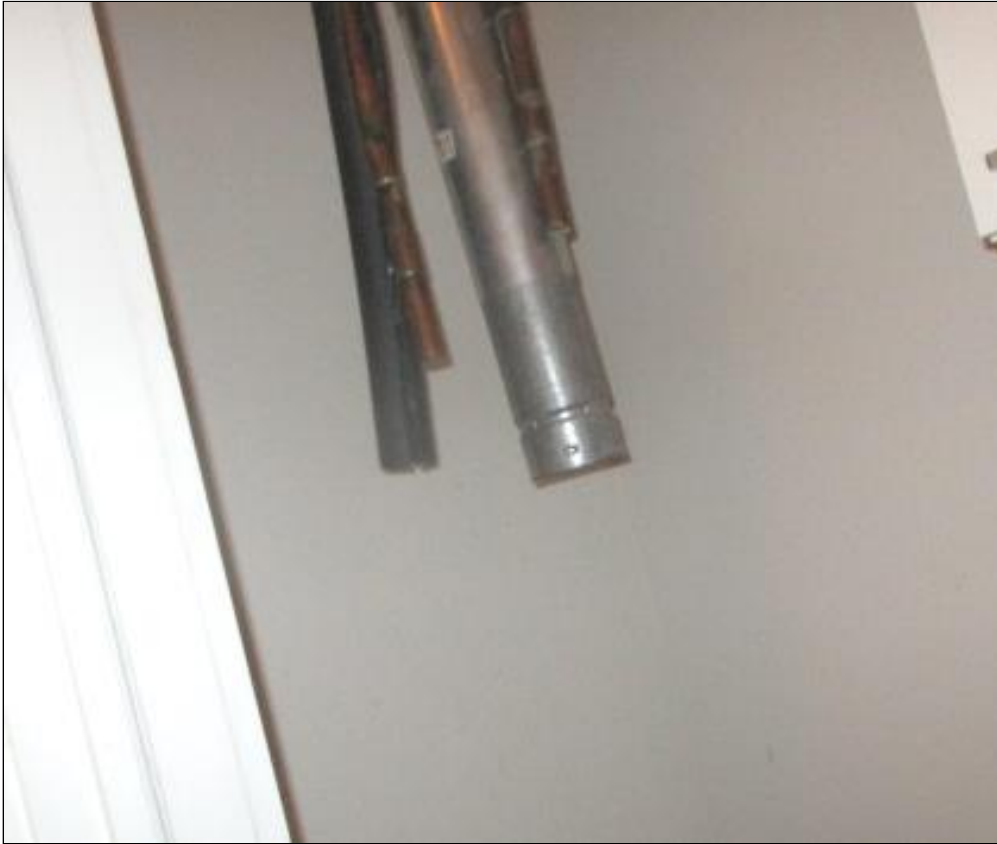
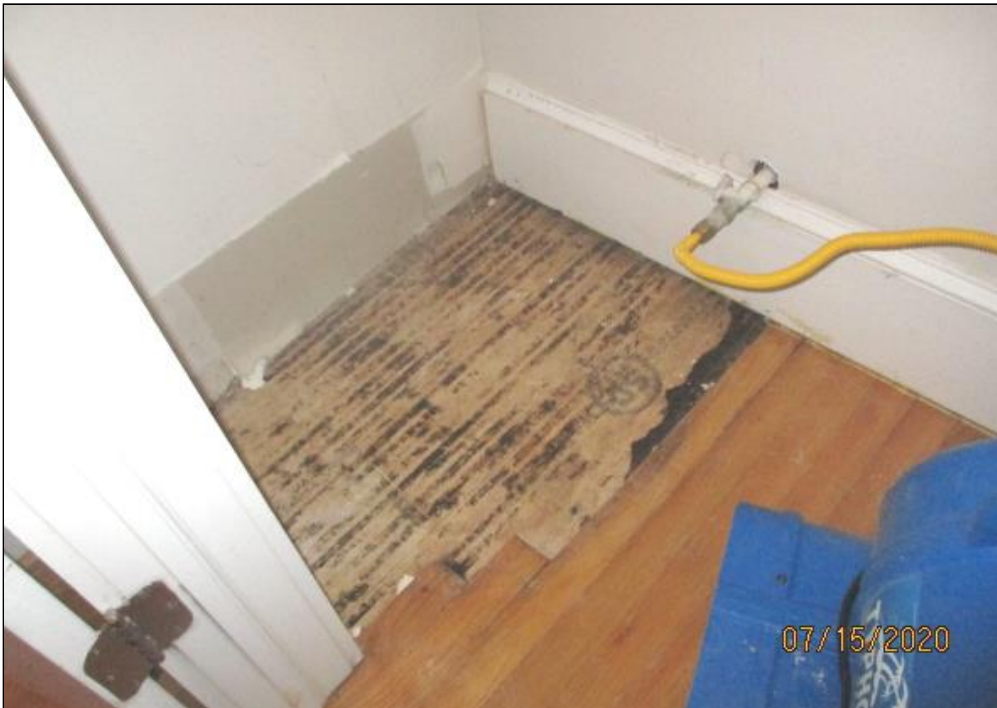
4.5 Water heater has been removed due to a leak. Water damage to the flooring extends from the hall utility closet and hall.

Replacement and repairs are pending.

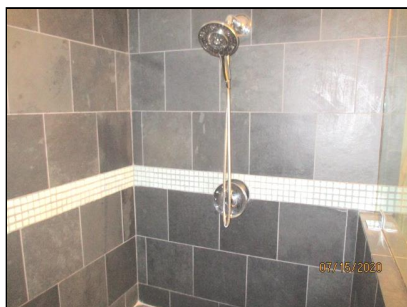
4.9 Item 1(Picture)

## 4.9 Hot water service not available.

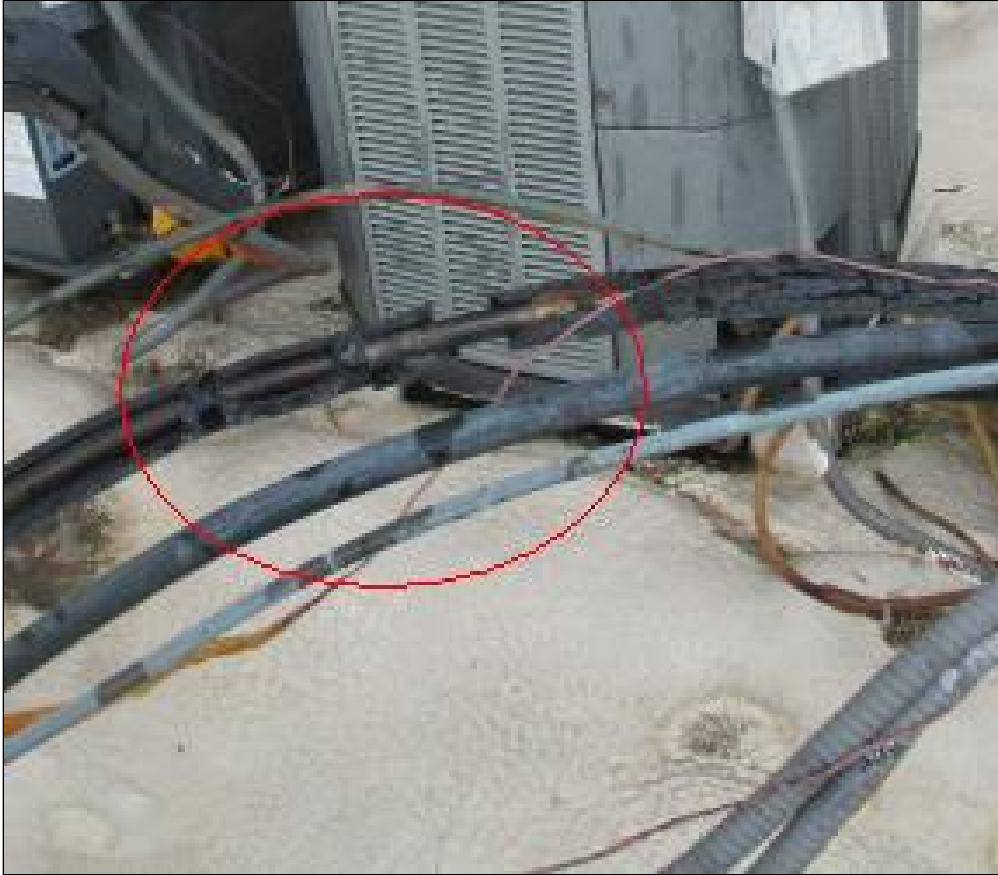
6.2 Item 1(Picture)

🏠 **6.2** The foam sleeve on suction line is missing foam sleeve in area(s) at outside unit. Missing foam on suction line can cause heat gain and energy loss and condensation. Piping and fittings for refrigerant vapor (suction) lines shall be insulated with insulation having a thermal resistivity of at least R-4. (Armor Flex- trade name)

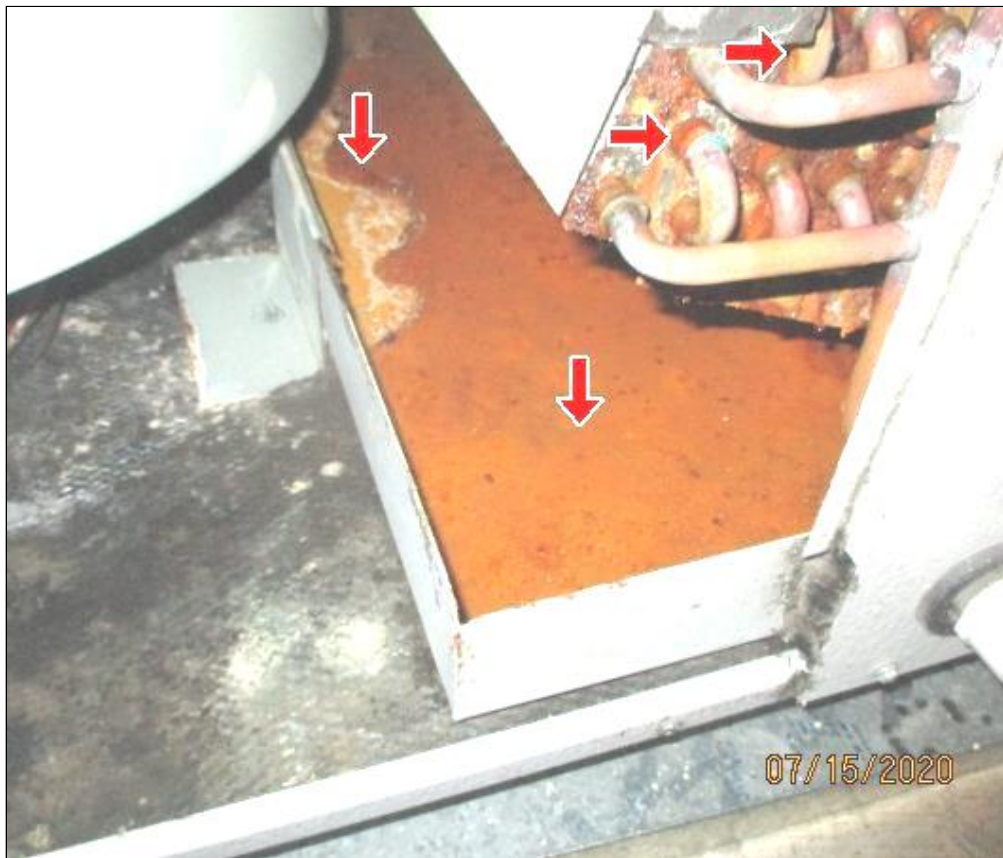
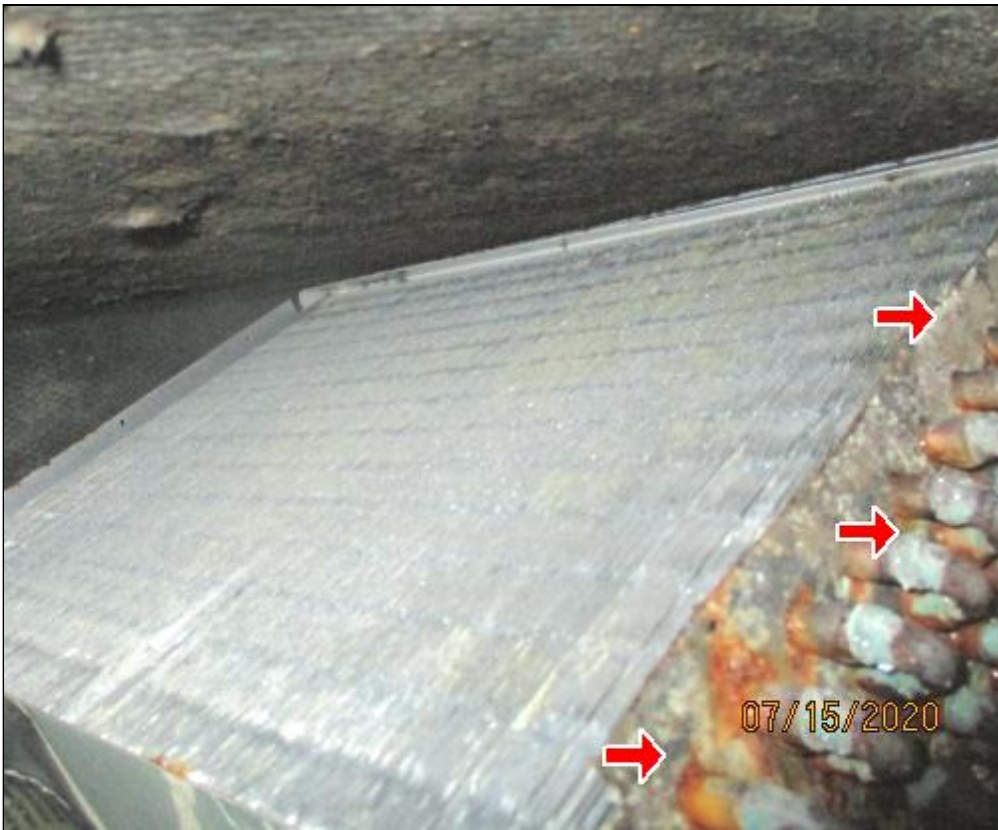
(2) Interior coil appears to be failing. Rusting may indicate the condensation discharge line is clogged.

Evaluation by a licensed HVAC technician is recommended.

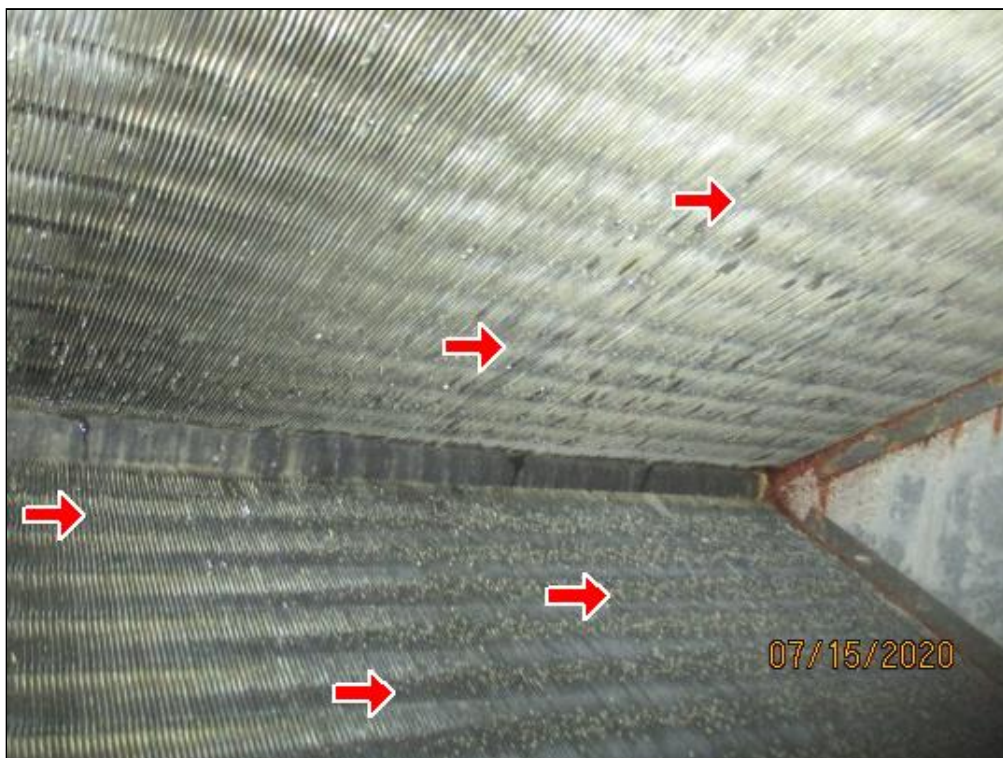
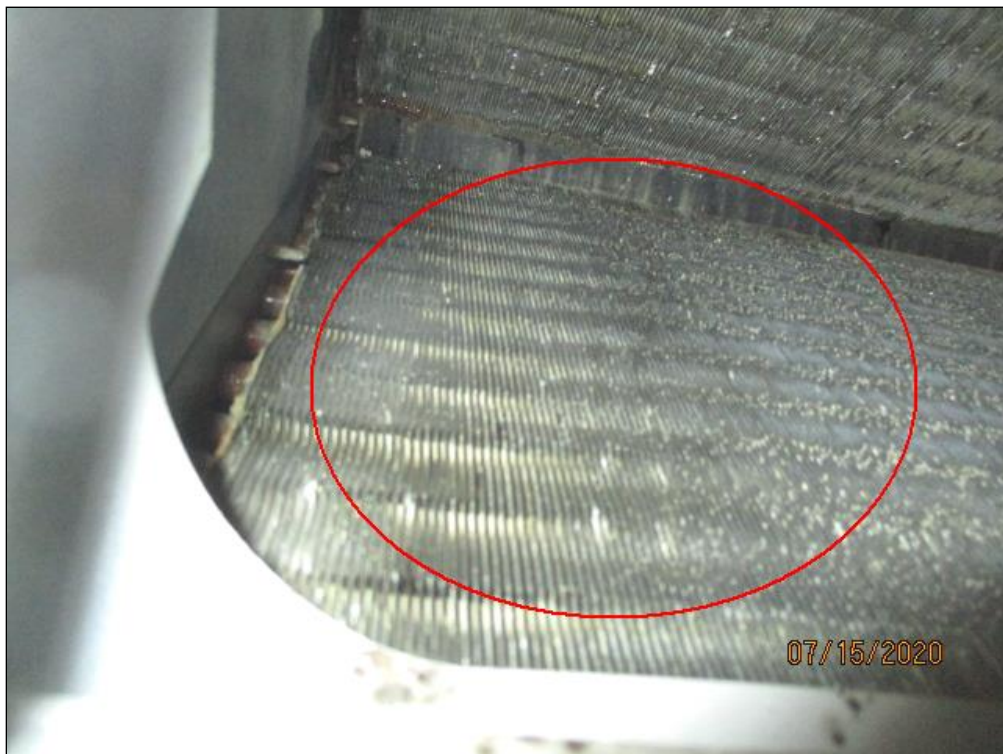
(3) Interior side of the coil is clogged more than 65% . This suggest that the unit has been operated at some point in the history without a filter.

Note: Given the location of the filter regular maintenance is difficult.

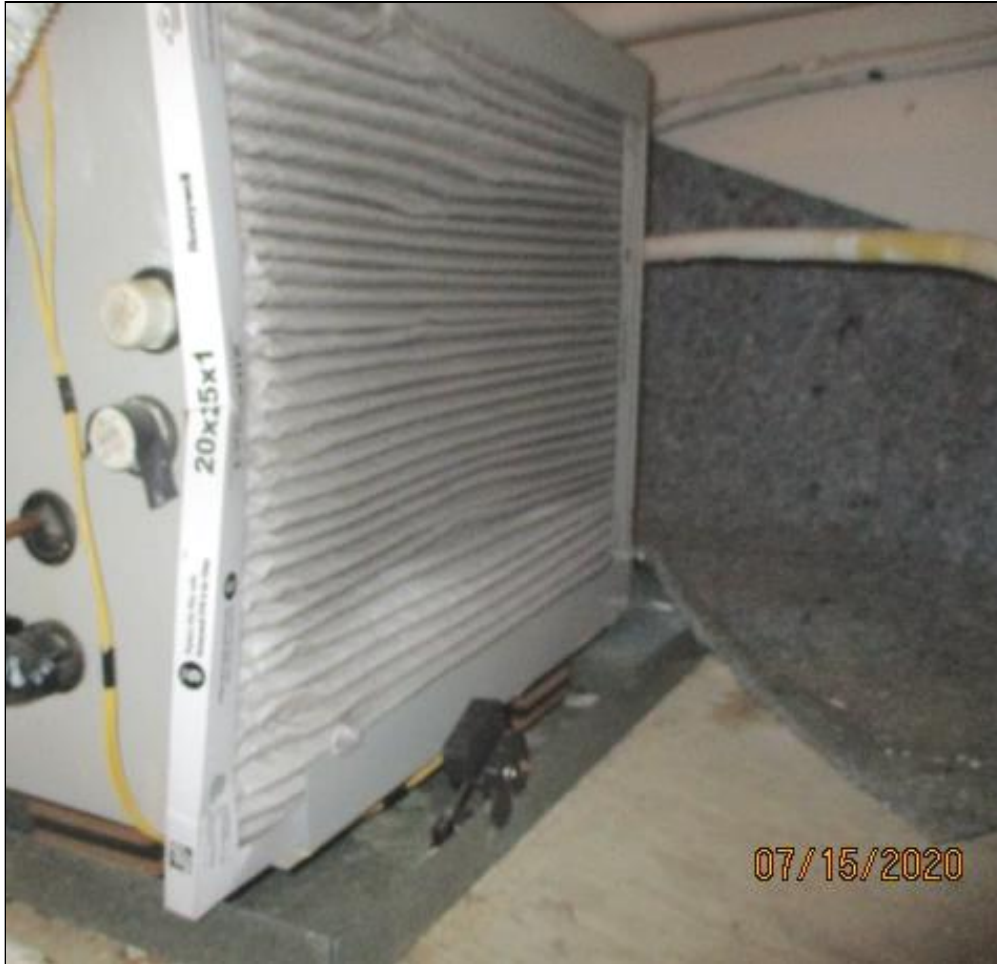
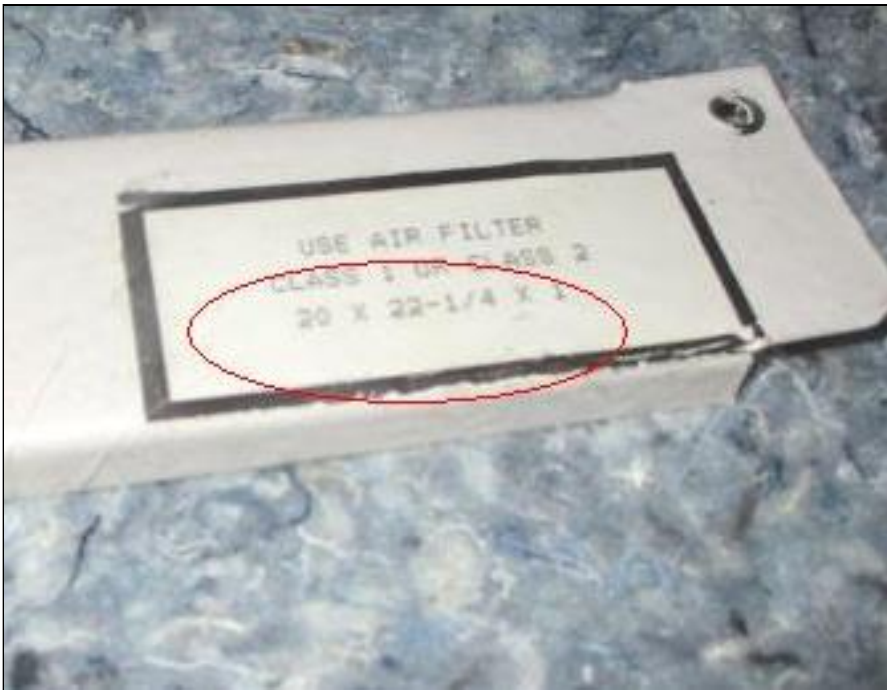
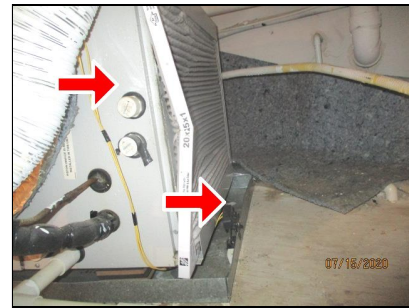
**7.2** Filter is dirty and should be replaced soon. Filter is not sized. The filter wrack cover is in the area.

A better quality improves performance and quality of air cleaning. Good choices include a one inch pleated filter or larger media filter that provide more surface area. Look for filters with a higher micro particle performance rating. ( 800 and up.)
