Inspection Report

Modified DIY - Mid Century Modern
Stone Mountain GA 30083

Common Cents Home Inspection Services Inc

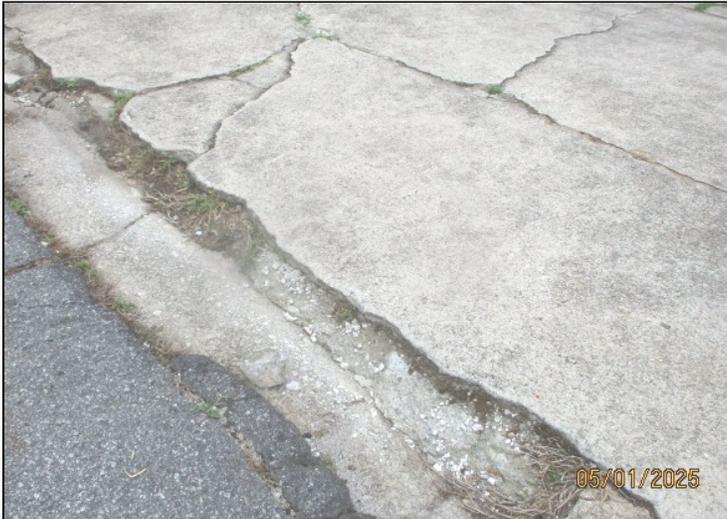
1.0 Item 1(Picture)

1.0 (1) Evidence of deterioration. Surface raised,settled creates trip hazard.

Drive replacement should be expected.

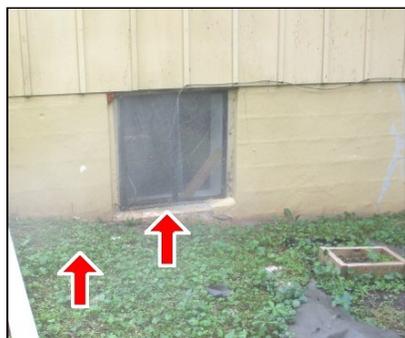
1.1 Item 1(Picture)

1.1 (2) Right rear window corner is at or below grade. Subject to moisture intrusion

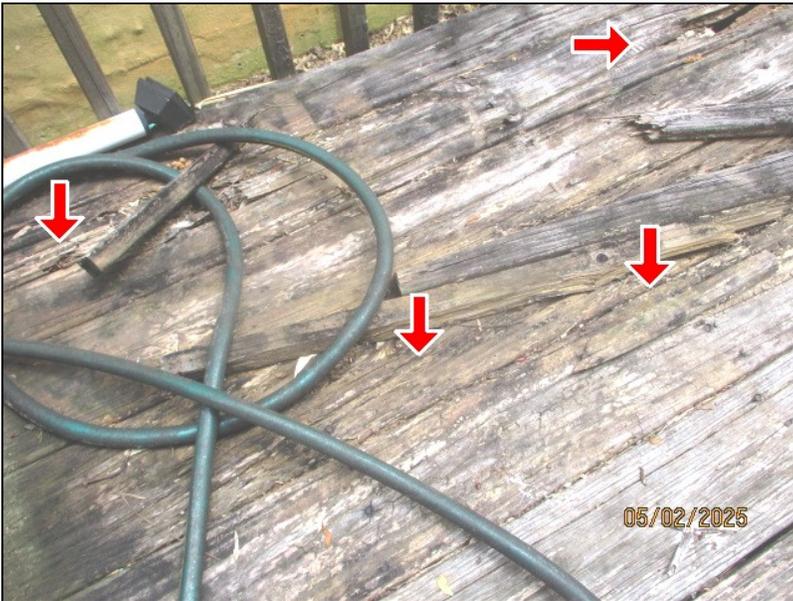
1.2 Item 11(Picture)

1.2 (6) More than 75% of the decking has failed from water damage and delayed maintenance.

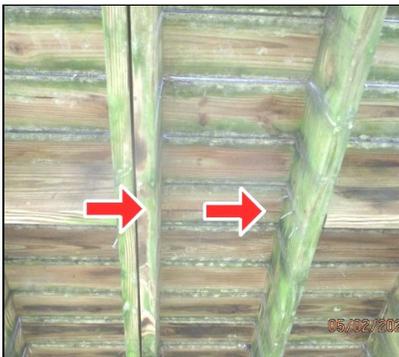
1.2 Item 15(Picture)

Missing in two sections minimum

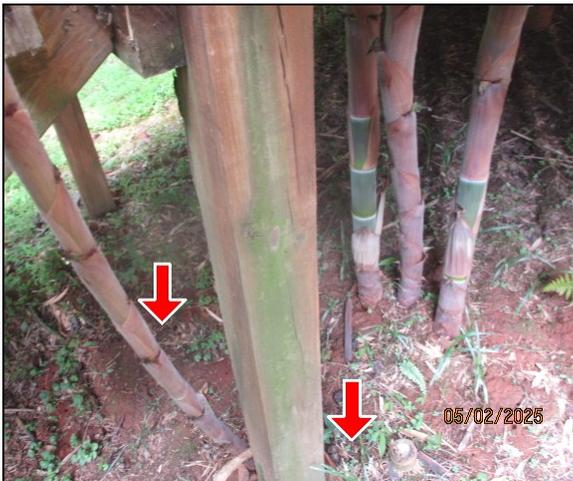
1.2 Item 18(Picture)

1.2 (11) Vertical supports are weight bearing. Terminate below grade and subject to decay. Probing indicated the post are resting on a concrete footing. Type not determined.

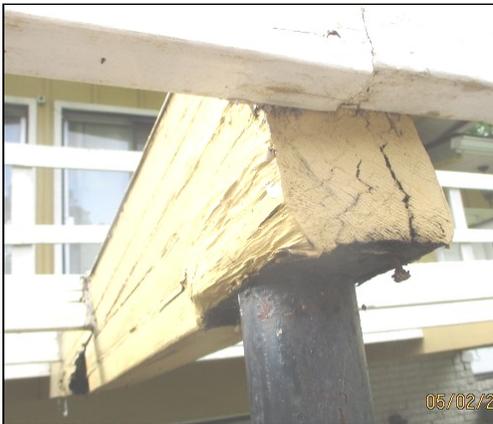
1.3 Item 4(Picture) Water Damage Advanced

More than 70% of the exposed wood material is failing. It is likely this structure should be demolished and rebuilt.

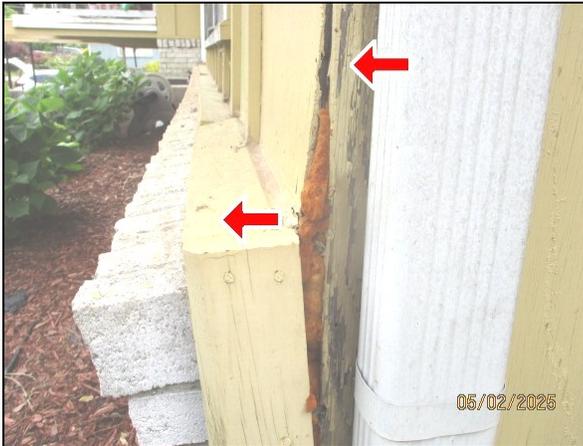
1.5 Item 4(Picture) Left Front Wall Frame Connection

1.5 (4) Settlement of masonry wall at front entry. Expansion foam is failing.

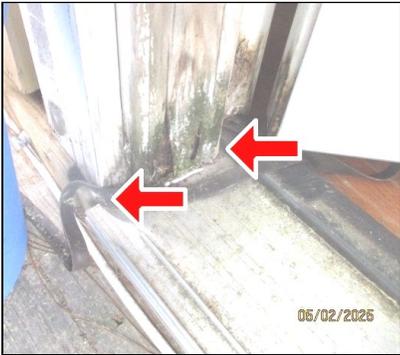
1.5 Item 7(Picture)

1.5 (5) Deck door frame threshold. Contributing factors missing caulk and paint coat.

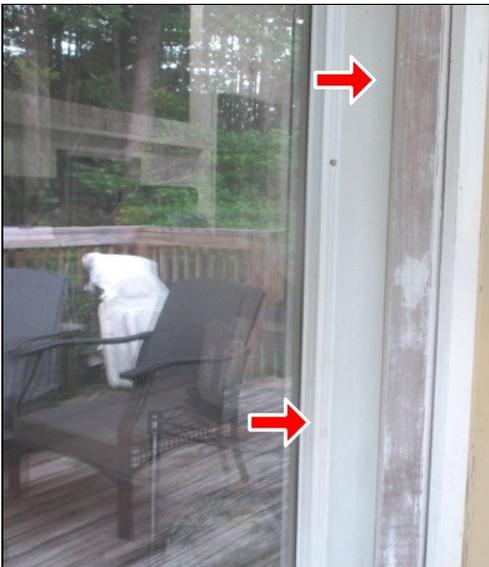
1.6 Item 1(Picture)

1.6 All exterior wood siding and trim are past due for a professional cleaning, repair and paint coat.

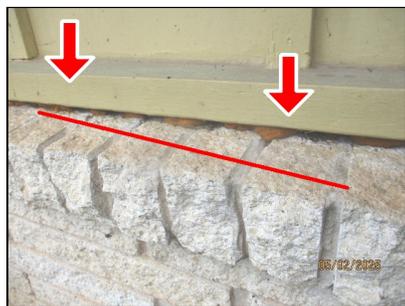
1.8 Item 1(Picture) Front Entry

1.8 (1) Failing and dislodged brick under the front door frame as well as at the corner of the walk. Tuck pointing is recommended.

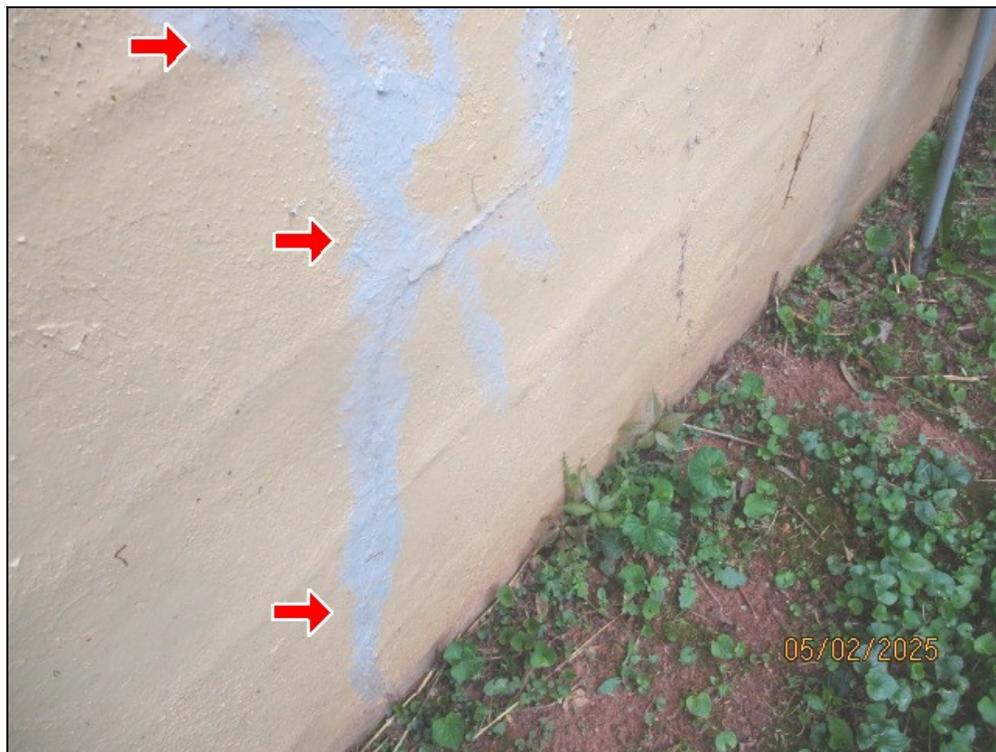
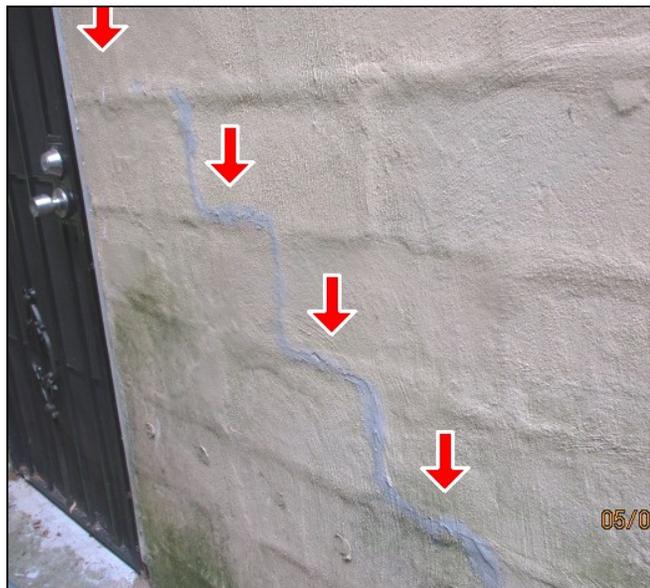
1.8 (2) A stair-step crack is a diagonal crack but, since mortar is usually not as strong as concrete block or brick, the crack migrates to the mortar joints as it zigzags along a path of least resistance.

Noted along the right side wall, back wall and rear corner.

Further evaluation by a structural engineer/contractor is recommended. One option includes helical piers that are drilled to bedrock and supports the wall foundation.

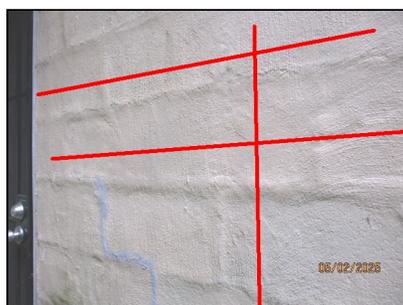
1.8 Item 8(Picture)

1.8 (3) All the mortar cinder block mortar lines present as bulging. Suggest trapping of moisture behind the exterior coating.. Condition consistent on all four sides of the dwelling.

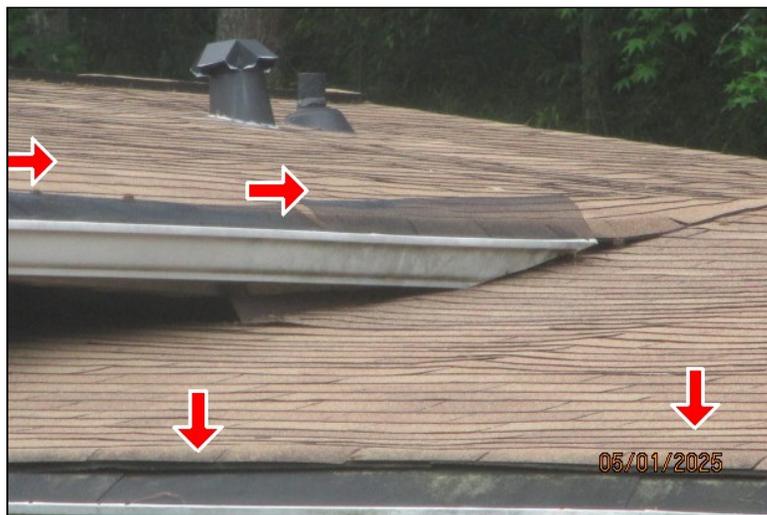
1.10 Item 1(Picture)

1.10 (1) Gutter guards are incorrectly installed. All material is designed to be tucked under the edge of the shingle and to lay flat on top of gutter collecting debris during surface water run off.

Others sections are missing guard section

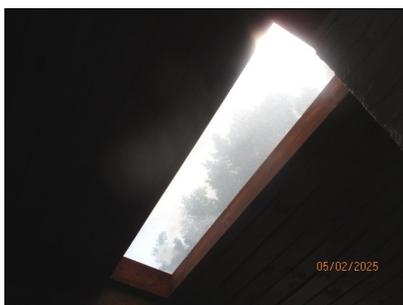
2.0 Item 12(Picture)

2.0 (4) Two skylights are failing. Replacement should be expected.

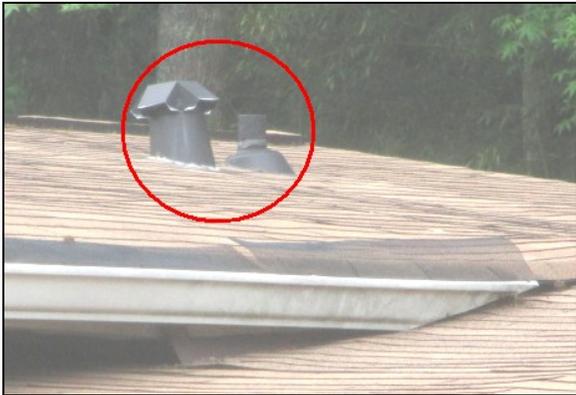
2.1 Item 1(Picture)

2.1 Penetrations appear to have received maintenance.

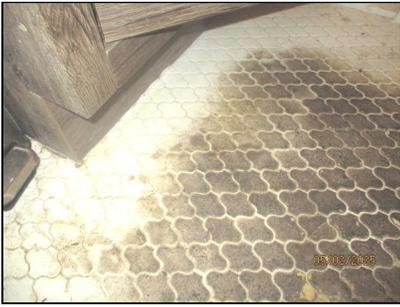
3.1 Item 1(Picture)

3.1 Master bath flooring tile has a dark glue type material covering the area.

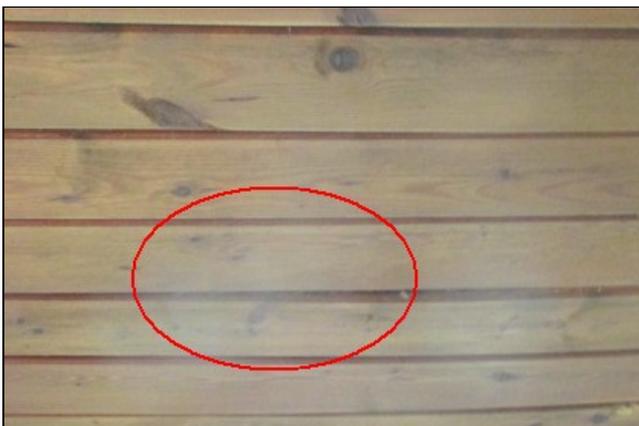
3.3 Item 4(Picture)

3.3 (3) Tongue and grooved ceiling material is original to construction. More than 6 areas present with water damage. Due to height restrictions brittle or damaged material could not be determined.

Note: Conditioning of wood material is always an option to be completed by a professional.

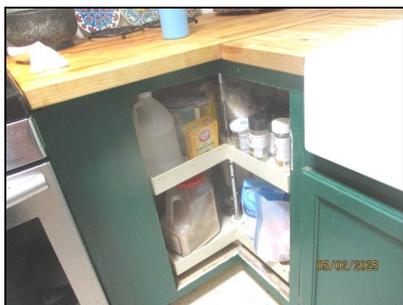
5.6 Item 1(Picture)

5.6 Missing base cabinet door interior corner next to stove.

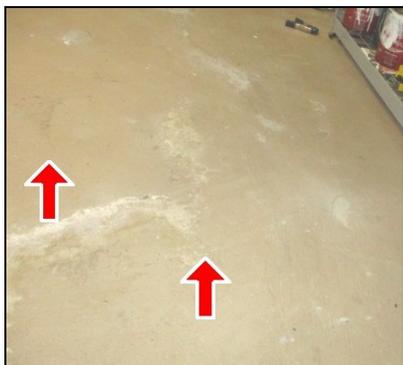
7.0 Item 1(Picture) Right Front Corner

7.0 (1) Slab foundation is raised 1.5 inches. Vertical lift extends along the length of the room towards exterior wall.

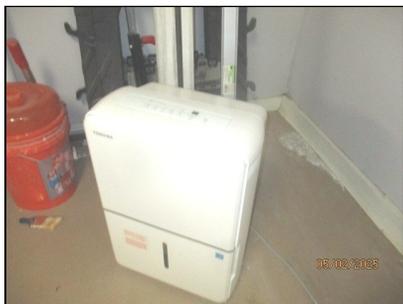
7.0 Item 2(Picture)

7.0 (2) Dehumidifier has been in use right front of basement.

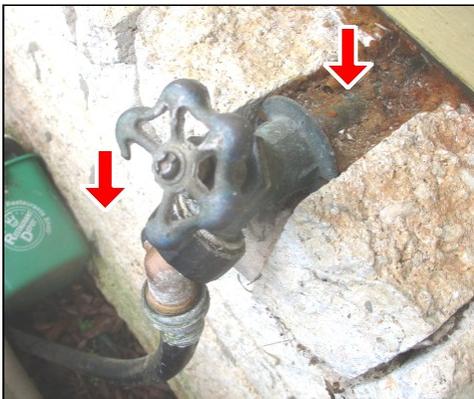
8.1 Item 1(Picture)

8.1 Front faucet control knob is damaged.

Note: Water intrusion behind the masonry wall is likely.

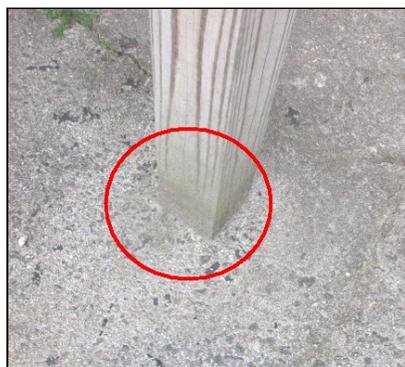
10.0 Item 1(Picture)

One support has been replaced with 4X6 wood in contact with concrete floor. This is subject to water intrusion under the wood support and premature failing from water damage.

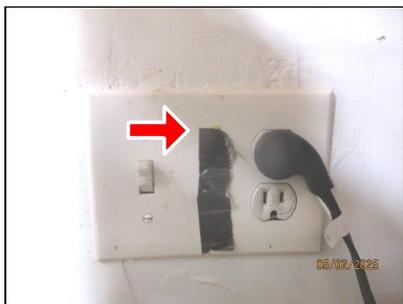
11.4 Item 1(Picture)

11.4 (1) Receptacle next to refrigerator has black tape over the receptacle. Source unknown

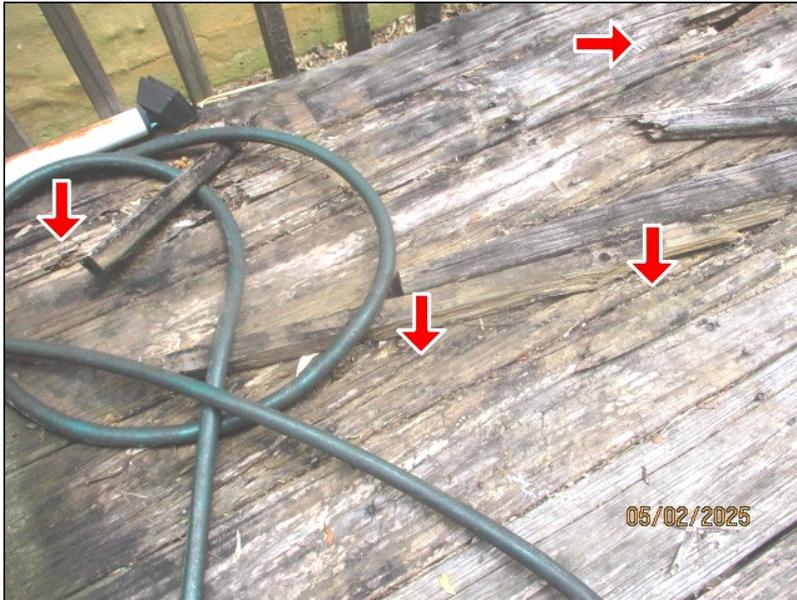
1.2 Item 11(Picture)

(6) More than 75% of the decking has failed from water damage and delayed maintenance.

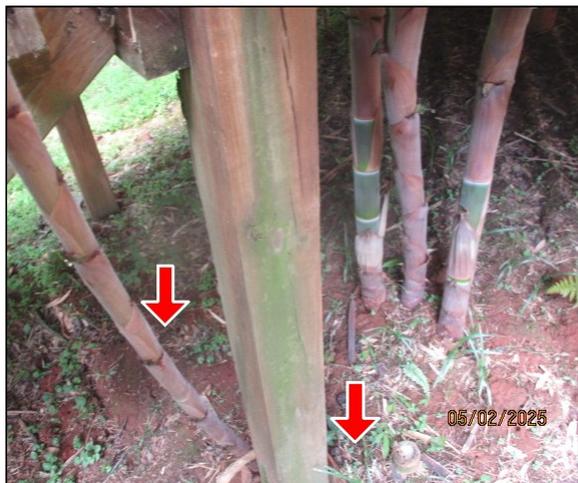
1.2 Item 18(Picture)

(11) Vertical supports are weight bearing. Terminate below grade and subject to decay. Probing indicated the post are resting on a concrete footing. Type not determined.

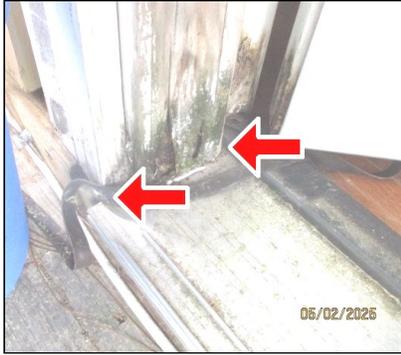
1.5 Item 7(Picture)

(5) Deck door frame threshold. Contributing factors missing caulk and paint coat.

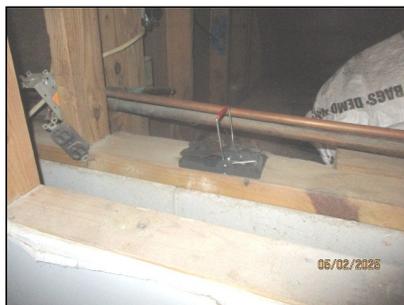
3.0 Item 1(Picture)

A number of rodent traps identified in the basement area under the stairs.

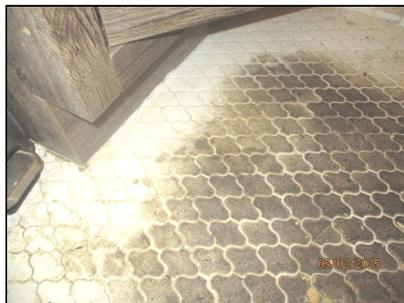
3.1 Item 1(Picture)

Master bath flooring tile has a dark glue type material covering the area.

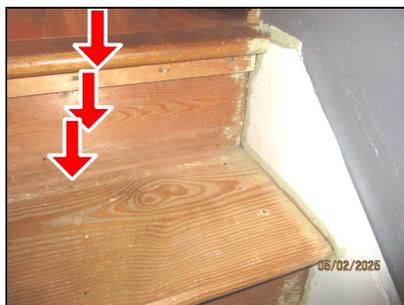
3.2 Item 1(Picture)

(1) First step down riser 8.5 inches while the remainder is 7.25. Creates unsafe step condition. Caution.

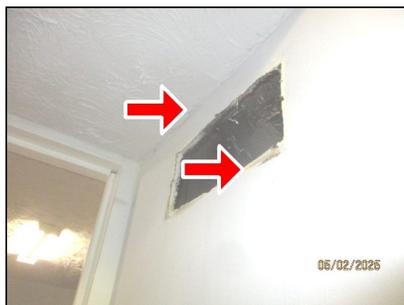
3.3 Item 3(Picture)

(2) Cut away in the right rear of basement wall next to the furnace. Adding a supply vent may have been planned.

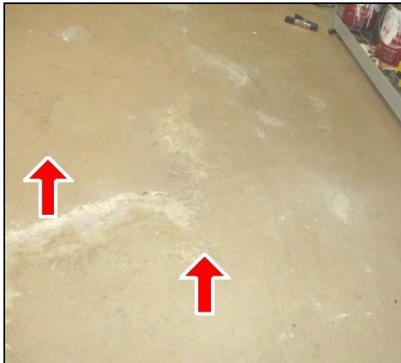
7.0 Item 1(Picture) Right Front Corner

(1) Slab foundation is raised 1.5 inches. Vertical lift extends along the length of the room towards exterior wall.

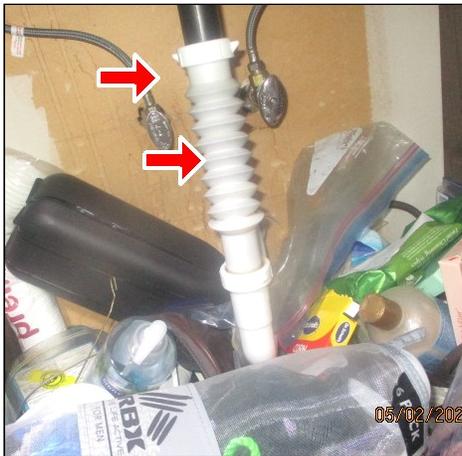
9.0.A Item 1(Picture)

Corrugated drain material is not approved for this application. Plumbing is gravity driven. All interior material is smooth in the direction of flow.

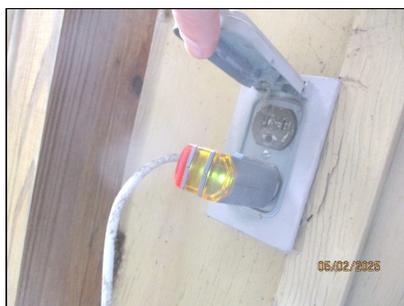
11.2 Item 1(Picture) No GFCI protection.

Updating the electrical system to include Ground Fault circuit Breaker(GFCI) is recommended. Ground Fault Circuit Interrupters are electrical safety devices that provide protection against electrical hazards in all bathrooms,garages, kitchens,basements ,exteriors and all other wet areas.
