Inspection Report

First Time Home Buyers Massive Structure

Property Address:
Popular Upscal Neighborhood
Atlanta GA 30328

Common Cents Home Inspection Services Inc

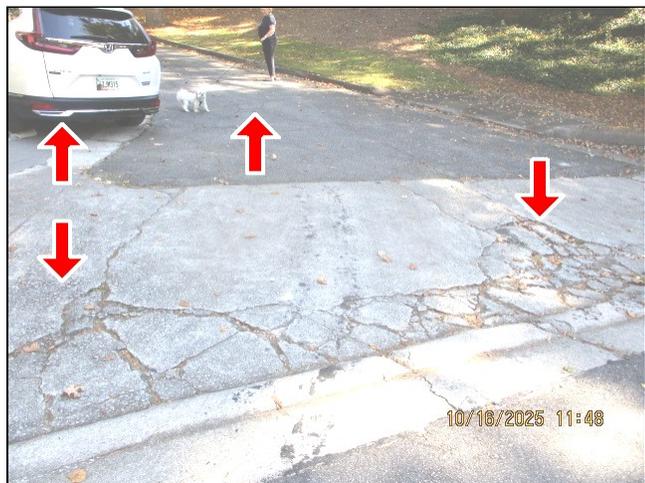
1.0 Item 1(Picture)

1.0 (3) Split entrance pad from street appears to be shared with neighbors.

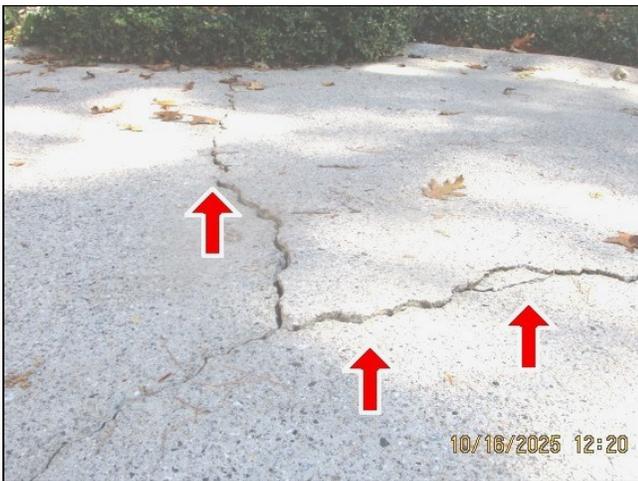
1.0 Item 2(Picture) Drive

Evidence of deterioration. Surface raised,settled creates trip

hazards

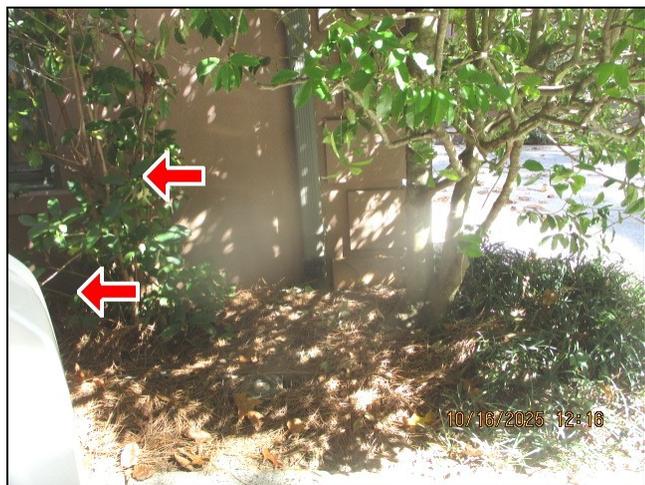
1.1 Item 1(Picture)

1.1 (2) Any landscape planting that is within 5 feet of the dwelling and subject to continued growth and encroachment against the exterior walls surfaces or root growth under the foundation footings should be considered for removal.

All corners. Plant material is original.

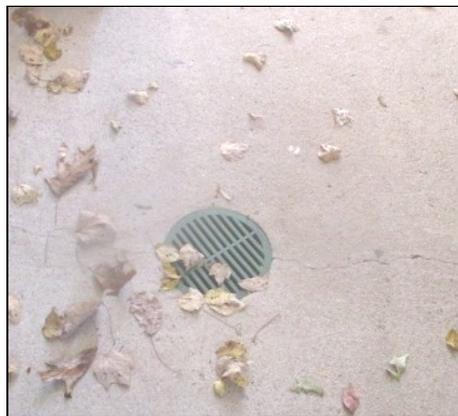
1.1 Item 2(Picture)

1.1 (4) Hall area between the main house and the garage is contained. Keeping debris away from the drain recommended.

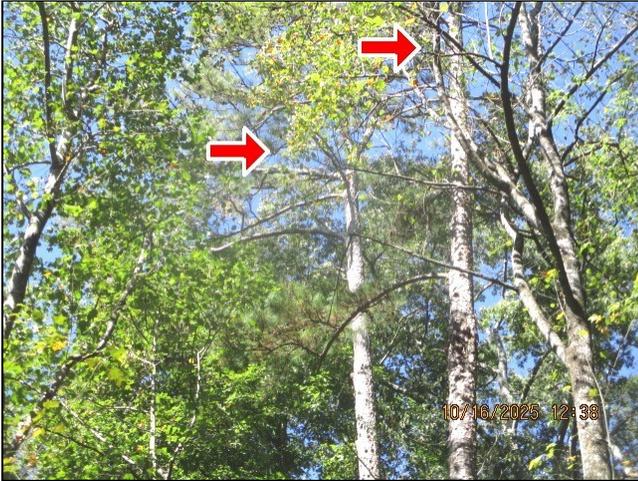
1.1 Item 3(Picture)

1.1 (5) Two pine trees to the left side of the lot are wind damaged with little growth.

Evaluation by an arborist and removal should be considered.

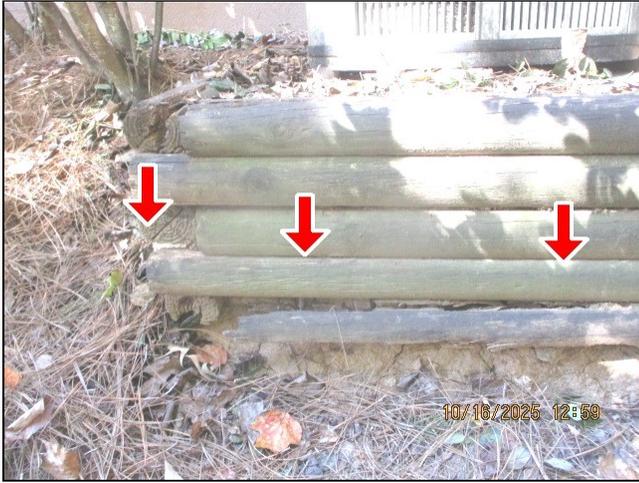
1.1 Item 4(Picture)

1.1 (6) HVAC compressor area. Water damage and rot.

Note: The walls are not secured together by any method. (nails or spikes)

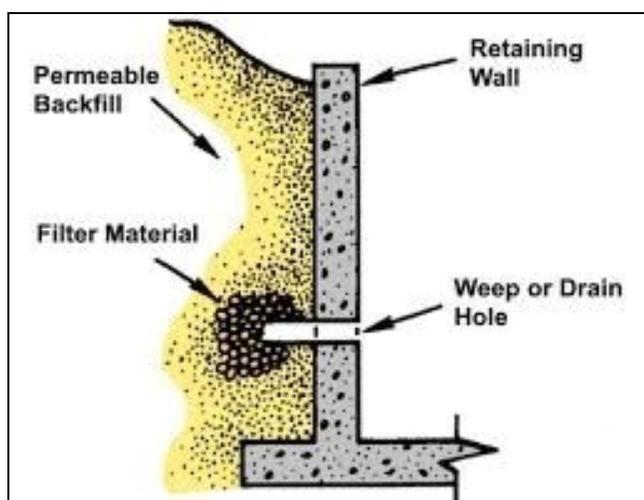
1.3 Item 1(Picture) Example: Weep Holes

1.3 (2) Weep holes are crucial for retaining walls because they allow water to escape, preventing the buildup of hydrostatic pressure that can cause the wall to fail. This is achieved by providing an outlet for rainmaker and grandfather, which helps prevent the soil behind the wall from becoming saturated and exerting excessive force on the structure

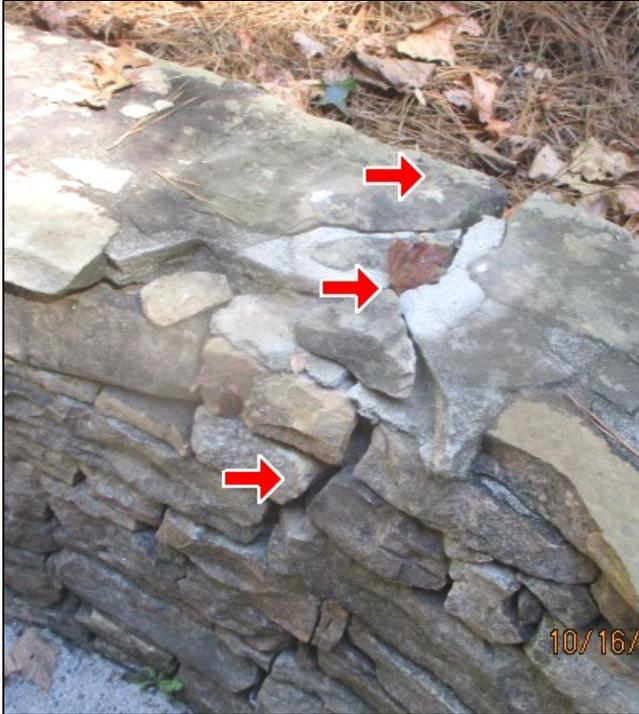
1.3 Item 2(Picture)

1.3 (4) Back elevation retaining wall has two cracks. Suggest the back fill may be to high.

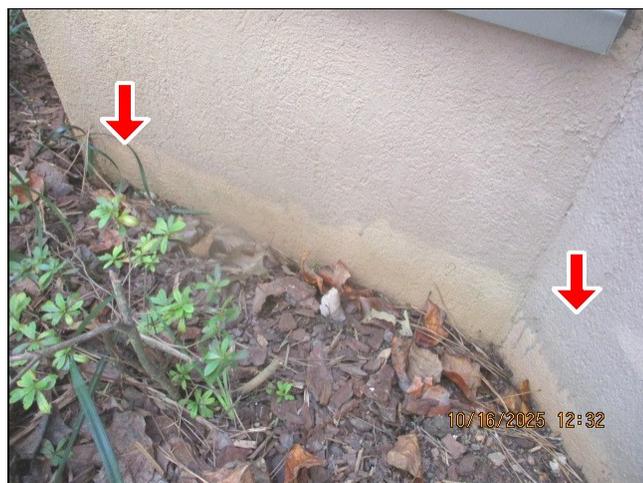
1.6 Item 1(Picture)

1.6 (2) Terminates below grade.

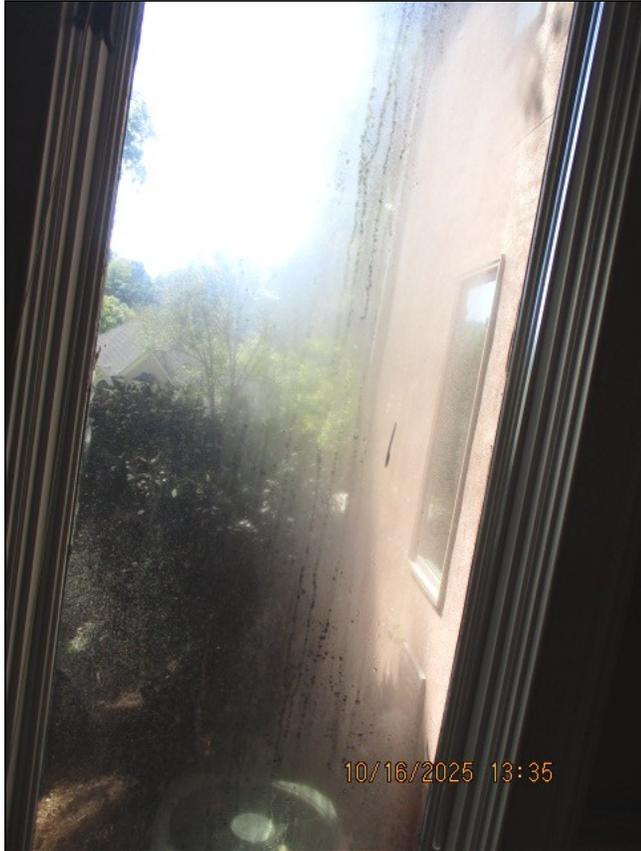
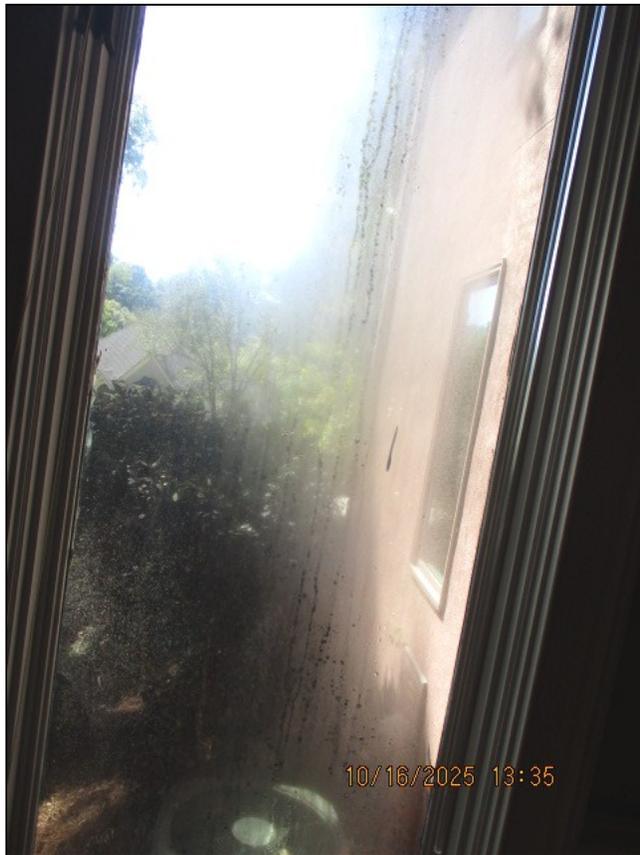
1.7 Item 1(Picture) Example

Windows sweating between its double panes of glass. These windows are factory sealed and designed to no air filtration. When the space between the panes loose their seal, condensation forms and it is noticeable as moisture accumulates and dries mineral deposits are collected. visibility decreases. Insulation value is only slightly reduced. how ever,

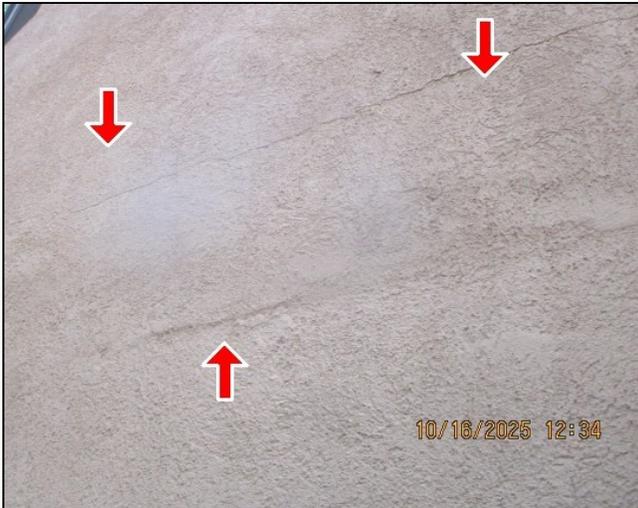
1.8 Item 1(Picture) Area is loose. Not secured to wall framing.

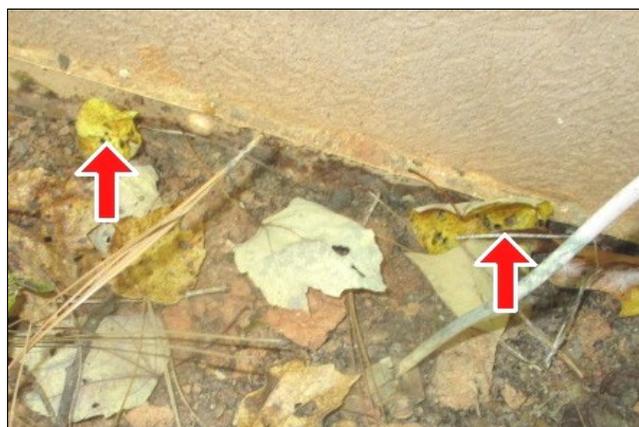
1.8 Item 8(Picture) Back Wall

1.8 (6) Bird pecking is contributing to this damage.

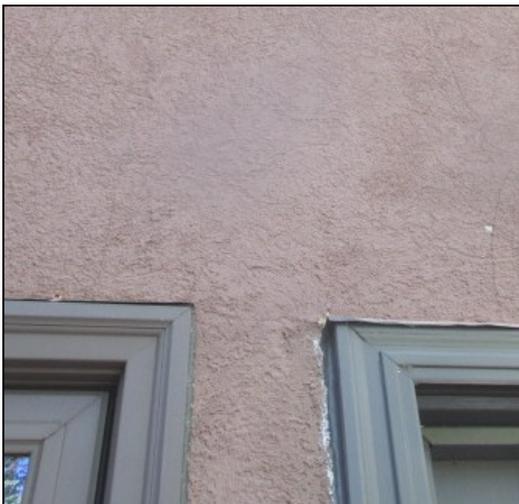
1.9 Item 7(Picture)

1.9 (3) All dissimilar material has failing sealant or is missing sealant.

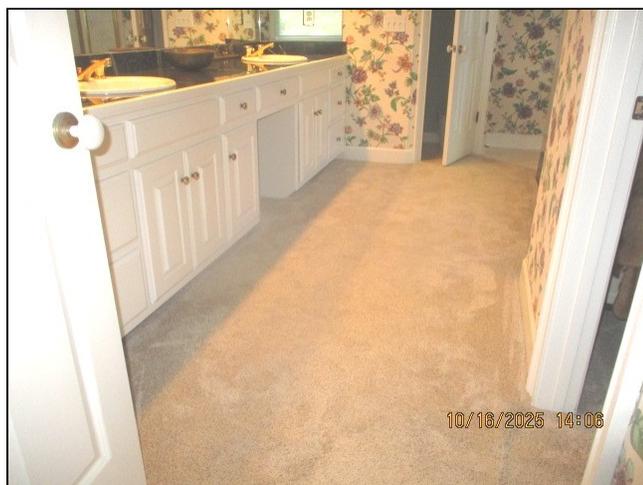
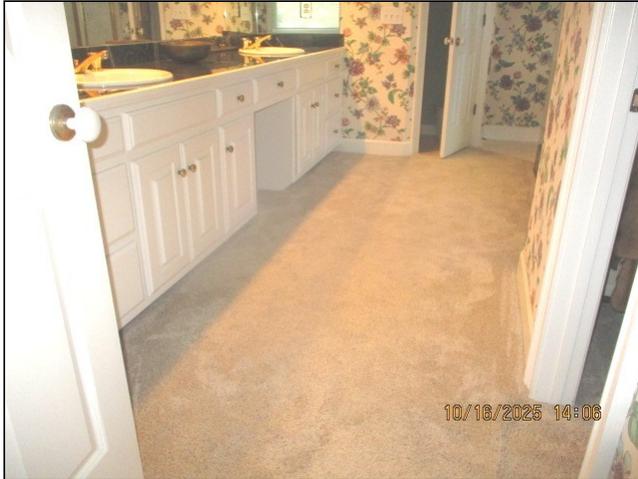
3.0 Item 2(Picture)

3.0 (5) Carpets in wet area is no longer recommended due to bacteria concerns.

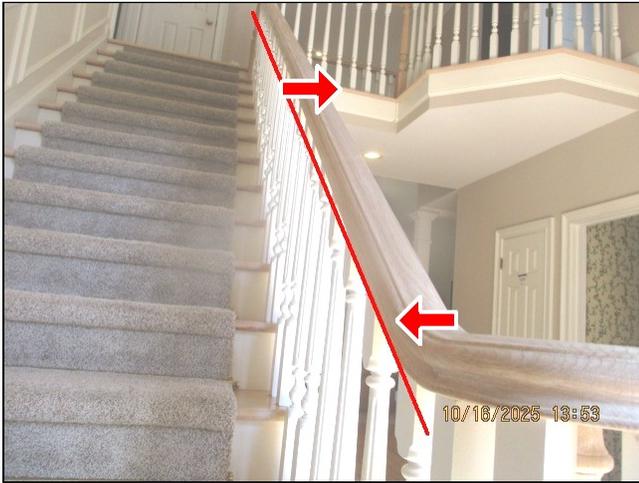
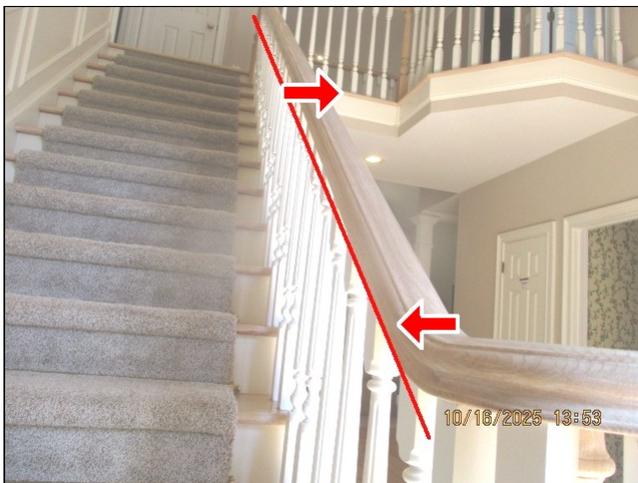
3.1 Item 1(Picture)

3.1 (1) Railing is over spanned. Loose

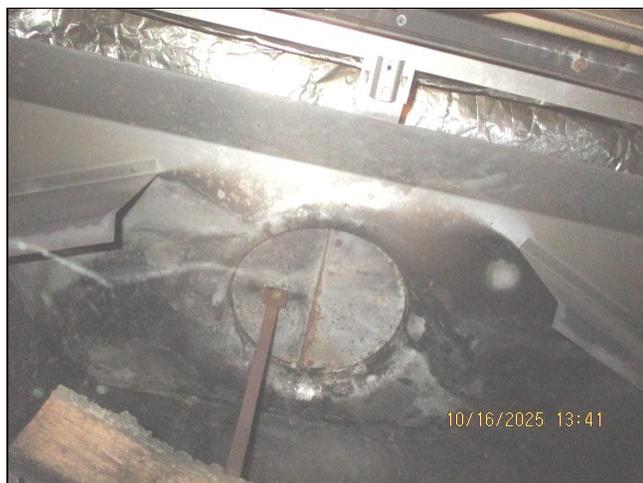
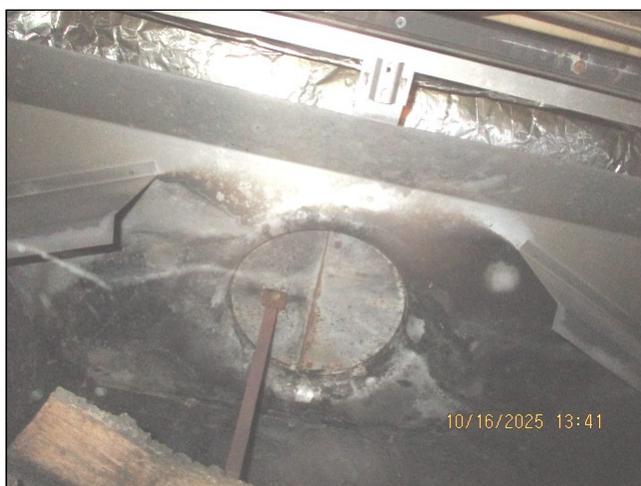
4.1 Item 1(Picture)

4.1 (1) Heavy build up noted in the fire box. Professional chimney sweep recommended annually.

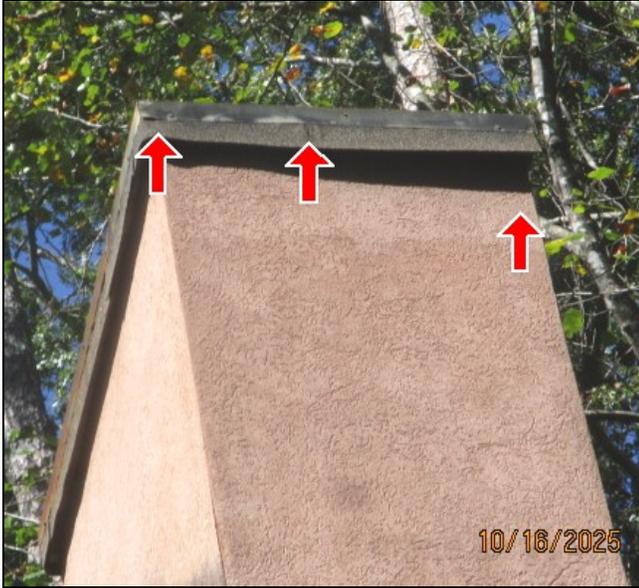
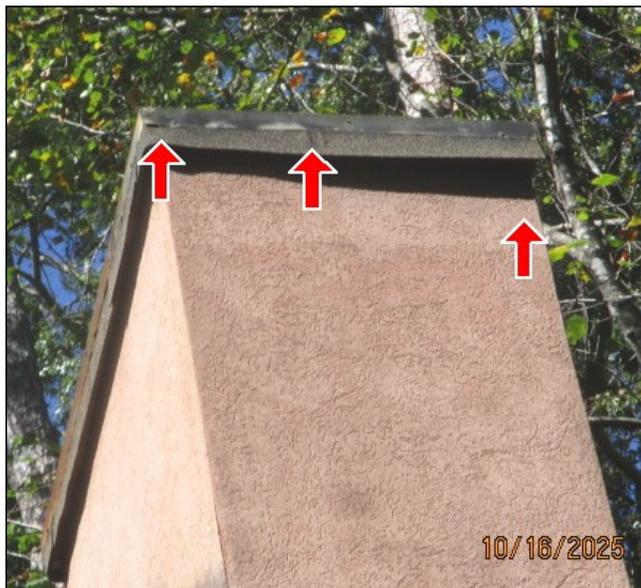
4.3 Item 1(Picture)

4.3 Due to height restrictions the top of the cap could not be evaluated. Original

Material presents with heavy rust.

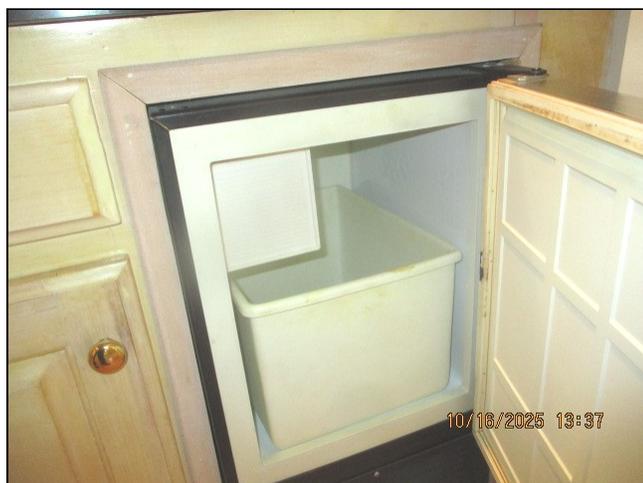
5.4 Item 1(Picture)

5.4 (1) Ice maker is not operating.

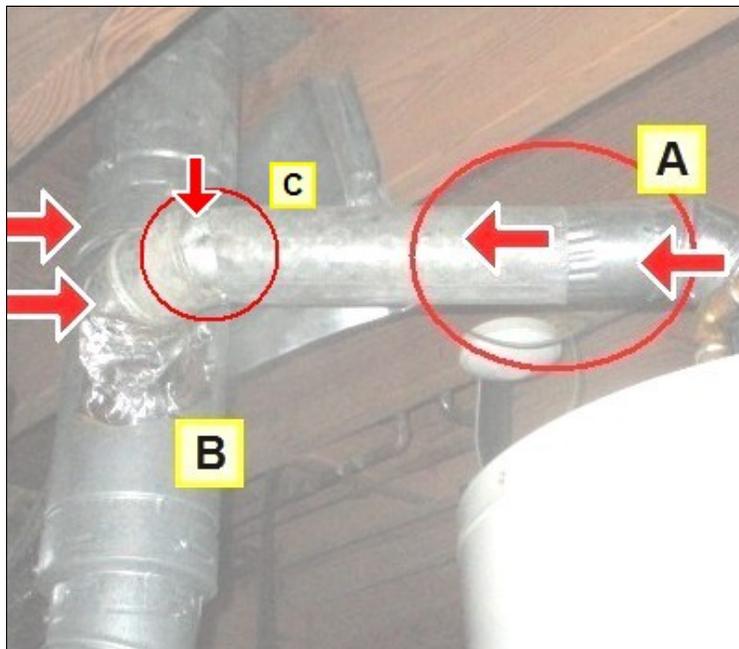
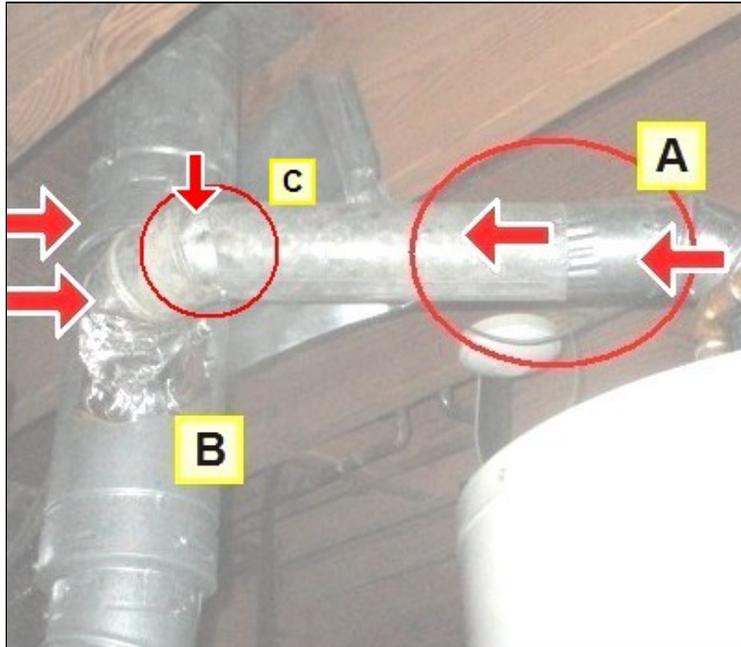
6.2 Item 2(Picture) potential backdraft issues and safety concerns

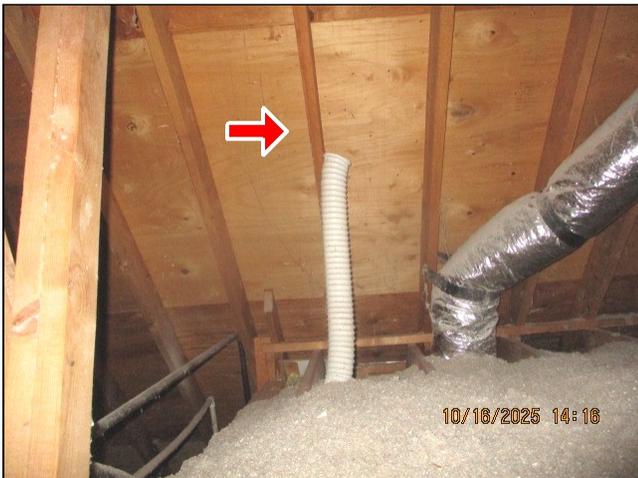
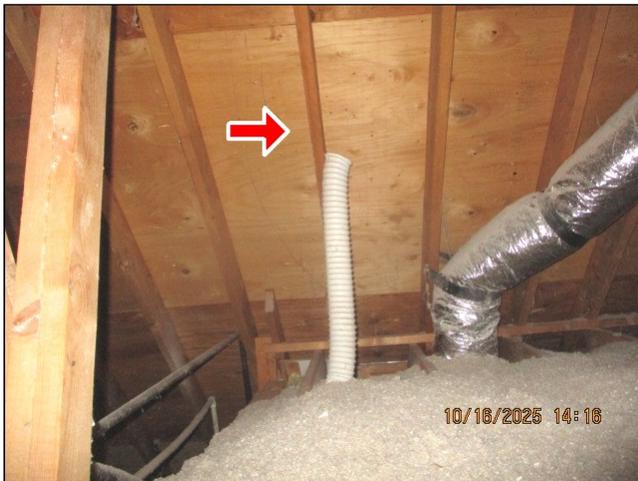
6.4 Item 1(Picture)

6.4 (1) Bathroom exhaust vents terminate in the attic.

6.4 (2) Reference: M1506.2 Recirculation of air. Exhaust air from bathrooms and toilet rooms shall not be recirculated within a residence or to another dwelling unit and shall be exhausted directly to the outdoors. Exhaust air from bathrooms and toilet rooms shall not discharge into an attic, crawl space or other areas inside the building

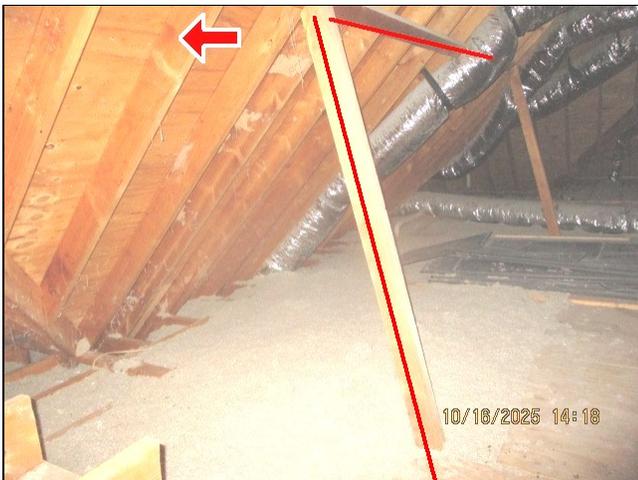
7.2 Item 2(Picture)

One section runs 10 feet plus with one support back to weight bearing wall. This does not establish a continuous load path. Double 2X4 is recommended.

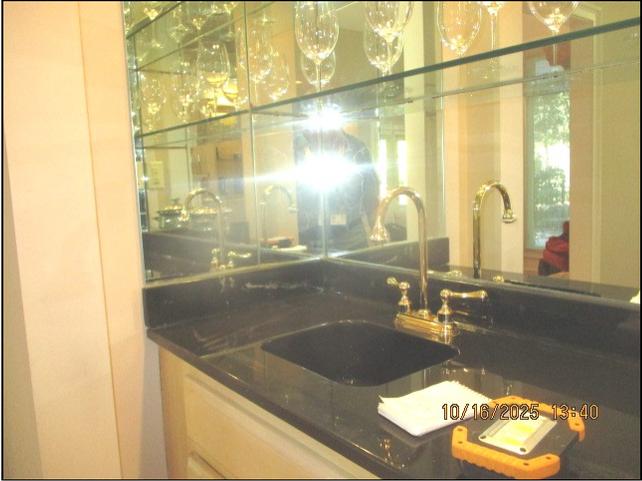
8.5 Item 1(Picture)

8.5 (2) Wet bar faucet is difficult to turn off. Original

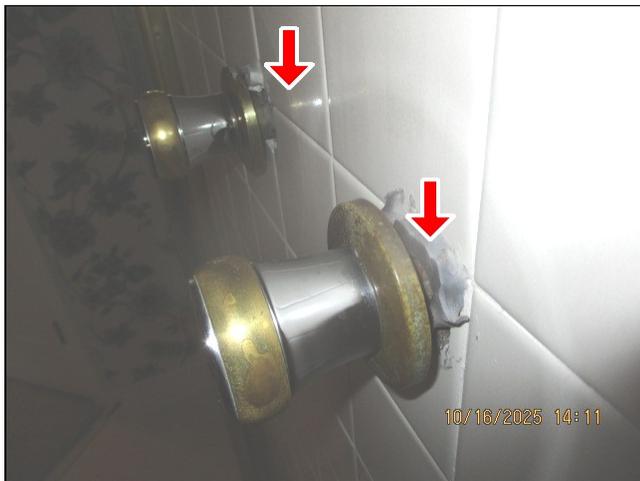
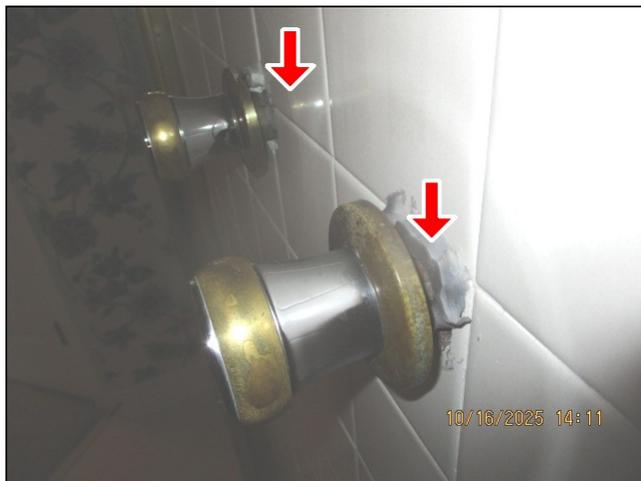
9.2.A Item 1(Picture) Move laterally

Note: Repairs and evaluation by a lic3nsed plumber is recommended. Moisture intrusion is a concern.

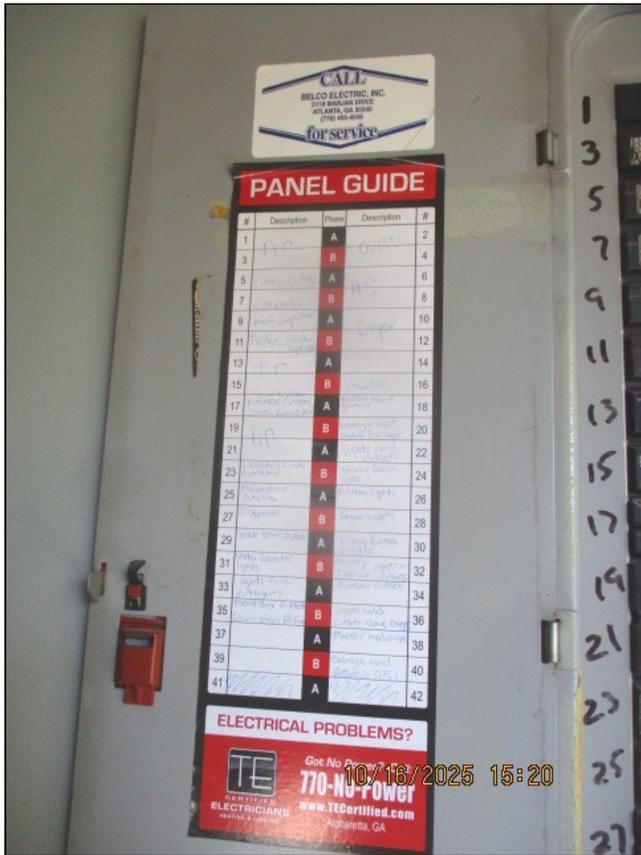
11.0 Item 1(Picture)

11.0 Panel is at maximum number of breaker. Additional circuits would require a sub panel.

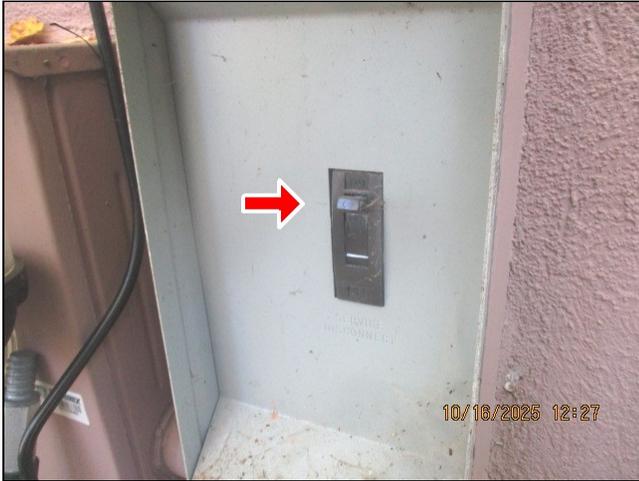
11.4 Item 1(Picture)

11.4 Back wall of the garage corner.

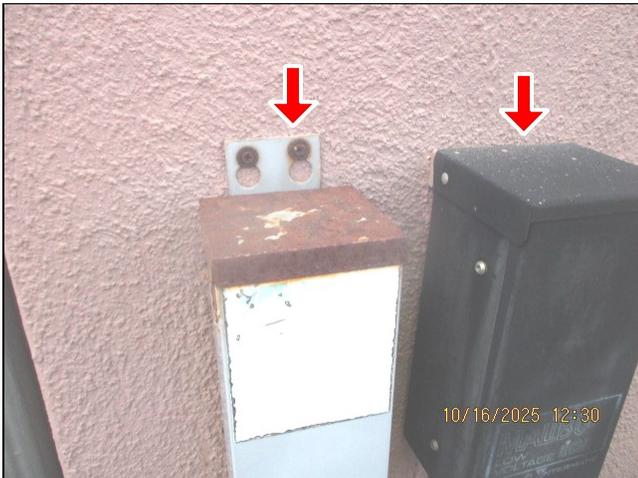
11.7 Item 1(Picture)

11.7 Low Voltage connection boxes are rusted. Hole enter the wall cavity.

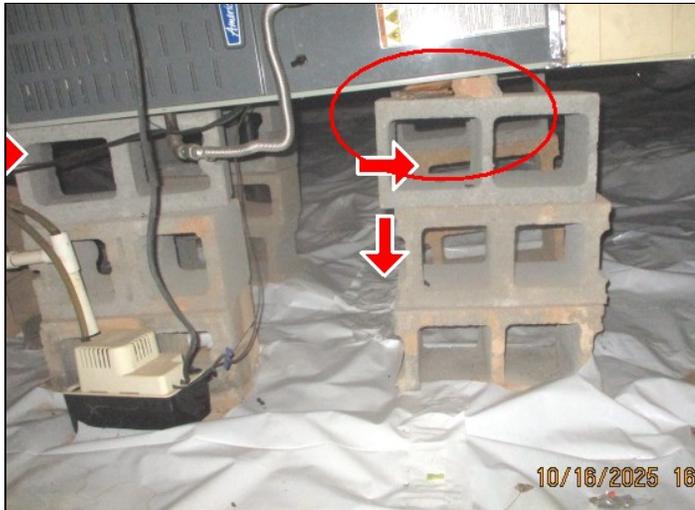
13.0 Item 1(Picture) Material is not stable

EVALUATION AND REPAIR BY A LICENSED HVAC CONTRACTOR IS RECOMMENDED.

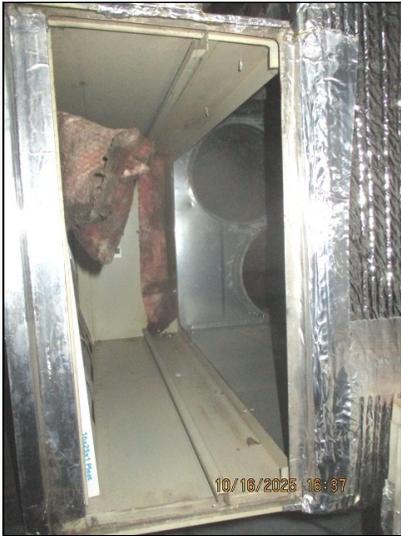
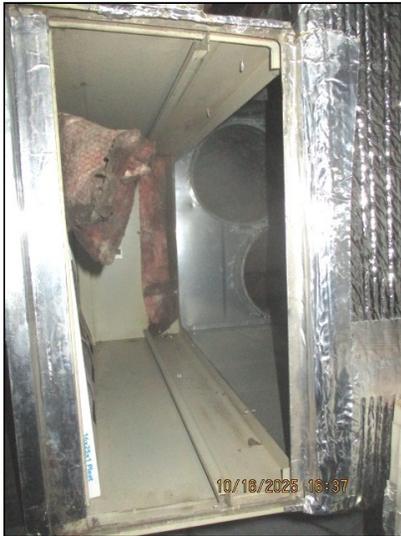
13.3 Item 2(Picture)

Both attic and crawl space unit are not using the approved media box filter as designed.
