Inspection Report

Life Event 55+

Property Address:
Full Brick Drive
Stone Mountain GA 30030

Date: 2/10/2025	Time: 02:00 PM	Report ID: Sample Condominium Inspection Review
Property: Full Brick Drive Stone Mountain GA 30030	Customer: Life Event 55+	Real Estate Professional: Supper Agent

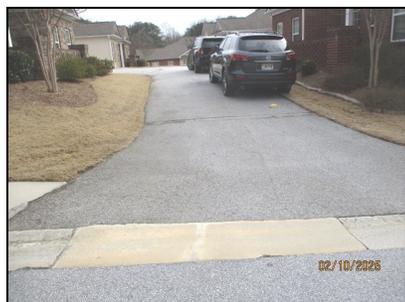
1.0 Item 1(Picture)

1.0 Shared drive. Community owned.

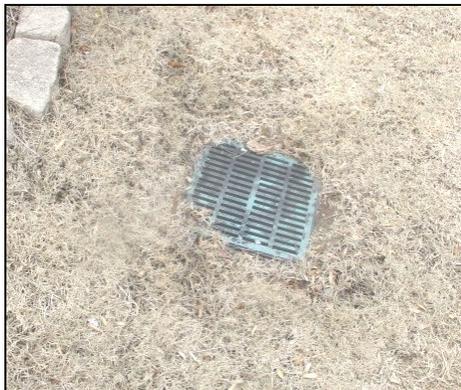
1.1 Item 1(Picture)

1.1 Drains are installed along the front of the lot to control surface water run off . Regular maintenance to keep the surface clear is beneficial.

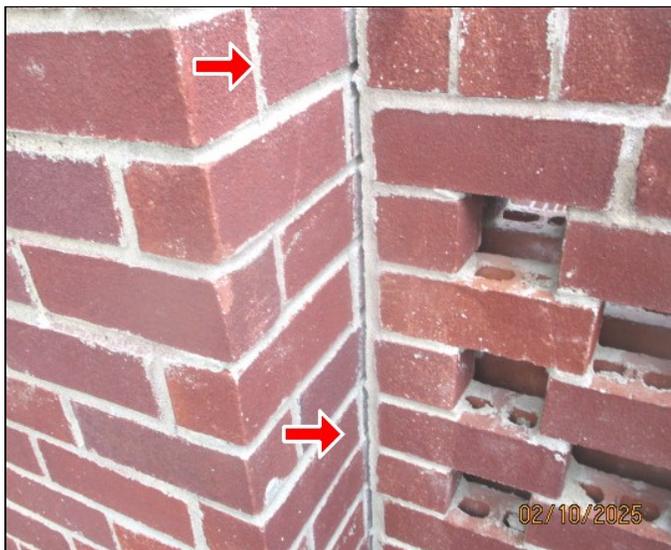
1.2 Item 1(Picture)

1.2 (2) Brick patio exterior is settling away from the exterior wall. It could be beneficial to tuck point this area to discourage continuing moisture intrusion.

Forward to HOA for disposition.

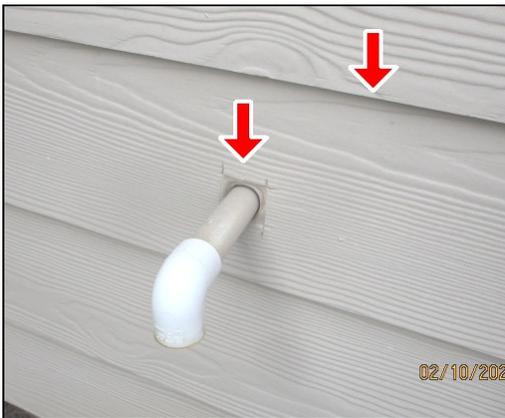
1.7 Item 1(Picture)

1.7 (2) Sealing exterior wall penetrations could be beneficial.

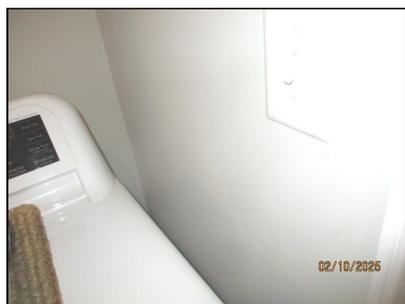
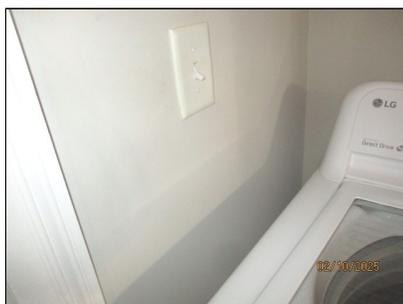
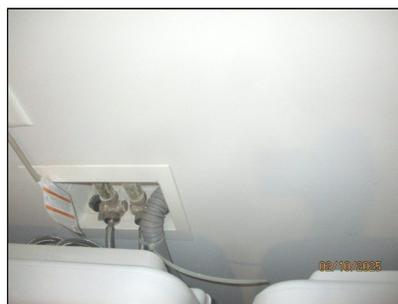
3.2 Laundry units do not remain with this transaction.

Noted are the conditions of the walls surrounding the units at the time of the inspection.

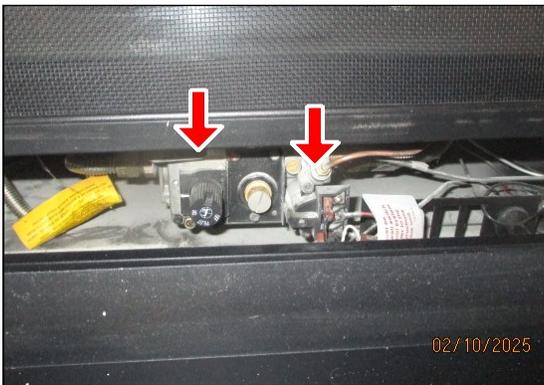
4.0 Item 1(Picture)

4.0 (1) Controls are located below the firebox.

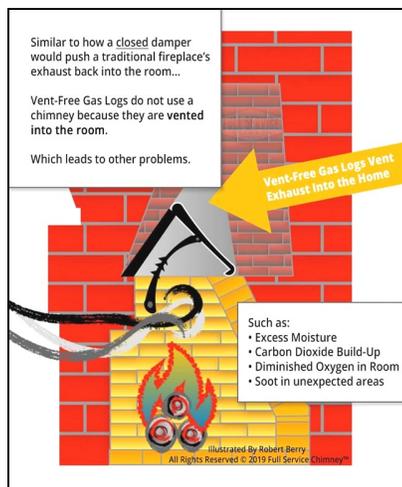
4.0 Item 2(Picture)

4.0 (2) Ventless Gas Logs release heat (and moisture) into the same room where the vent-free fireplace is installed and recirculate the same air back into the room.

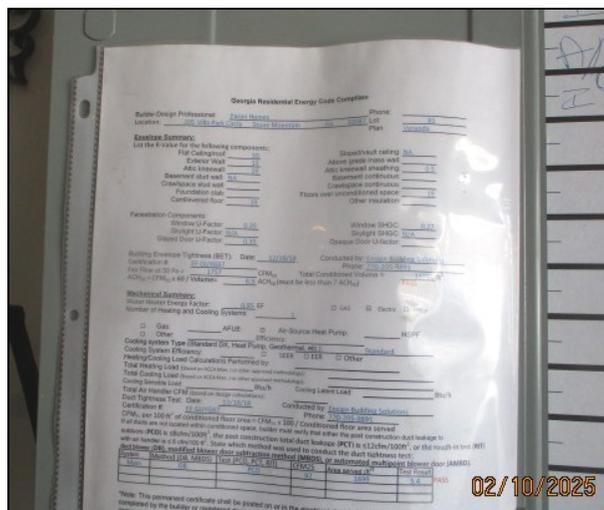
6.0 Item 1(Picture)

6.0 (1) Reference: N1101.8 Certificate. A permanent certificate shall be posted on or in the electrical distribution panel. The certificate shall be completed by the builder or registered design professional. The certificate shall list the predominant R-values of insulation installed in or on ceiling/roof, walls, foundation (slab, basement wall, crawl space wall and/or floor) and ducts outside conditioned spaces (Effective January 1,2008 Ga. Amendments.) (401.3 Energy Code)

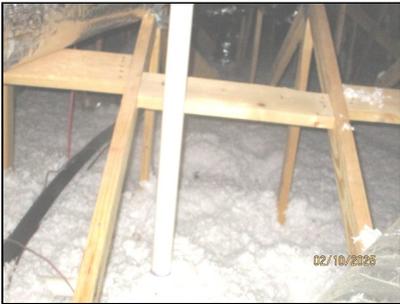
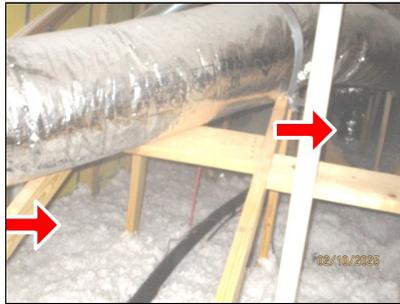
6.0 (2) Insulation efficiency is only as strong as its weakest point. Heat loss or gain is rated as R-Value indicates insulating power or thermal resistance. The higher the R-value, the greater the insulating power. Higher R-values are more effective at maximizing your energy savings and comfort. Disturbed or missing insulation should be replaced.

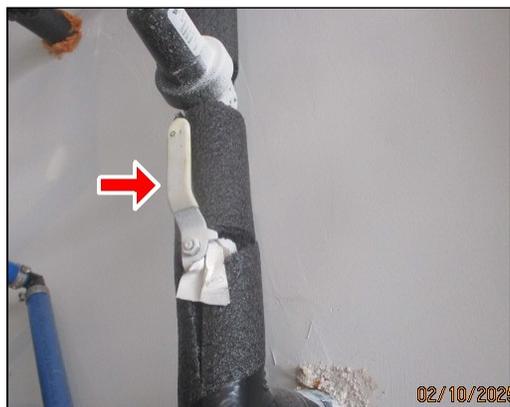
8.0 Item 1(Picture)

8.0 Interior corner of the garage over the water heater.

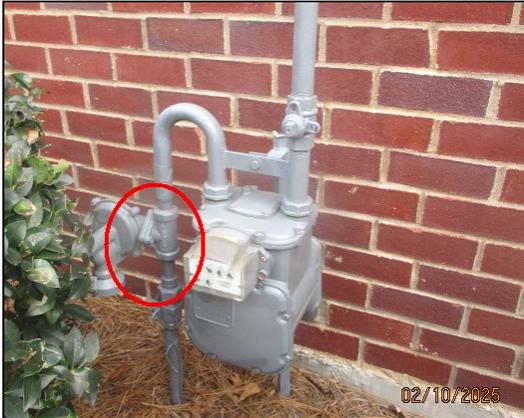
8.3 Item 1(Picture)

8.3 Gas Cutoff: The outdoor emergency cut-off valve for the main gas supply was found along the right end wall. The location for this valve must be known so it can be closed in the event of a damaged pipe or small leak. **Additional tool is required to perform this function.**

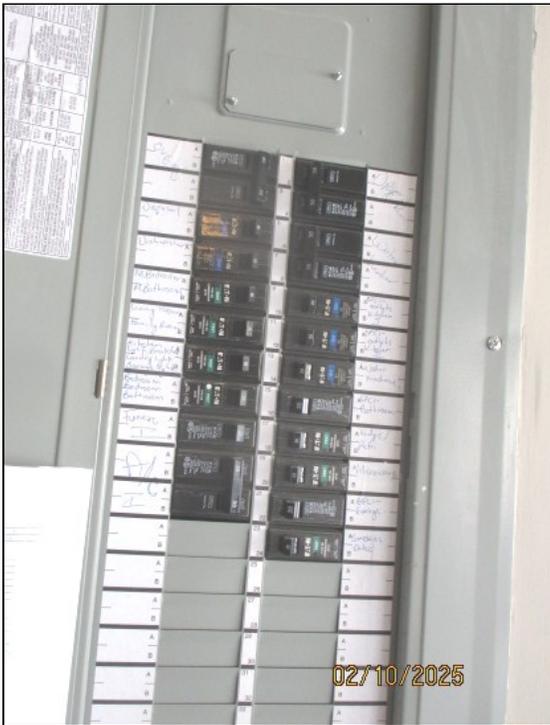
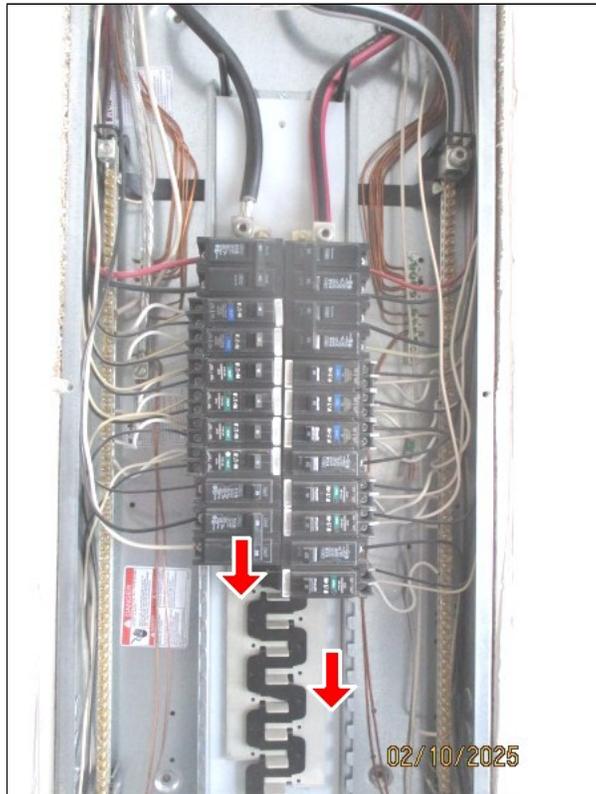
11.0 View exterior and interior.

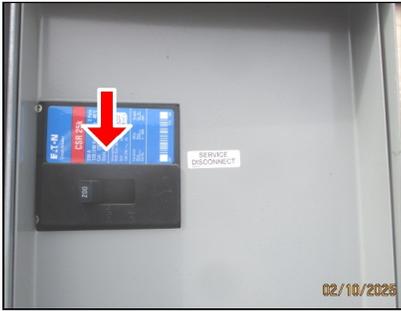
11.2 Item 1(Picture)

11.2 Exterior service disconnect.

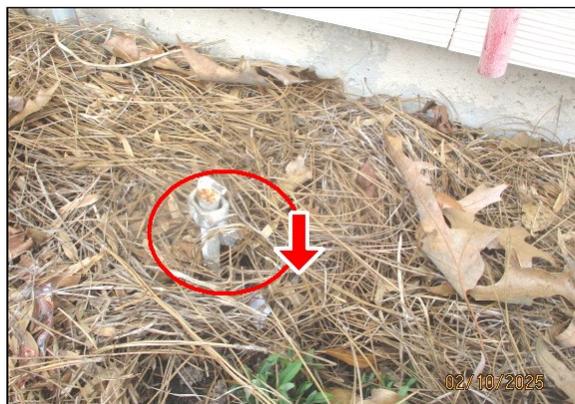
11.4 Item 1(Picture)

Electrode is improperly installed and the connector is subject to physical damage.

Note: E3508.1.4.1 Installation. The rod and pipe electrodes shall be installed such that at least 8 feet (2438 mm) of length is in contact with the soil. They shall be driven to a depth of not less than 8 feet (2438 mm) except that, where rock bottom is encountered, electrodes shall be driven at an oblique angle not to exceed 45 degrees from the vertical or shall be buried in a trench that is at least 30 inches (762 mm) deep. The upper end of the electrodes shall be flush with or below ground level except where the aboveground end and the grounding electrode conductor attachment are protected against physical damage

It is not clear if this code was in play at the time of construction.

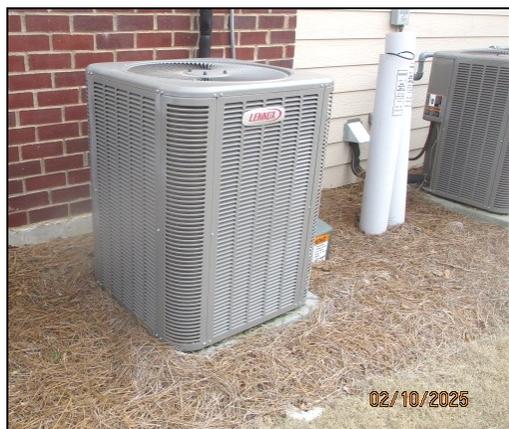
12.0 Item 1(Picture)

12.0 Lennox

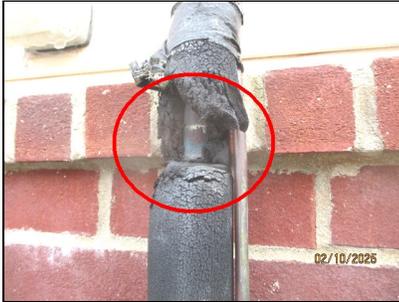
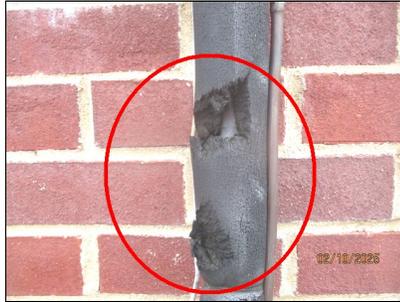
12.2 The foam sleeve on suction line is missing foam sleeve in area(s) at outside unit. Missing foam on suction line can cause heat gain and energy loss and condensation.
Piping and fittings for refrigerant vapor (suction) lines shall be insulated with insulation having a thermal resistivity of at least R-4. (Armor Flex- trade name)

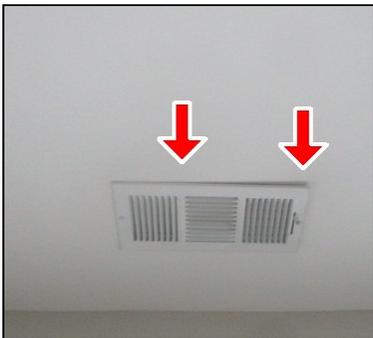
12.3 Item 1(Picture) Front Sunroom

12.3 Supply vent cover appears to be loose. Secure

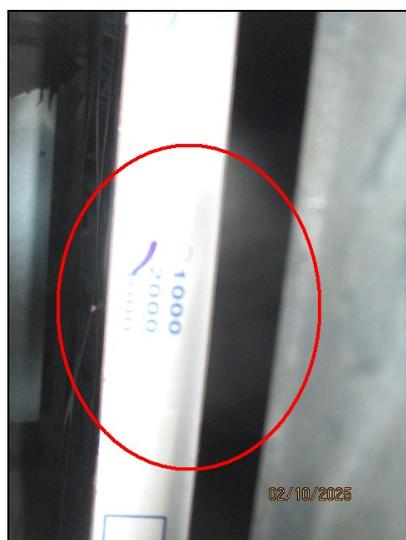
Filter is undersized for the opening in the plenum. 16X20 is undersized for filtration

Filter is not secured in a track or head in place by other approved means.

13.3 Item 1(Picture) Gap by 3 inches

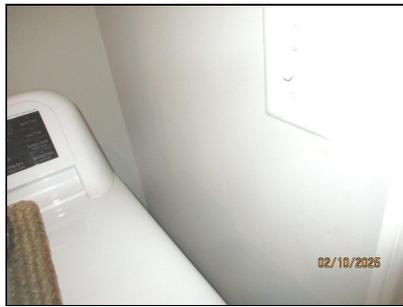
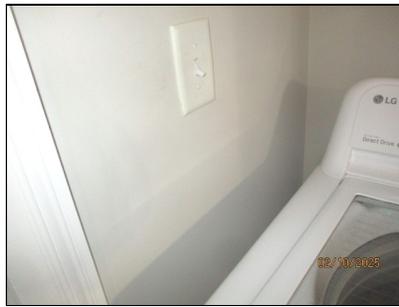
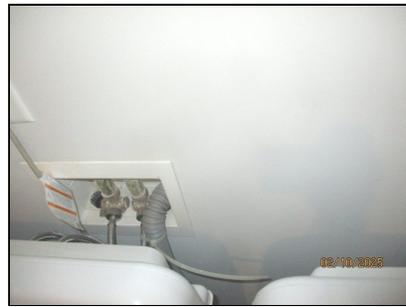
Laundry units do not remain with this transaction.

Noted are the conditions of the walls surrounding the units at the time of the inspection.

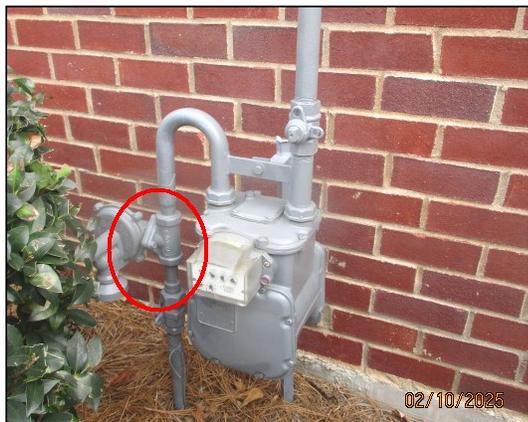
8.3 Item 1(Picture)

Gas Cutoff: The outdoor emergency cut-off valve for the main gas supply was found along the right end wall. The location for this valve must be known so it can be closed in the event of a damaged pipe or small leak. **Additional tool is required to perform this function.**

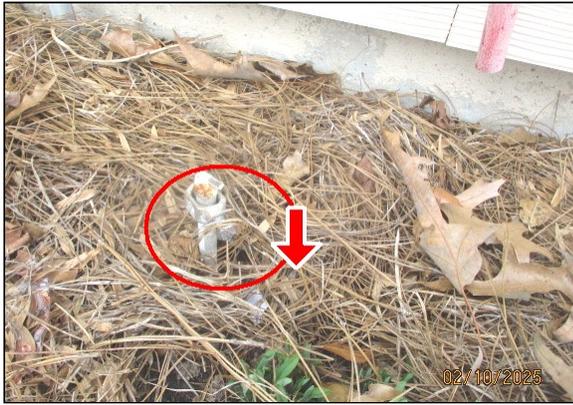
11.4 Item 1(Picture)

Note: E3508.1.4.1 Installation. The rod and pipe electrodes shall be installed such that at least 8 feet (2438 mm) of length is in contact with the soil. They shall be driven to a depth of not less than 8 feet (2438 mm) except that, where rock bottom is encountered, electrodes shall be driven at an oblique angle not to exceed 45 degrees from the vertical or shall be buried in a trench that is at least 30 inches (762 mm) deep. The upper end of the electrodes shall be flush with or below ground level except where the aboveground end and the grounding electrode conductor attachment are protected against physical damage

It is not clear if this code was in play at the time of construction.

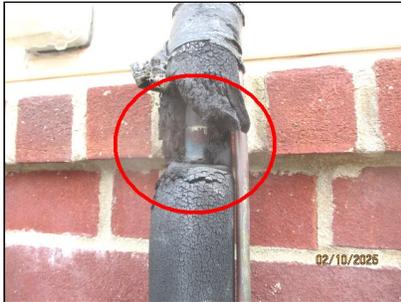
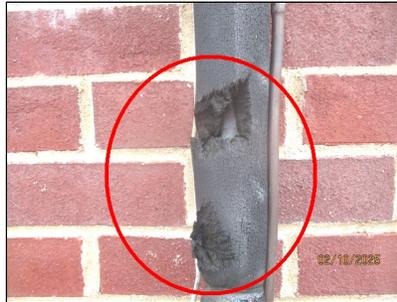
The foam sleeve on suction line is missing foam sleeve in area(s) at outside unit. Missing foam on suction line can cause heat gain and energy loss and condensation.

Piping and fittings for refrigerant vapor (suction) lines shall be insulated with insulation having a thermal resistivity of at least R-4. (Armor Flex- trade name)

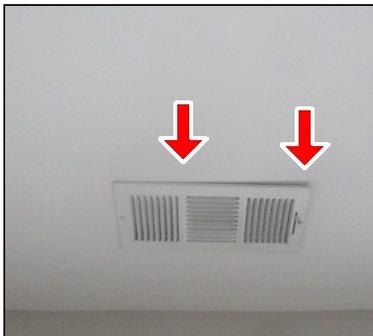
12.3 Item 1(Picture) Front Sunroom

Supply vent cover appears to be loose. Secure

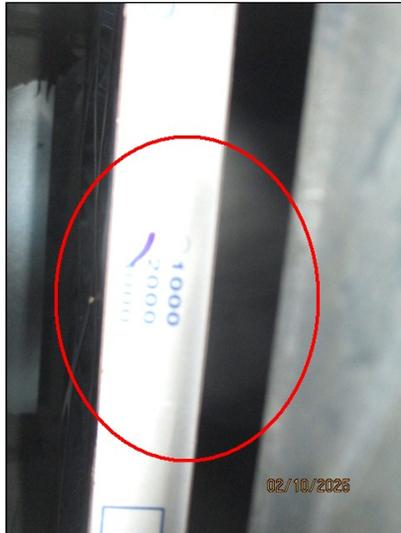
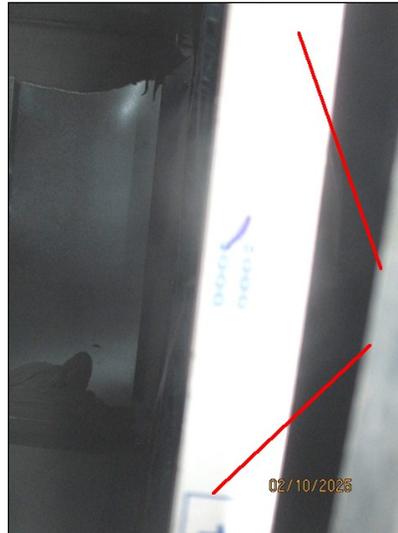
Filter is undersized for the opening in the plenum. 16X20 is undersized for filtration

Filter is not secured in a track or head in place by other approved means.

13.3 Item 1(Picture) Gap by 3 inches
