Inspection Report

Property Address:
1234 Home Avenue
First Time Buyer GA 30084

Common Cents Home Inspection Services

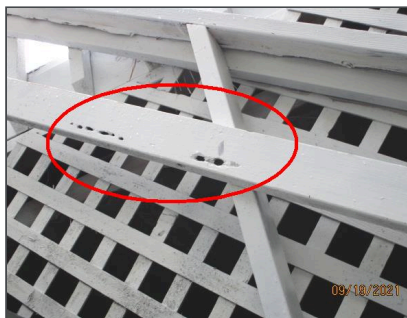
1.1 Item 4(Picture)

(3) Carpenter bee damage.

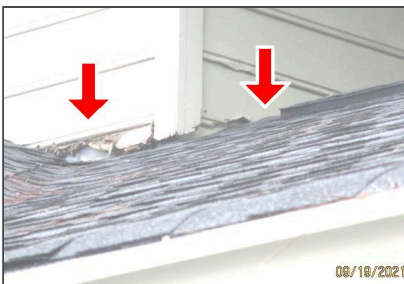
1.9 Item 1(Picture)

(2) Siding manufactures of all type and local building codes require a 2-4 inch clearance above roof contact to allow for surface water run off.

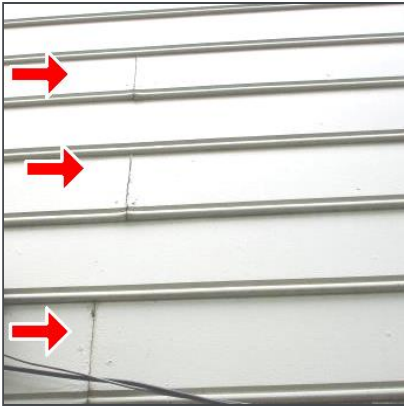
1.9 Item 3(Picture)

(3) End joints present with some swelling. Normally all siding material would have a 1/8 inch gap to allow for expansion and contraction.

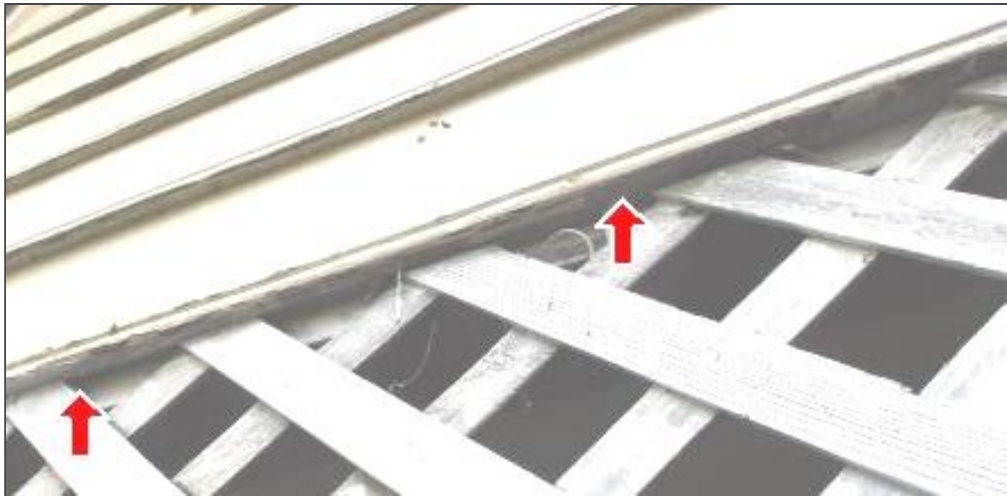
1.9 Item 6(Picture)

(4) Edges in some areas are swelling at the bottom. This indicates that the paint coat was not consistent along the bottom of the material.

Siding damage left rear corner. repair, caulk and paint coat recommended.

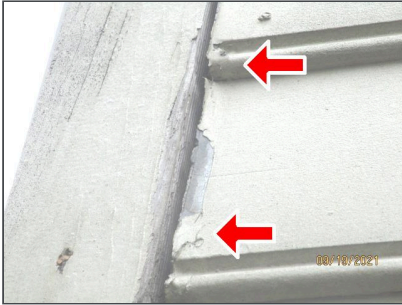
1.9 Item 10(Picture)

(5) Missing sealant at dissimilar material. This would be required regardless of the type material.

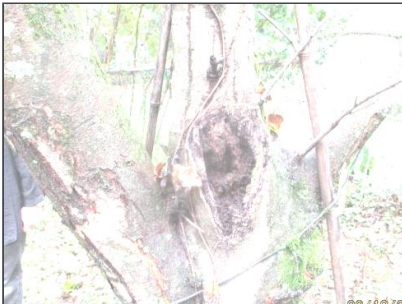
1.2 Item 1(Picture)

(1) Right side. Tree appears with rot and decay. Removal should be expected.

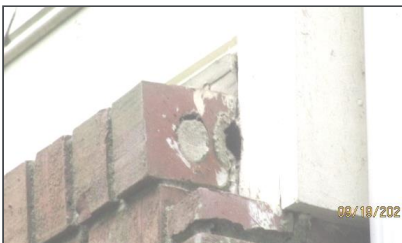
1.8 Item 1(Picture)

Damaged row brick, left rear corner.

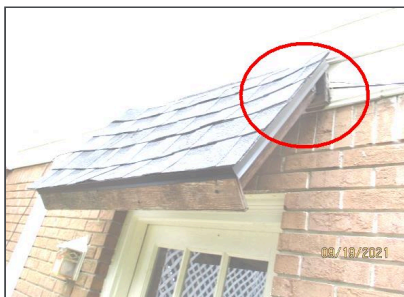
2.0 Item 1(Picture)

(2) Shed roof over basement door has failed. Lacking support and flashing at dissimilar materials. Design will require addittional bracing on both sides at a minimum.

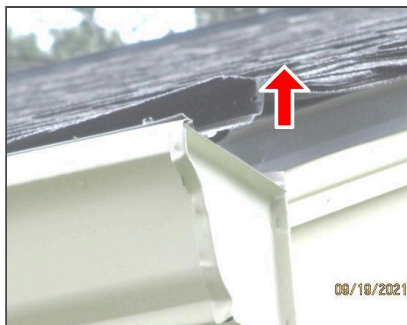
2.0 Item 2(Picture)

(3) Right side corner shingle is lifts above the gutter. Secure.

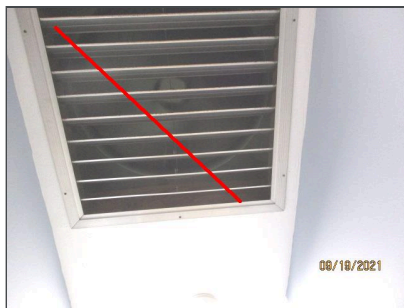
6.2 Item 2(Picture)

Whole House Fans- Failure to cover these opening creates as much heat loss as an open window during the winter season. Other options exist on line that could be beneficial.

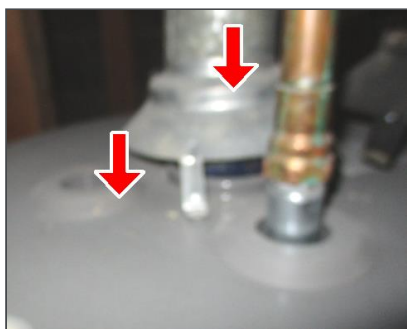
7.1 Item 1(Picture)

Flu vent bonnet is not secured in place.

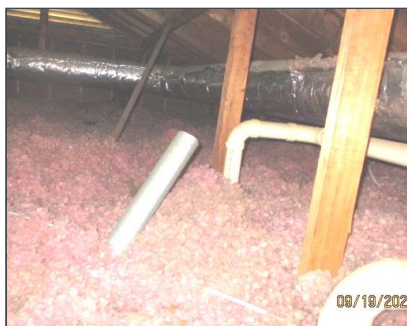
7.2 Item 1(Picture)

Bathroom exhaust vents terminate in the attic.

Reference: M1506.2 Recirculation of air. Exhaust air from bathrooms and toilet rooms shall not be recirculated within a residence or to another dwelling unit and shall be exhausted directly to the outdoors. Exhaust air from bathrooms and toilet rooms shall not discharge into an attic, crawl space or other areas inside the building

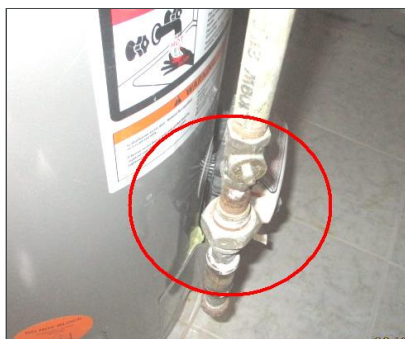
9.6 Item 2(Picture) Original Gas Shut Off

Original shut off valve requires addittional tool and effort. Code requirement in place at the time the unit was replaced.

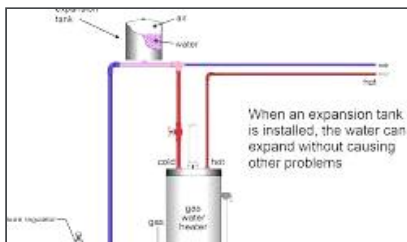
9.7 Item 2(Picture) Diagram

(3) NO EXPANSION TANK AS REQUIRED BY THE 2001 PLUMBING CODE AND THE LOCAL WATER
AUTHORITY

Thermal expansion tank is required in addition to the pressure relief valve where storage water heating
equipment is located. (P2903.4)

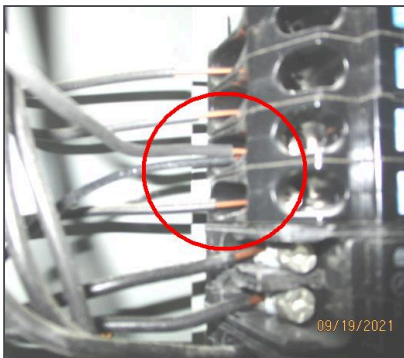
10.0 Item 1(Picture)

Reference:: 110.14 NEC- Limited to one wire per terminal

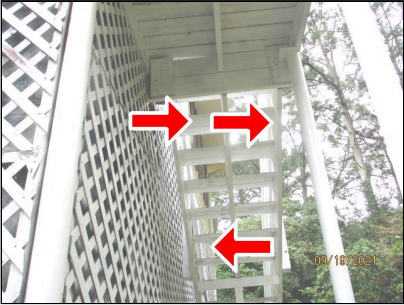
1.1 Item 1(Picture)

1.1 (1) Stairs have lateral movement. Repairs recommended.

The deck band is not attached properly to the wall or band of the home. It should have 5/8 galvanized "Lag Screws" or "Carriage Bolts" (preferred) approximately every 36 inches. I recommend a qualified contractor repair as needed (R311.5 2012)

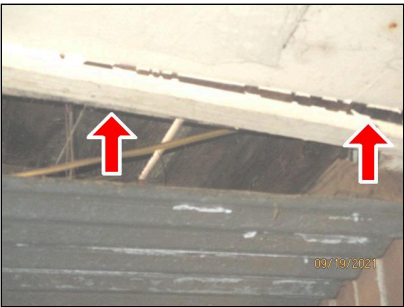
1.1 Item 2(Picture)

(2) The deck band is not attached properly to the wall or band of the home. It should have 5/8 galvanized "Lag Screws" or "Carriage Bolts" (preferred) approximately every 36 inches. I recommend a qualified contractor repair as needed (R311.5 2012)

Deck flashing detail is missing. This prevent surface water from entering the wall cavity where the assembly is bolted to the dwelling.

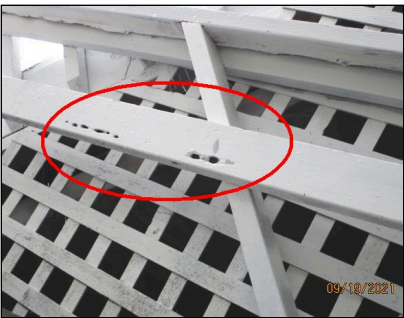
1.1 Item 4(Picture)

(3) Carpenter bee damage.

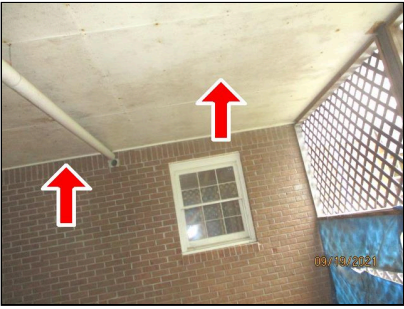
1.1 Item 5(Picture)

(4) Paint coat is failing under the sun room area. Seal, pressure wash, paint

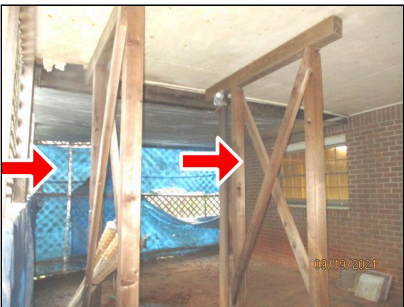
1.1 Item 6(Picture)

(5) Condition of the bracing under the deck flooring is not accessible.

4X4 bracing is original . No evidence of movement noted at the time of the inspection.

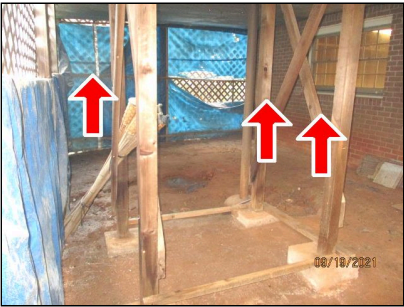
1.1 Item 7(Picture)

(6) Cross bracing 2X4 is under rated for this application.

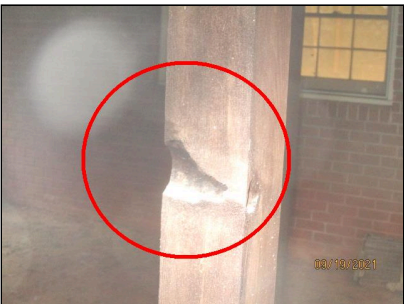
1.1 Item 8(Picture)

(7) Vertical supports are over notched. Evaluation and replacement is recommended not less than 6X6. A decking contractor or contractor whose back round and experience are known.

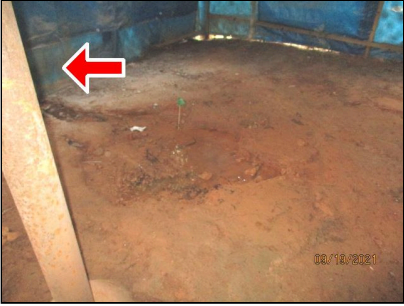
1.1 Item 9(Picture)

(8) All columns under the deck are pitting. At a minimum sand, primer and rust inhibitor coating is recommended.

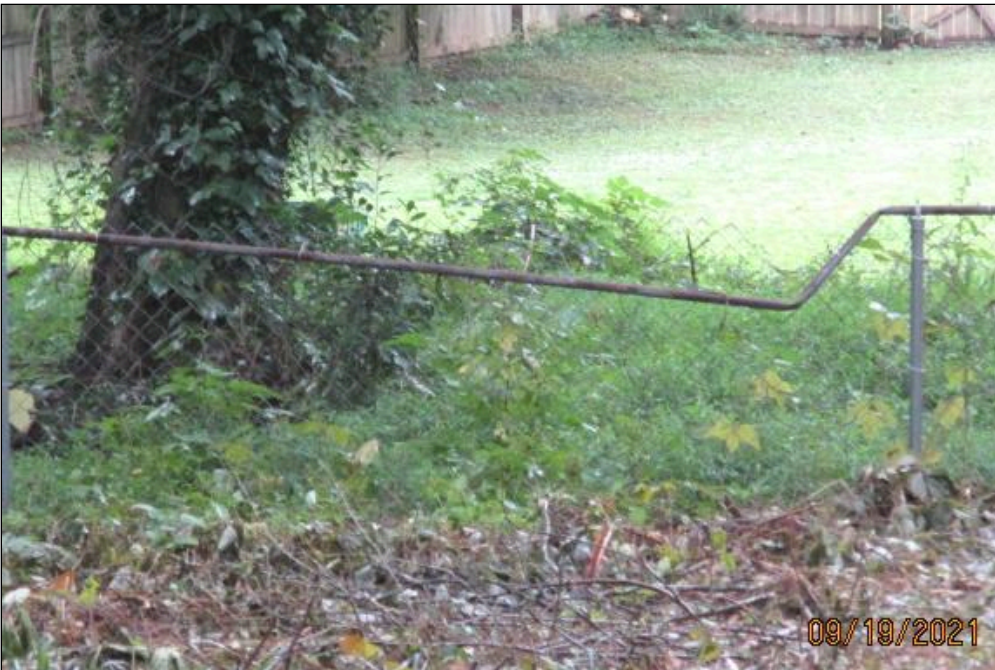
1.3 Item 1(Picture)

**1.3** Damaged sections along the back left corner. Repairs recommended for improved safety.

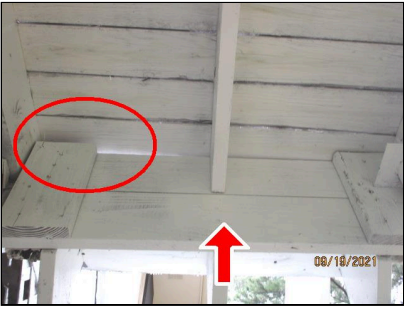
1.5 Item 1(Picture)

1.5 (1) Unlovely connection from the deck stairs to the landing. Adding joist hangers recommended.

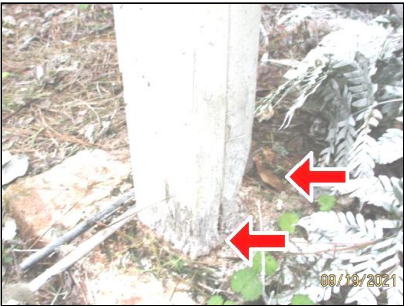
1.5 Item 2(Picture)

(2) Knee wall support post has decay and water damage. Replacement recommended.

Note: Riser plates are available for this application that prevents the post from being in contact with surface water.

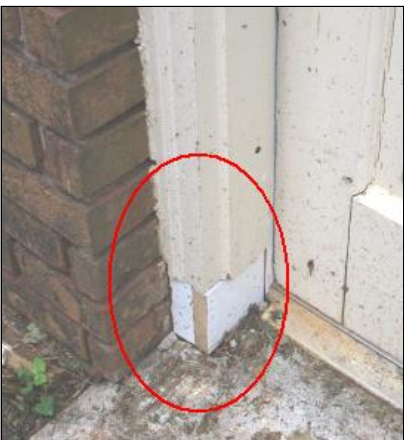
1.5 Item 3(Picture)

(3) Repairs to basement door frame have not been sealed or painted. Water intrusion noted to the interior floor.

No weather stripping exist along the bottom . Original

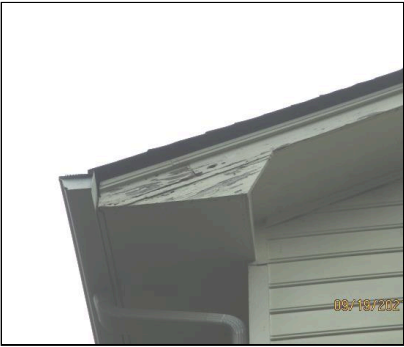
1.6 Item 1(Picture)

**1.6** Chipping, peeling paint coat along the fascia.

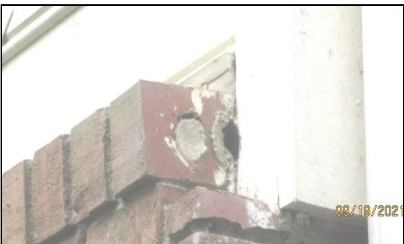
1.8 Item 1(Picture)

**1.8** Damaged row brick, left rear corner.

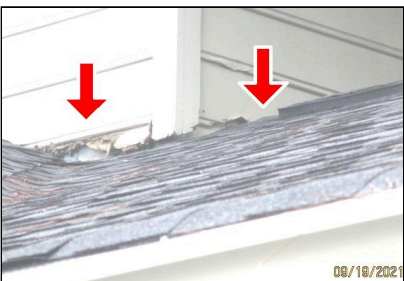
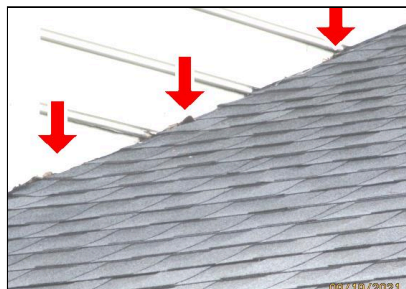
1.9 (1) Siding boards installed on some or all of the exterior wall surfaces is a wood fiber composition product. This type of siding product has a documented history of deterioration due to moisture exposure/absorption, as the result of improper installation&/or neglected maintenance of caulking and painting. The condition of caulking seals and painting MUST be effectively maintained to help reduce potential for moisture damage/deterioration. The purchase of a property with this type of siding product require understanding the current material condition and future maintenance requirements.

(2) Siding manufactures of all type and local building codes require a 2-4 inch clearance above roof contact to allow for surface water run off.

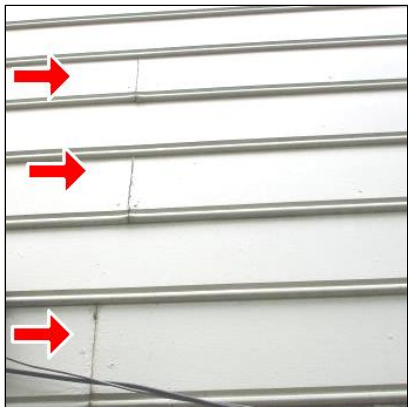
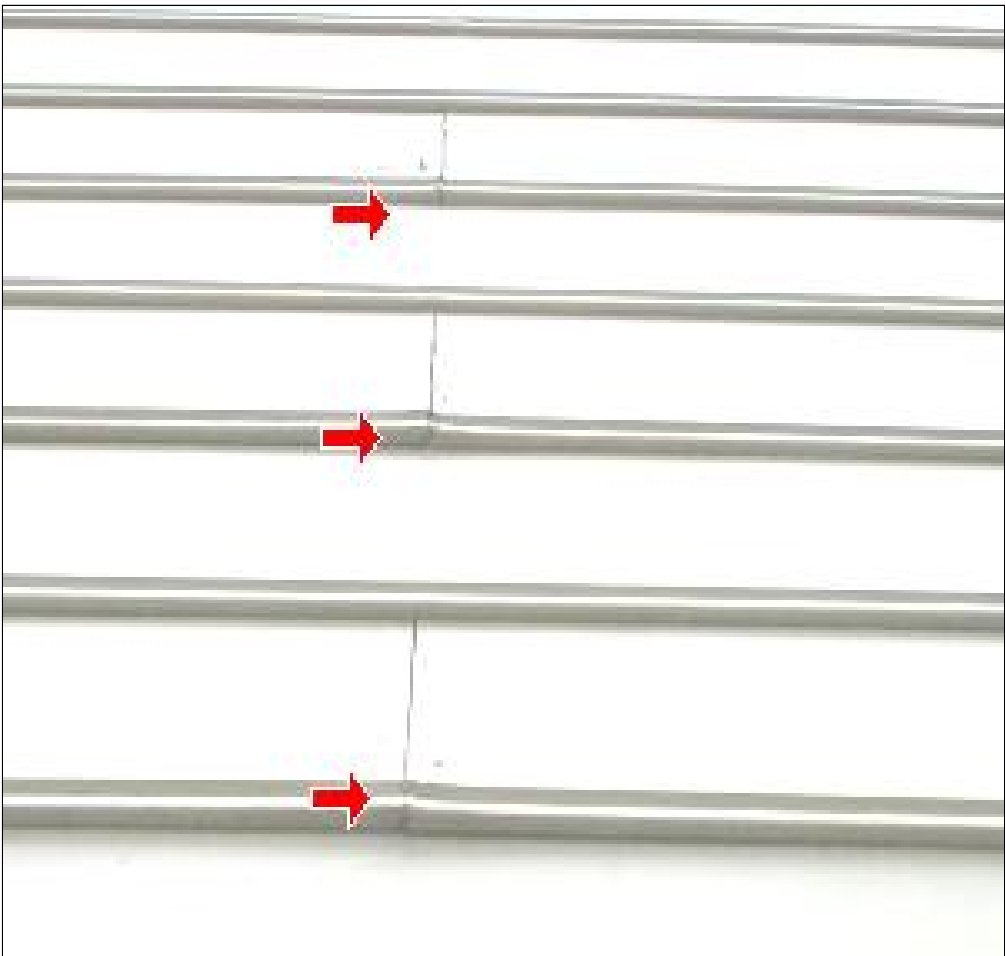
(3) End joints present with some swelling. Normally all siding material would have a 1/8 inch gap to allow for expansion and contraction.

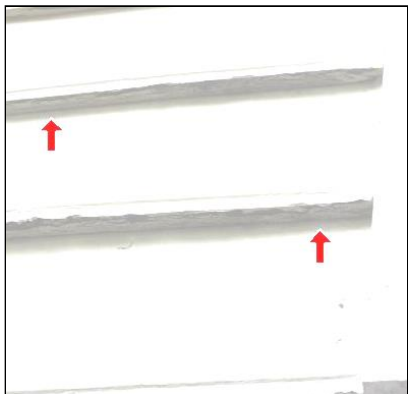
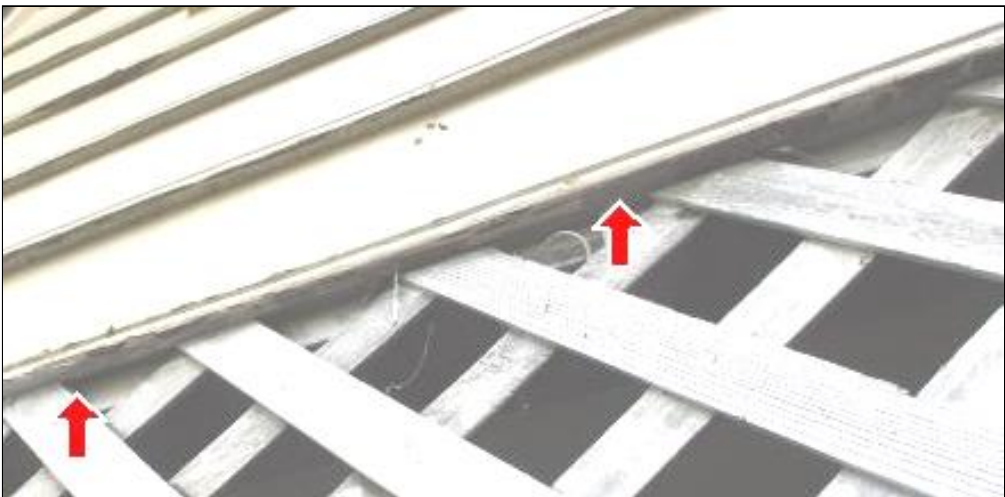
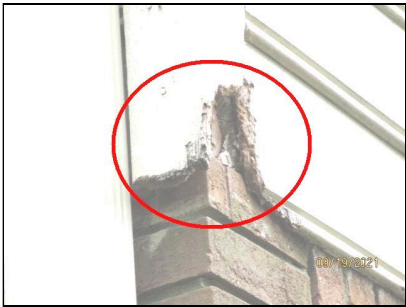
(4) Edges in some areas are swelling at the bottom. This indicates that the paint coat was not consistent along the bottom of the material.

Siding damage left rear corner. repair, caulk and paint coat recommended.

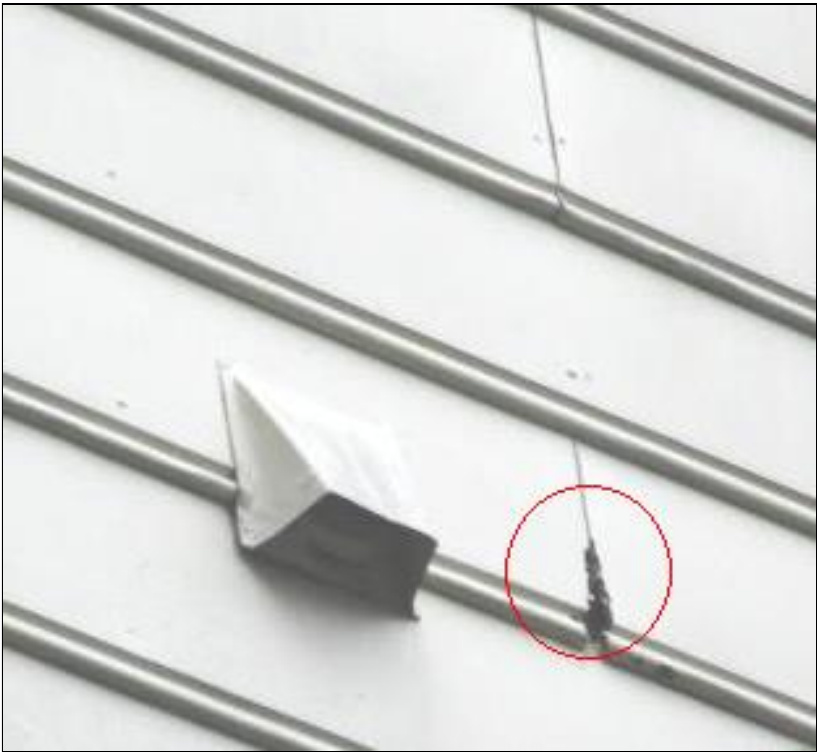
1.9 Item 8(Picture) Damaged End Joint Left Side

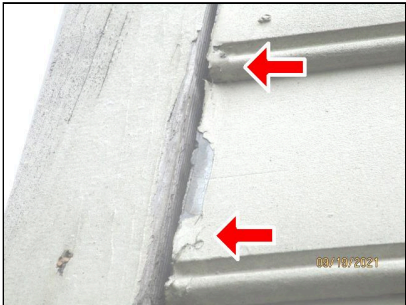
1.9 Item 10(Picture)

(5) Missing sealant at dissimilar material. This would be required regardless of the type material.

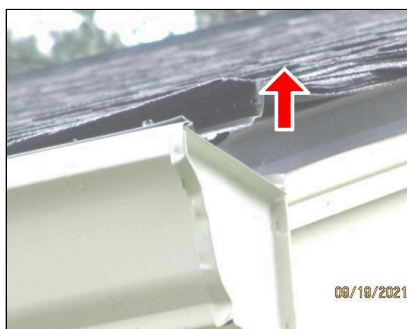
2.0 Item 2(Picture)

- 🏠 (3) Right side corner shingle is lifts above the gutter. Secure.

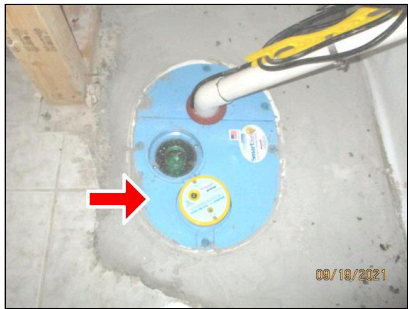
6.1 Item 2(Picture) Moisture Alarm

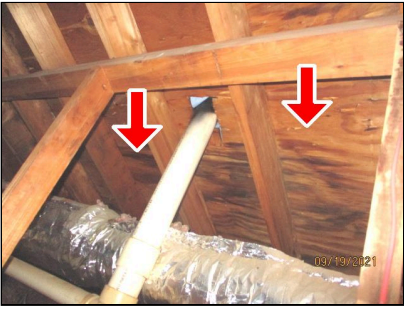
6.2 Item 4(Picture)

🏠 (3) Leak noted in the attic, back side. Appears to be old. Material was dry at the time of the inspection.

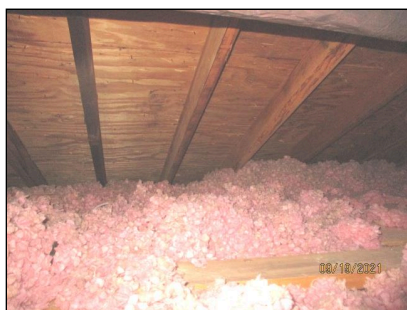
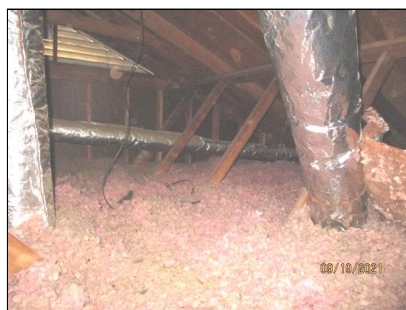
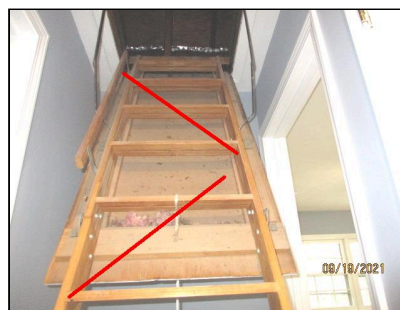
**7.0** Insulation efficiency is only as strong as its weakest point. Heat loss or gain is rated as R-Value indicates insulating power or thermal resistance. The higher the R-value, the greater the insulating power. Higher R-values are more effective at maximizing your energy savings and comfort. Disturbed or missing insulation should be replaced. To improve the thermal envelope **install 75 % of pull down stairs with R-5 batts**. This is to include secured and continuous weather stripping. Other units for this type barrier are available on line and at your local building supply. Doing so improves the thermal envelope.

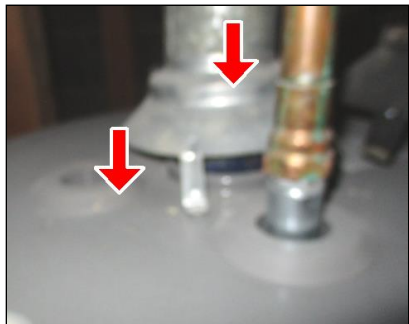
7.1 Item 1(Picture)

**7.1** Flu vent bonnet is not secured in place.

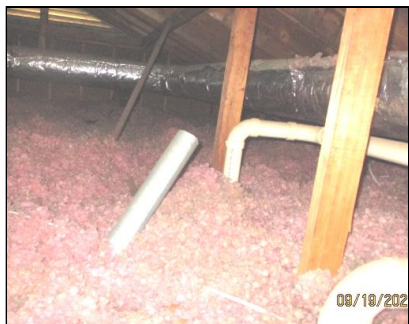
7.2 Item 1(Picture)

**7.2** Bathroom exhaust vents terminate in the attic.

Reference: M1506.2 Recirculation of air. Exhaust air from bathrooms and toilet rooms shall not be recirculated within a residence or to another dwelling unit and shall be exhausted directly to the outdoors. Exhaust air from bathrooms and toilet rooms shall not discharge into an attic, crawl space or other areas inside the building

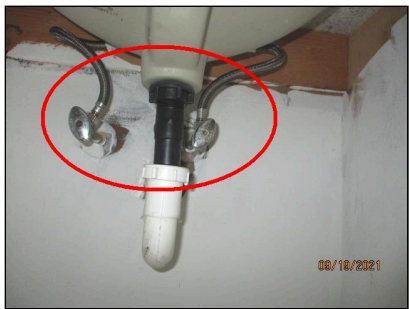
8.1.B Item 1(Picture)

Active leak at the P trap. Secure/Repair

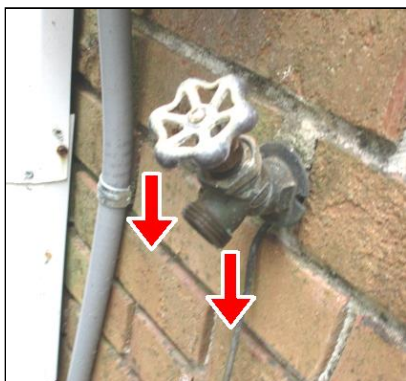
9.1 Item 1(Picture)

9.1 Back faucet at basement door has active leak. Failing stem is one option.

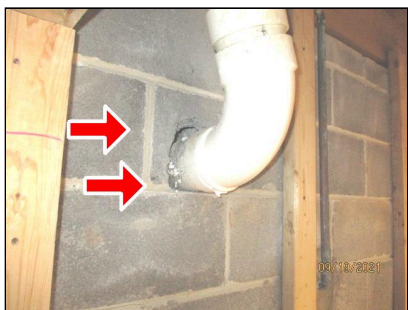
9.4 Item 1(Picture)

(2) Seal waste line penetration that exits the front cinder block wall. Expansion foam would be one option.

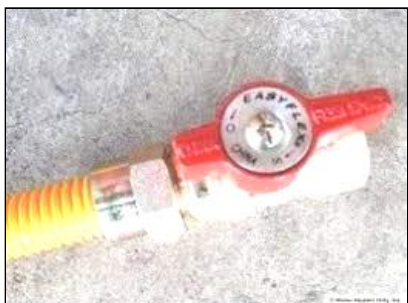
9.6 Item 1(Picture) Quick Shut Off

9.6 (1) Gas Cutoff: The outdoor emergency cut-off valve for the main gas supply was found along the right side wall. The location for this valve must be known so it can be closed in the event of a damaged pipe or small leak. **Addittional tool is required to perform this function.**

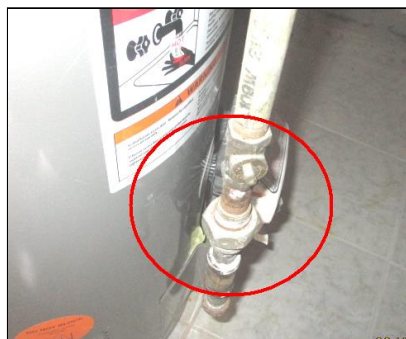
Original shut off valve requires addittional tool and effort. Code requirement in place at the time the unit was replaced.

9.6 Item 2(Picture) Original Gas Shut Off

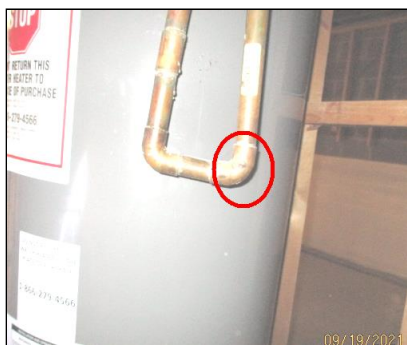
(2) Missing drip leg at the pressure relief valve discharging vertically. This drip leg allows for condensation to drain **away from the valve** that may cause premature failure.

Ref: Discharge may not run up hill or be trapped. (2803.6.1 IRC 2012)

9.7 Item 1(Picture) Missing Drip Leg

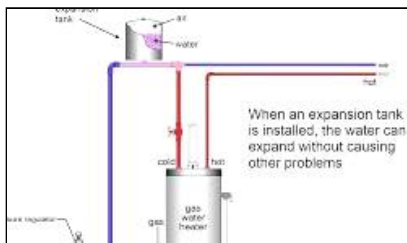
9.7 Item 2(Picture) Diagram

(3) NO EXPANSION TANK AS REQUIRED BY THE 2001 PLUMBING CODE AND THE LOCAL WATER AUTHORITY

Thermal expansion tank is required in addition to the pressure relief valve where storage water heating equipment is located. (P2903.4)

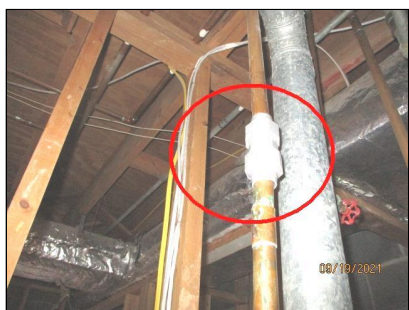
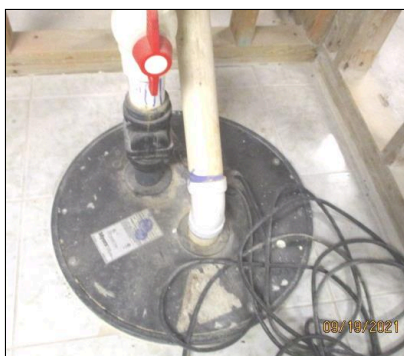
🏠 (4) Plastic coupling with copper material is not recommended.

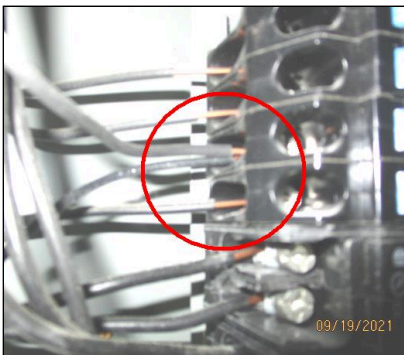
10.0 Item 1(Picture)

10.0 Reference:: 110.14 NEC- Limited to one wire per terminal

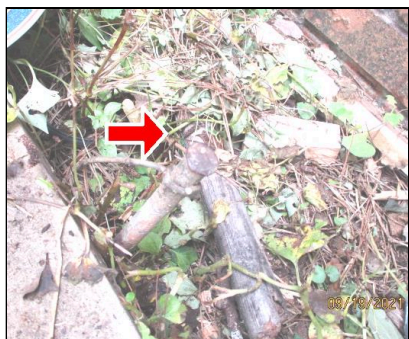
10.3 Item 1(Picture)

10.3 (1) Adding a bonding jumper between the hot and cold water lines at the water heater should be considered for added continuity. (bonding)

(2) Ground rod is not flush with or below the ground level at this phase. **Installation.** The upper end of the electrode shall be flush with or below the ground level unless the above ground end, and the grounding electrode conductor attachment are protected.

Repairs completed by a licensed electrician.

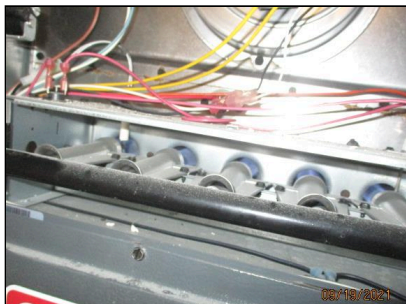
12.2 Item 1(Picture)

12.2 No roll out of flames on start up at the time of the inspection.

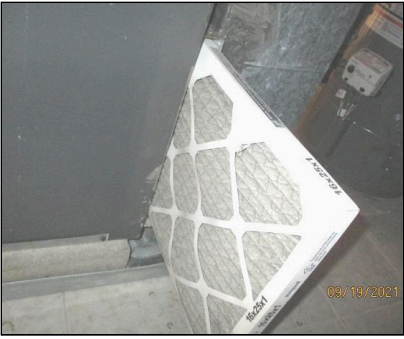
12.3 Item 1(Picture)

**12.3** A better quality improves performance and quality of air cleaning. Good choices include a one inch pleated filter or larger media filter that provide more surface area. Look for filters with a higher micro particle performance rating.(800 and up.)

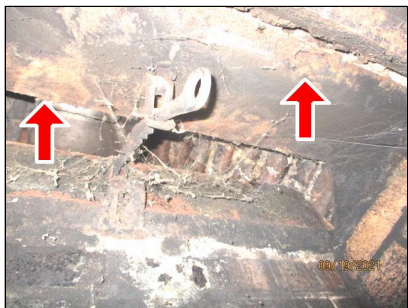
13.0 Item 1(Picture)

**13.0** Damper operation function as designed. rust noted due to age and moisture intrusion over time.

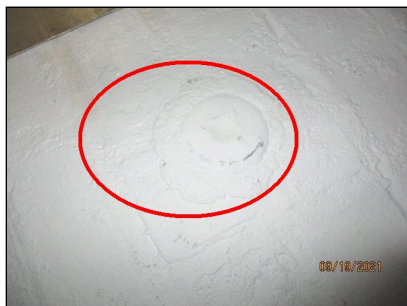
13.3 Item 1(Picture)

- 🏠 **13.1** Heavy build up noted in the fire box. Professional chimney sweep recommended annually.
- 🏠 **13.2** Chimney caps are recommended to prevent the intrusion of rain, snow, rodents and debris. Sizing should include over lapping the corners and trim a minimum of 4 inches.
- 🏠 **13.3** Gas line has been terminated and filled with caulk. No gas line visible entering the fire box.
