Inspection Report

Modified DIY - Mid Century Modern
Stone Mountain GA 30083

Common Cents Home Inspection Services Inc

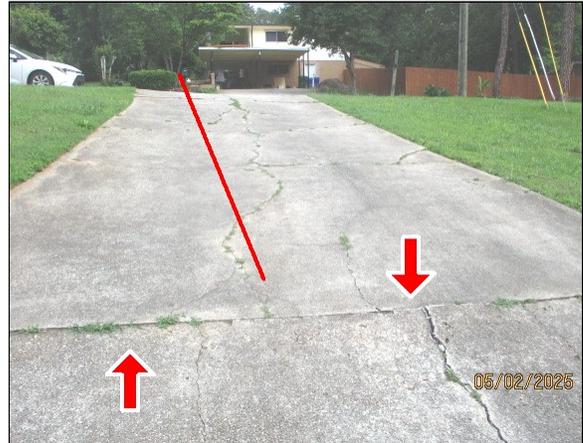
1.0 Item 2(Picture)

1.0 (1) Evidence of deterioration. Surface raised,settled creates trip hazard.

Drive replacement should be expected.

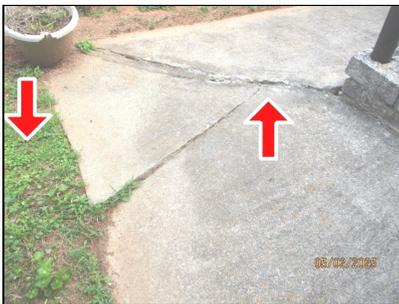
1.0 Item 3(Picture) Exterior Corner Walk

1.0 (2) Surface water is sloped towards the dwelling and level to the back of the lot. Water is more concentrated from the curb along the right side of the dwelling.

1.0 (3) Water intrusion and erosion has contributed to this condition.

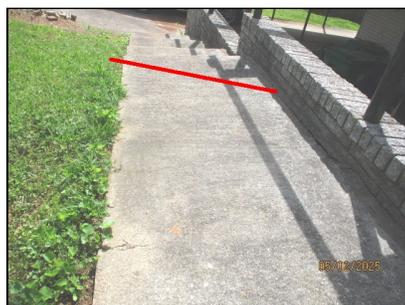
1.0 Item 5(Picture)

1.0 (4) Erosion along the front of the retaining wall. Walk has shifted towards the wall.

Ref:AF103.4.2 Concrete joints. All control joints, isolation joints, construction joints and any other joints in concrete slabs or between slabs and foundation walls shall be sealed with a caulk or sealant. Gaps and joints shall be cleared of loose material and filled with polymerizing caulk or other elastomeric sealant applied in accordance with the manufacturer's recommendations.

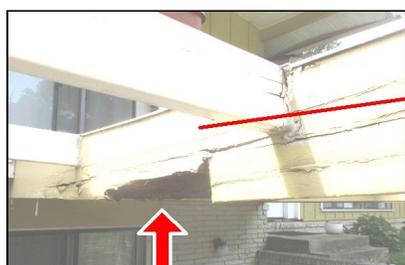
1.2 Item 1(Picture)

1.2 (1) ENTIRE DECK AND CARPORT ROOF ARE UNSAFE TO FOOT TRAFFIC AND MAY FAIL WITHOUT FURTHER NOTICE.

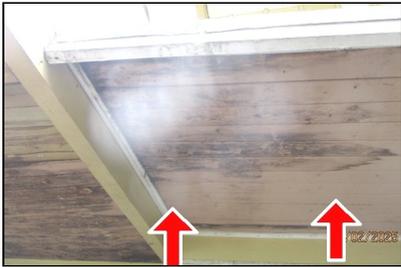
1.2 Item 2(Picture)

1.2 (2) Contributing factors include failed flashing, sealant exterior paint coat. The walking area appears installed over indoor/outdoor carpet.

Note: Design drainage does not exist

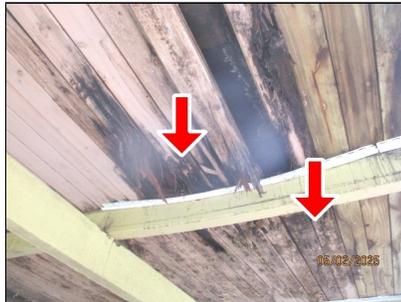
1.2 Item 3(Picture) Multiple events of intrusion.

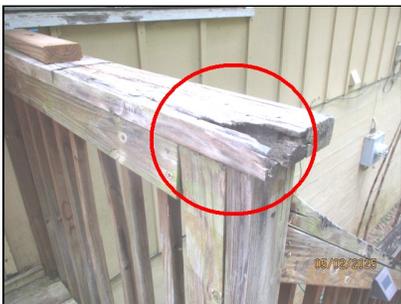
1.2 Item 7(Picture)

1.2 (4) Deck Water Damage

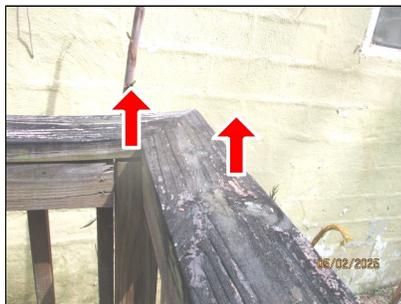
1.2 Item 8(Picture) UV Damage

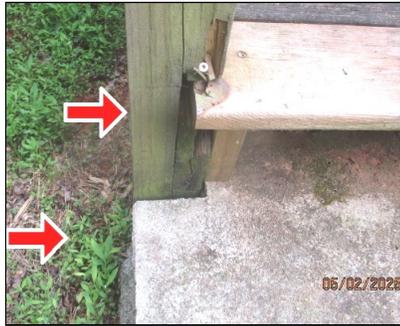
1.2 Item 10(Picture)

1.2 (5) Lateral movement deck stair railing. Water damage at the base.

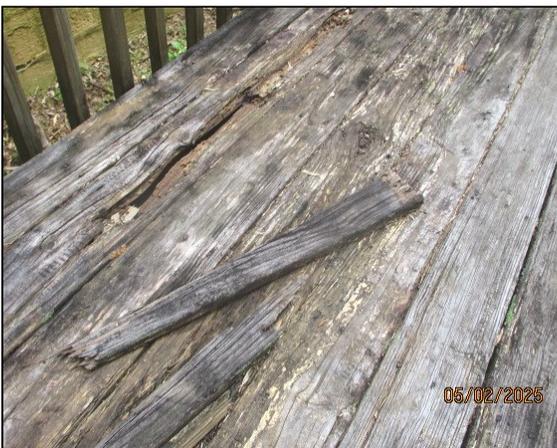
1.2 Item 12(Picture)

1.2 (6) More than 75% of the decking has failed from water damage and delayed maintenance.

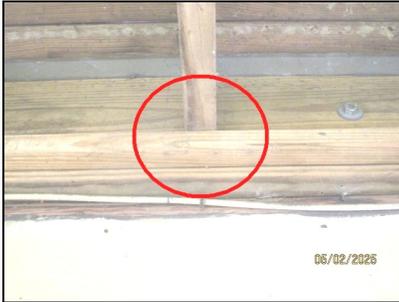
1.2 Item 13(Picture)

1.2 (7) Ledger strip is not appear to be adequately nailed. Local building code requires three nails on the ledger strip underneath each joist.

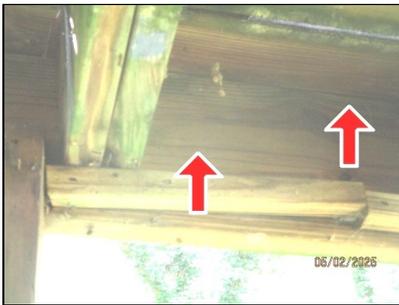
1.2 Item 14(Picture)

1.2 (8) Damaged ledger strip . Not secured as recommended.

Note: Removing ledger strip and adding sized joist hangers could be beneficial.

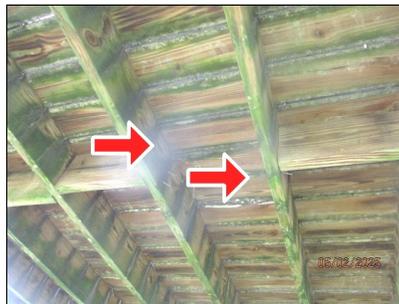
1.2 Item 16(Picture)

1.2 (9) Floor joist blocking consists of solid pieces of lumber installed between floor joists to prevent them from twisting and to help distribute weight more evenly across the floor system.

Missing in two sections minimum

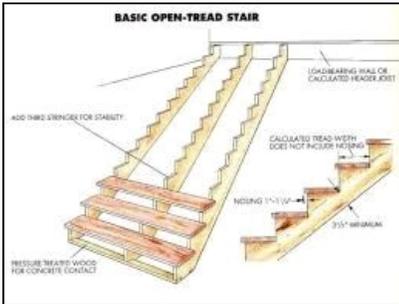
1.2 Item 17(Picture)

1.2 (10) Stair stringers should generally be spaced no more than 16-18 inches on center (OC). Risers should also be filled

Consult the Ga. Deck Perscriptive.

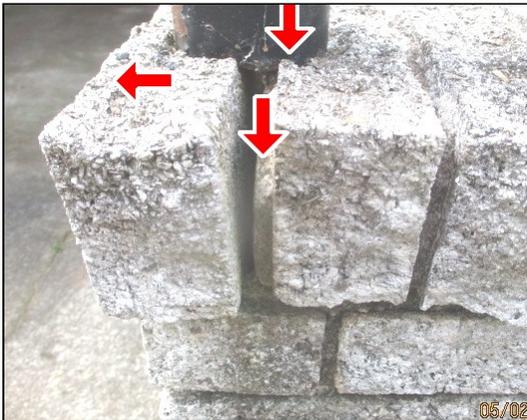
Failing mortar joints along top run of brick. Subject to water intrusion and further erosion.

1.3 Item 2(Picture) Along front Walk

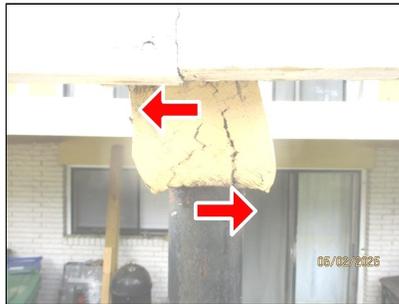
1.3 Item 3(Picture) Lateral Cantilevered

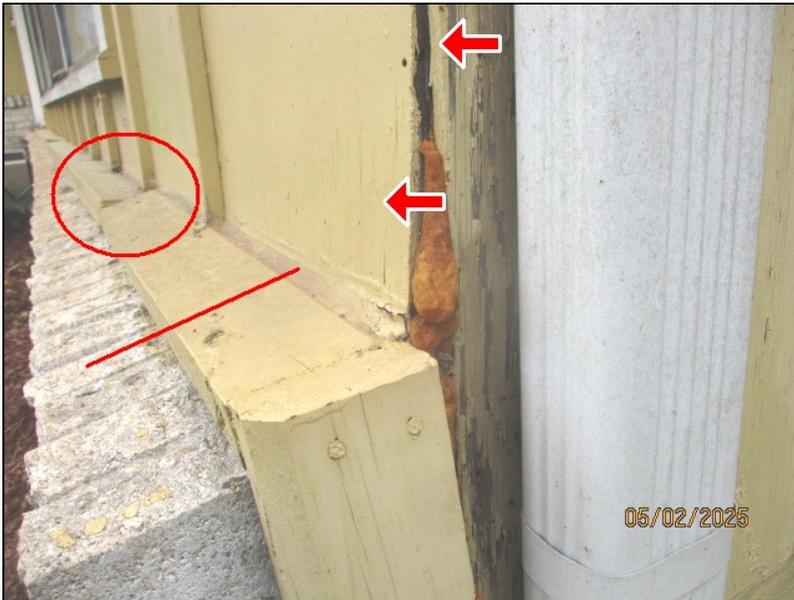
1.5 Item 5(Picture)

1.5 (4) Settlement of masonry wall at front entry. Expansion foam is failing.

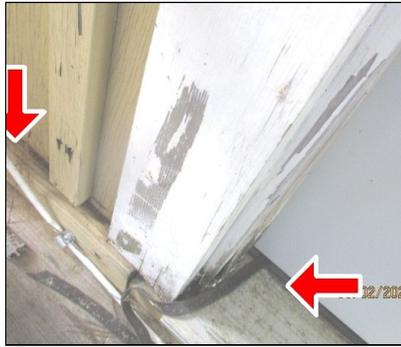
1.5 Item 8(Picture)

1.5 (5) Deck door frame threshold. Contributing factors missing caulk and paint coat.

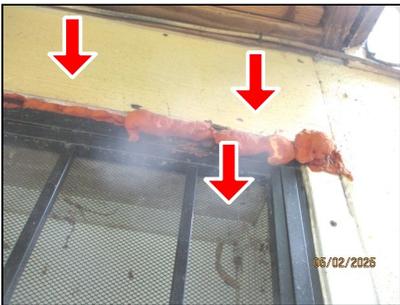
1.5 Item 9(Picture)

1.5 (6) Basement door appears to have been added. Header over the door is undersized for this application.

Expansion foam is not rated.

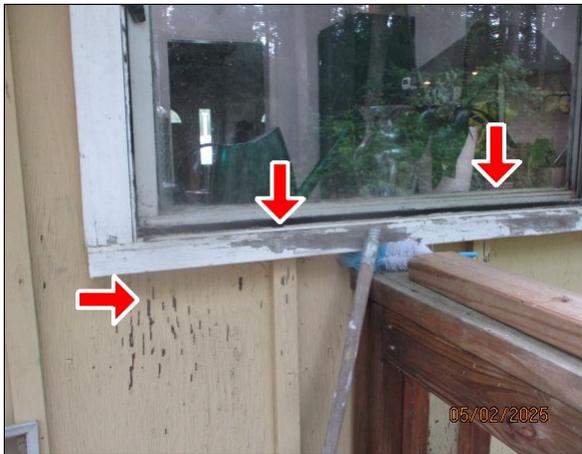
1.6 Item 2(Picture)

1.6 All exterior wood siding and trim are past due for a professional cleaning, repair and paint coat.

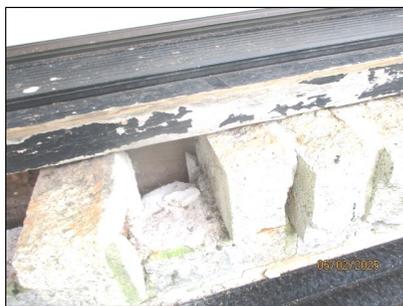
1.8 Item 2(Picture)

1.8 (1) Failing and dislodged brick under the front door frame as well as at the corner of the walk. Tuck pointing is recommended.

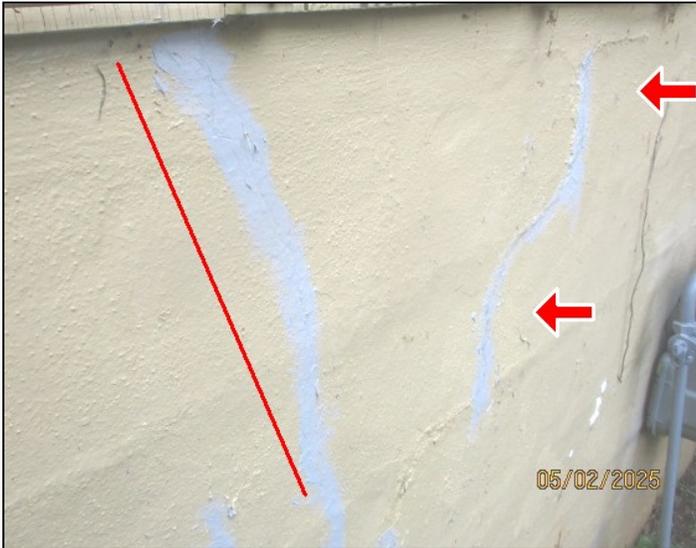
1.8 Item 5(Picture)

1.8 (2) A stair-step crack is a diagonal crack but, since mortar is usually not as strong as concrete block or brick, the crack migrates to the mortar joints as it zigzags along a path of least resistance.

Noted along the right side wall, back wall and rear corner.

Further evaluation by a structural engineer/contractor is recommended. One option includes helical piers that are drilled to bedrock and supports the wall foundation.

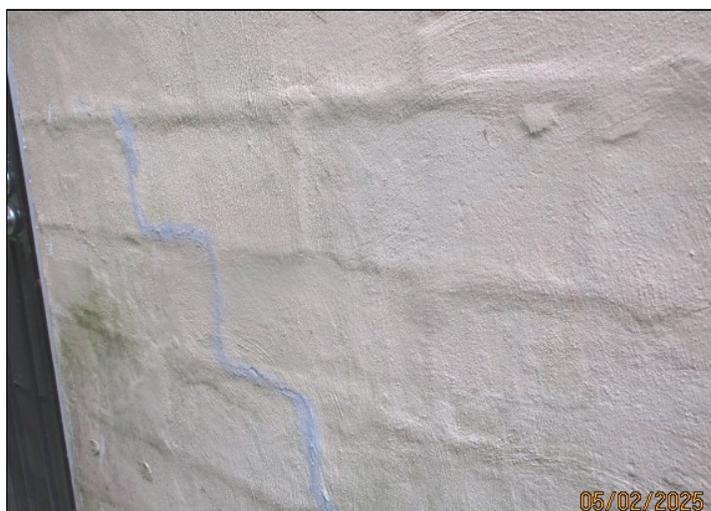
1.8 Item 9(Picture)

1.8 (3) All the mortar cinder block mortar lines present as bulging. Suggest trapping of moisture behind the exterior coating.. Condition consistent on all four sides of the dwelling.

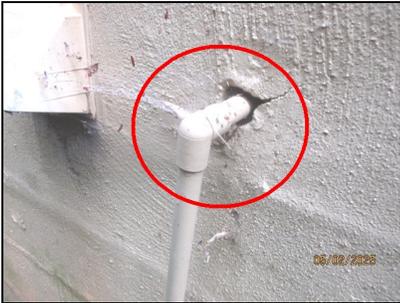
1.9 Item 1(Picture)

Major contributing factor to a majority of the water damage conditions evaluated.

Material to consider for sealing. Elastomeric caulk such a silicone, latex and/or acrylic for cracks less than 1/2 in width. Long lasting type is preferred. High temperature caulk around chimney and furnaces flues should be confirmed.

Spray foam for cracks from 1/2" to 3" (urathane or latex) . Verify application. Spray foam is not UV rated and requires addittional protection.

Seal all exterior penetration that enter the wall cavity

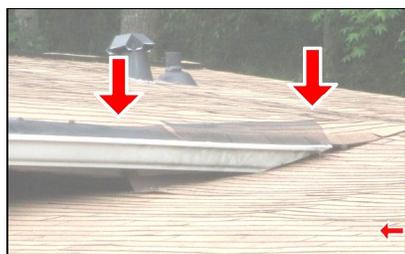
2.0 Item 1(Picture)

Multiple repairs. Curling and cupping of existing shingles. Replacement should be expected.

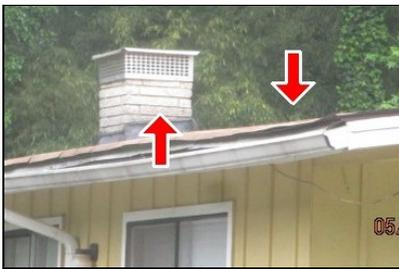
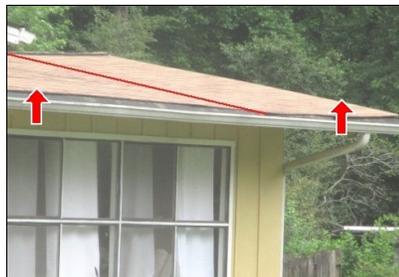
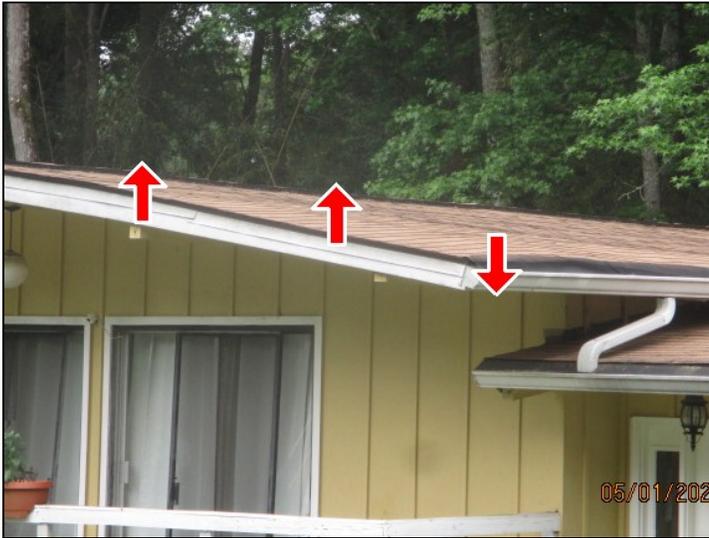
2.0 (2) Deflection in roof joists refers to the bending or sagging of the joists under a load, like a roof's weight and the weight of people or snow. It's essentially how much a joist bends when it's supporting a load, and it's a critical factor in ensuring the structural integrity and longevity of a roofing material.

Further evaluation by a licensed roofing contractor is recommended.

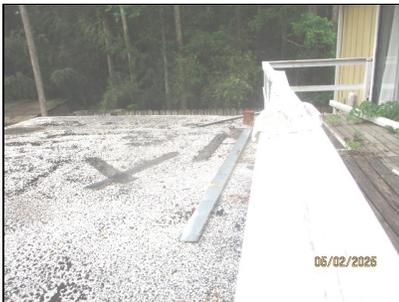
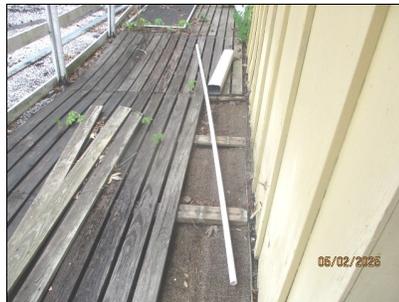
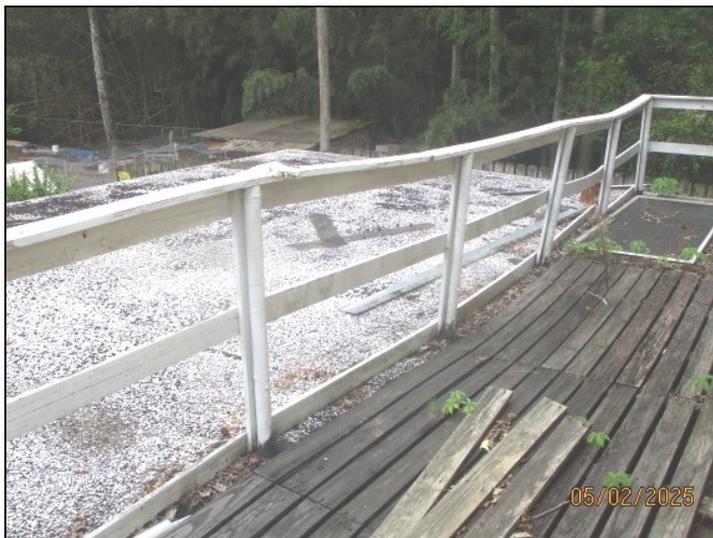
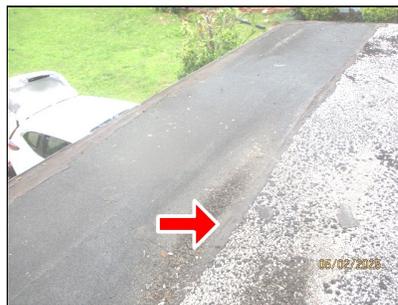
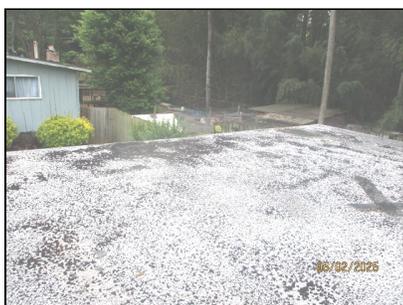
2.0 (3) Built Up roof system has failed. Numerous areas are ponding water. Multiple repairs exist.

Evaluation and replacement by a licensed roofer recommended.

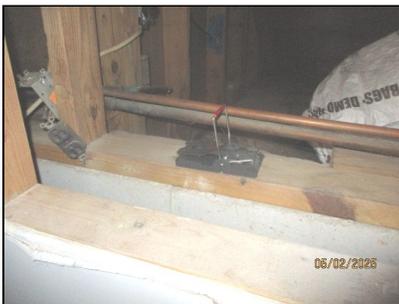
3.0 Item 1(Picture)

3.0 A number of rodent traps identified in the basement.area under the stairs.

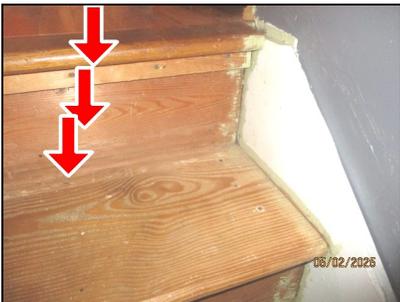
3.2 Item 1(Picture)

3.2 (1) First step down riser 8.5 inches while the remainder is 7.25. Creates unsafe step condition. Caution.

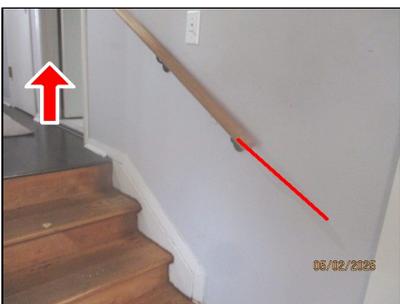
3.2 Item 2(Picture)

3.2 (2) Handrail grip size. all required handrails shall be be of one of the following types or provide equivalent grip ability. The minimum width of the handrail above the recess shall be 1 1/4 inches (32mm) to a maximum off 2 3/4 inches (70mm) .

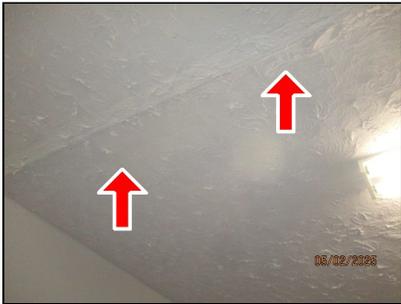
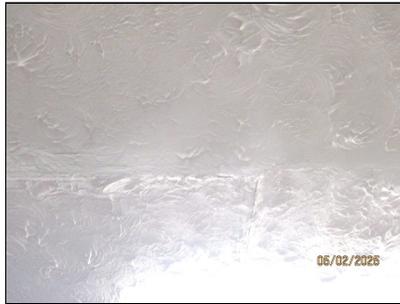
3.3 (1) Three types of ceiling material in use.

Note: Sheet rock in basement appears DIY.

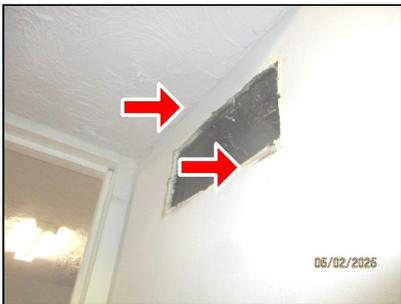
3.3 Item 3(Picture)

3.3 (2) Cut away in the right rear of basement wall next to the furnace. Adding a supply vent may have been planned.

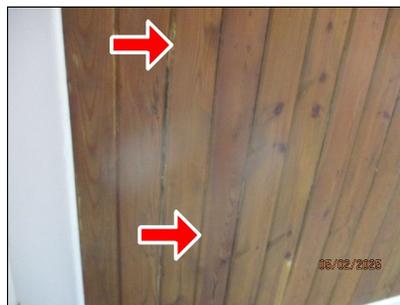
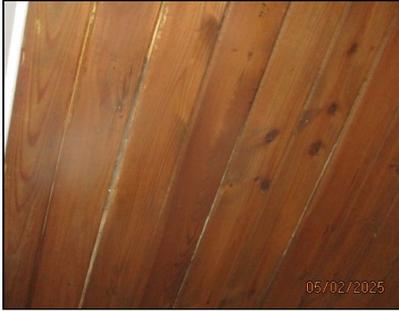
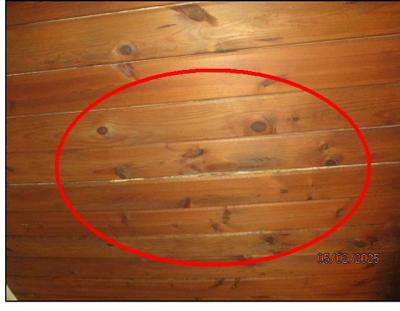
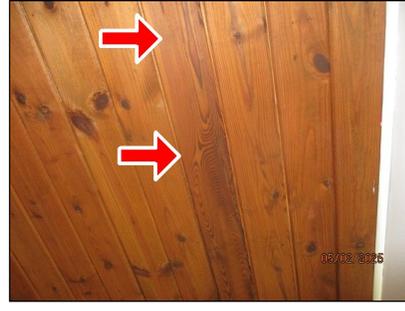
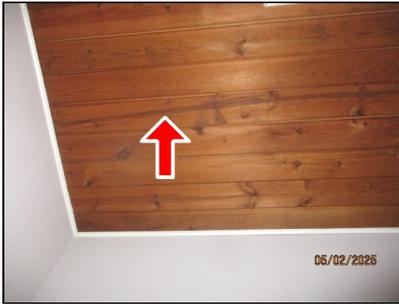
3.3 (3) Tongue and grooved ceiling material is original to construction. More than 6 areas present with water damage. Due to height restrictions brittle or damaged material could not be determined.

Note: Conditioning of wood material is always an option to be completed by a professional.

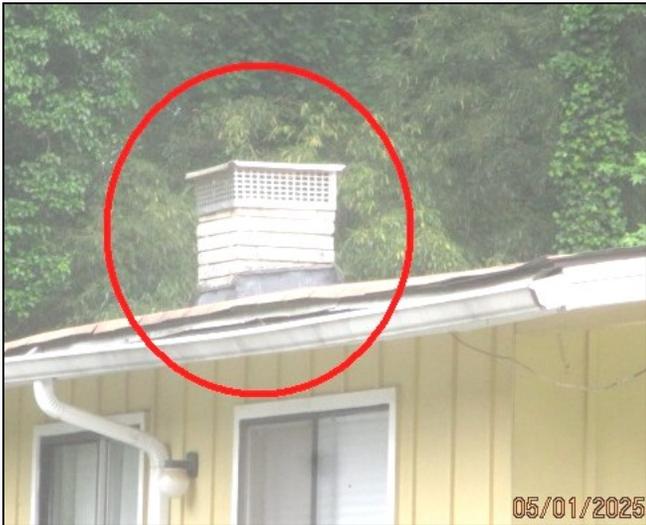
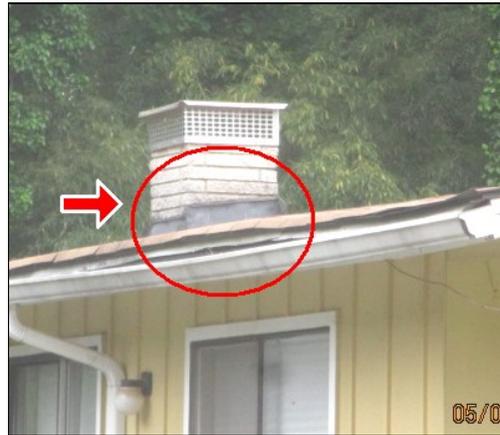
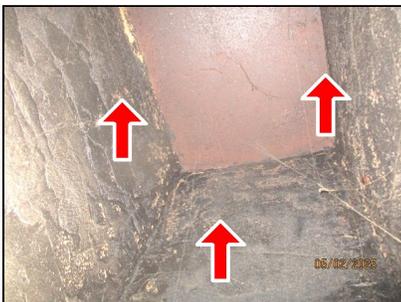
4.0 (1) Vent us unlined with approved venting material.

Note: Fireplace chimney flu draft has been closed.

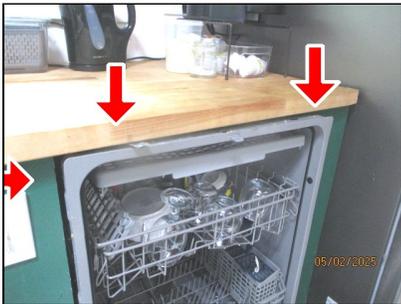
5.0 Item 1(Picture)

5.0 Dishwasher will not operate. Unit is not secured Replacement should be expected

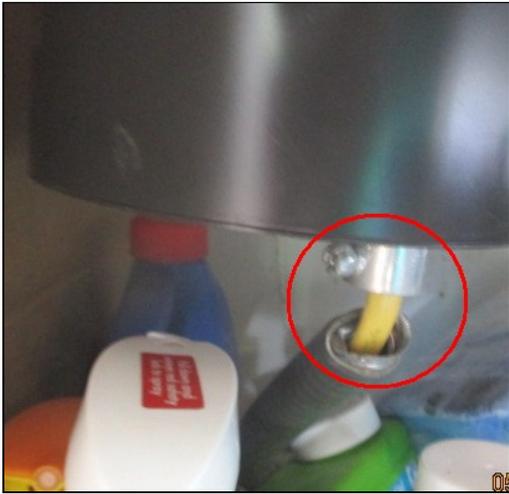
5.2 The food disposer wiring is missing a romex connector (anti-strain device). I recommend repair as needed.

5.2 Item 1(Picture) Loose Insulation
Conduit

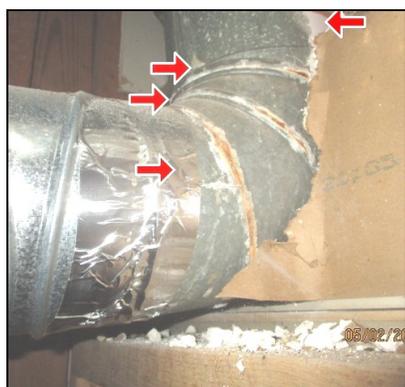
6.1 Corrosion at the elbow joint. Replacement recommended.

This vent is responsible for discharging carbon monoxide (lethal gas) created by a gas flame to the exterior of the dwelling.

6.1 Item 1(Picture) Closet/
Laundry

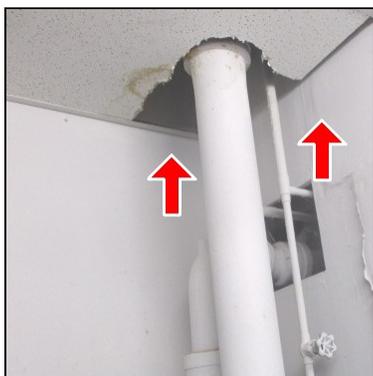
No evidence of fire blocking was identified.

6.3 Item 1(Picture) Exterior corner of basement

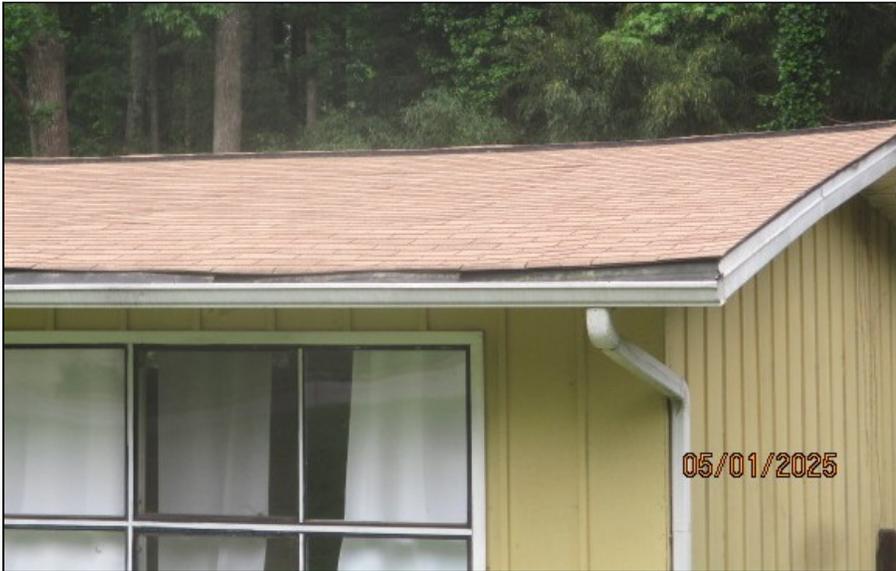
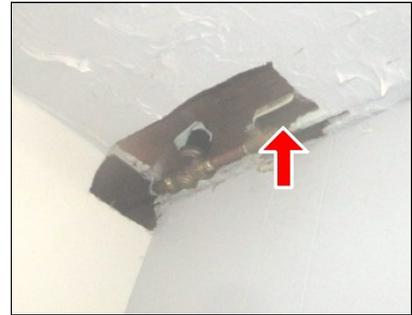
8.0 Located in the ceiling of the front basement area. The valve is not readily accessible.

Note: Additional equipment will be needed to access the shut off.

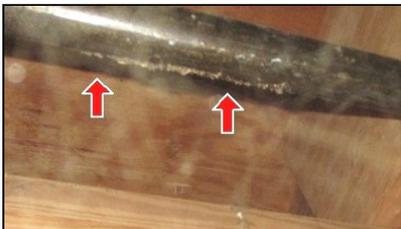
Note: Clean out plug next to the washer has been painted.

8.4 Item 1(Picture) Hall Closet/
Utility Room

Evaluation and repair by a licensed plumber is recommended.

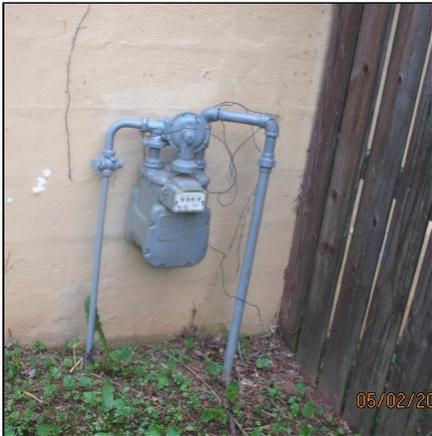
8.5 Item 1(Picture)

8.5 Gas Cutoff: The outdoor emergency cut-off valve for the main gas supply was found along the back wall. The location for this valve must be known so it can be closed in the event of a damaged pipe or small leak. **Additional tool is required to perform this function.**

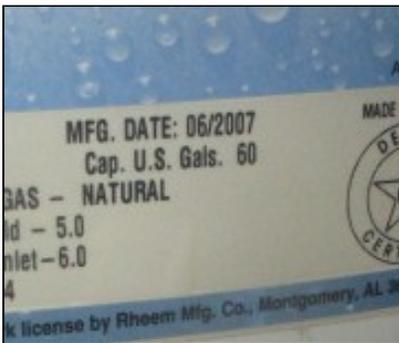
8.6 Item 1(Picture)

8.6 (2) Average useful life of a gas water heater is 12-16 years. 18 years

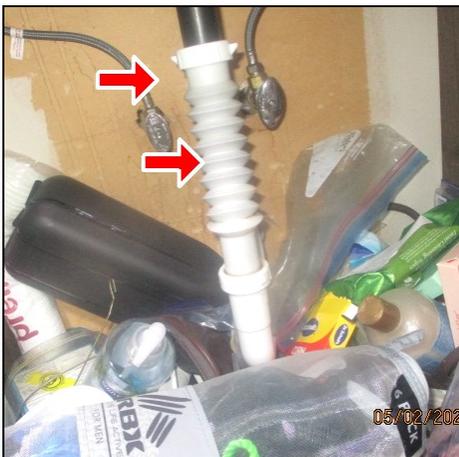
9.0.A Item 1(Picture)

9.0.A Corrugated drain material is not approved for this application. Plumbing is gravity driven. All interior material is smooth in the direction of flow.

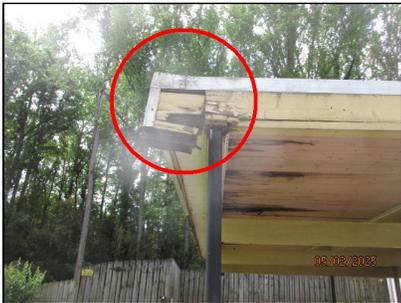
10.0 Item 5(Picture)

10.0 (3) Extensive water damage and failure of supporting lateral bracing.

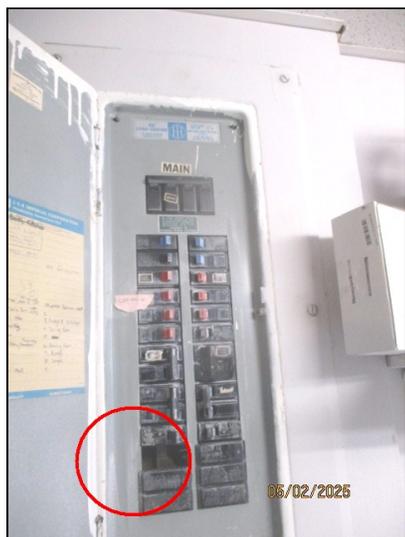
11.0 Item 1(Picture) Missing Spacer

11.0 NEC 314.20b- Per National Electric Code (NEC), "Internal parts of electrical equipment, including bus bars, wiring terminals, insulators and other surfaces, shall not be damaged or contaminated by foreign materials such as paint, plaster, cleaners or abrasives, and corrosive residues. There shall not be any damaged parts that might adversely affect safe operation or mechanical strength of the equipment such as parts that are broken; bent; cut; deteriorated by corrosion, chemical action, or overheating. Foreign debris shall be removed from equipment."

Note: that application of cleaners or abrasives is not permitted. This essentially means that, per the NEC, over spray panel interiors must be replaced or evaluated by a licensed electrician for safety.

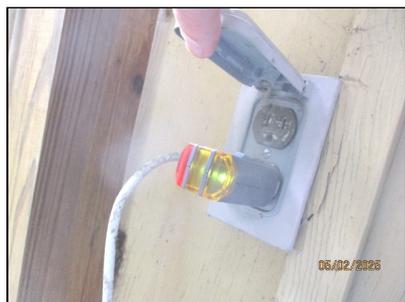
11.2 The GFCI will sense the difference in the amount of electricity flowing into the circuit to that flowing out, even in amounts of current as small as 4 or 5 milliampere. The GFCI reacts quickly (less than one-tenth of a second) to trip or shut off the circuit. Monthly testing is recommended by the National Electrical Code.

11.2 Item 1(Picture) No GFCI protection.

Updating the electrical system to include Ground Fault circuit Breaker(GFCI) is recommended. Ground Fault Circuit Interrupters are electrical safety devices that provide protection against electrical hazards in all bathrooms,garages, kitchens,basements ,exteriors and all other wet areas.

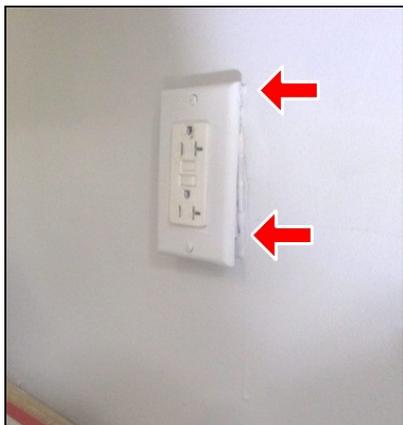
11.4 Item 2(Picture)

11.4 (2) Outlets in the basement right rear corner are not functioning.

Electrical box is not secured to the wall.

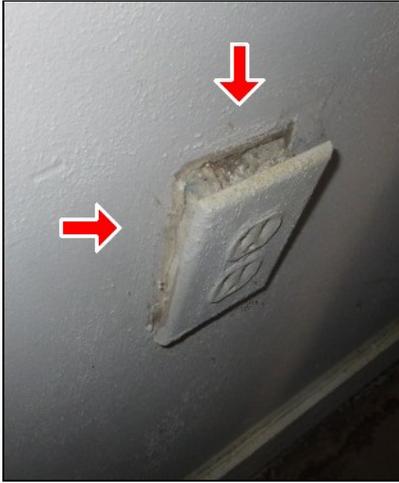
11.4 Item 3(Picture)

11.4 (3) Electrical box is not secure along the front wall of the basement.

Note: Numerous outlets are loose or not secure through out the dwelling.

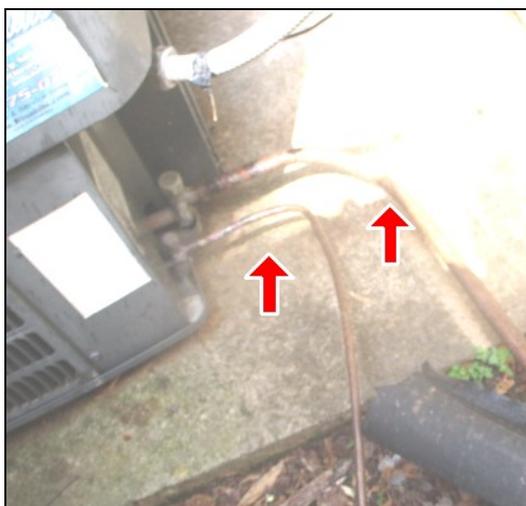
12.2 Item 1(Picture)

12.2 (1) The foam sleeve on suction line is missing foam sleeve in area(s) at outside unit. Missing foam on suction line can cause heat gain and energy loss and condensation.

Piping and fittings for refrigerant vapor (suction) lines shall be insulated with insulation having a thermal resistivity of at least R-4. (Armor Flex- trade name)

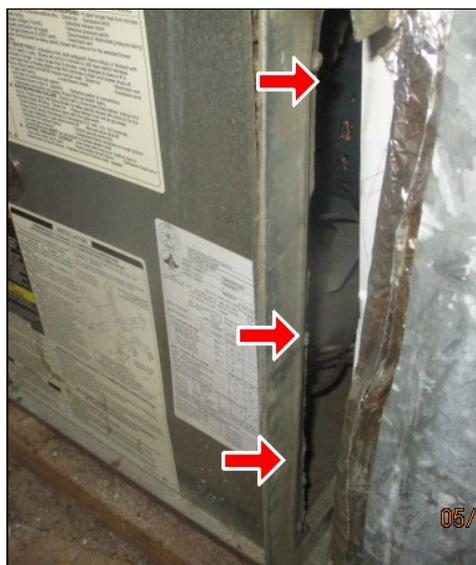
13.3 Item 1(Picture)

13.3 (1) A better quality improves performance and quality of air cleaning. Good choices include a one inch pleated filter or larger media filter that provide more surface area. Look for filters with a higher micro particle performance rating.(800 and up.)

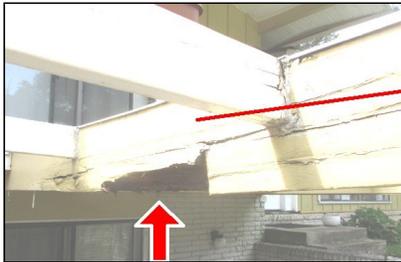
1.2 Item 1(Picture)

(1) ENTIRE DECK AND CARPORT ROOF ARE UNSAFE TO FOOT TRAFFIC AND MAY FAIL WITHOUT FURTHER NOTICE.

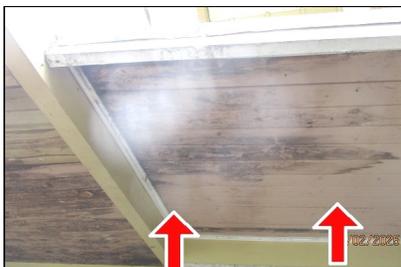
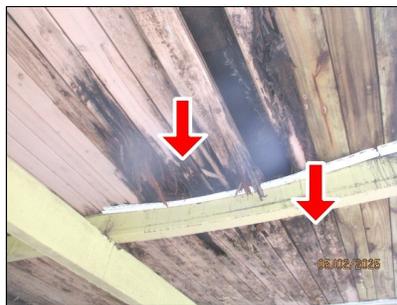
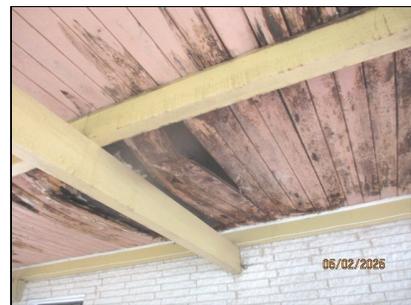
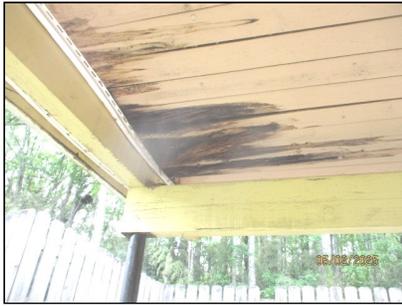
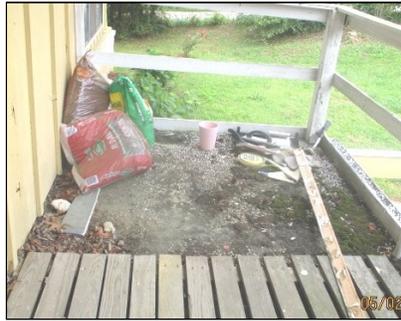
(2) Contributing factors include failed flashing, sealant exterior paint coat. The walking area appears installed over indoor/outdoor carpet.

Note:Design drainage does not exist

1.2 Item 3(Picture) Multiple events of intrusion.

1.2 Item 6(Picture) Over Carpet.

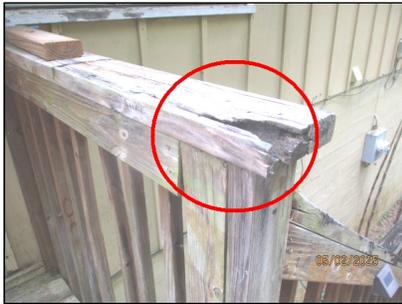
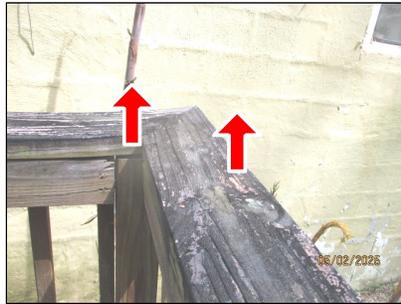
(4) Deck Water Damage

1.2 Item 8(Picture) UV Damage

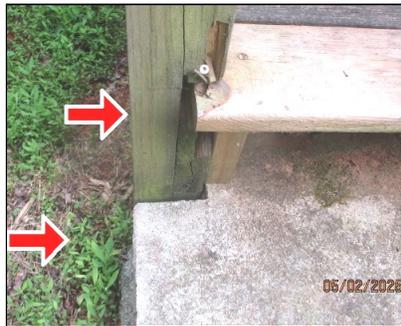
1.2 Item 10(Picture)

(5) Lateral movement deck stair railing. Water damage at the base.

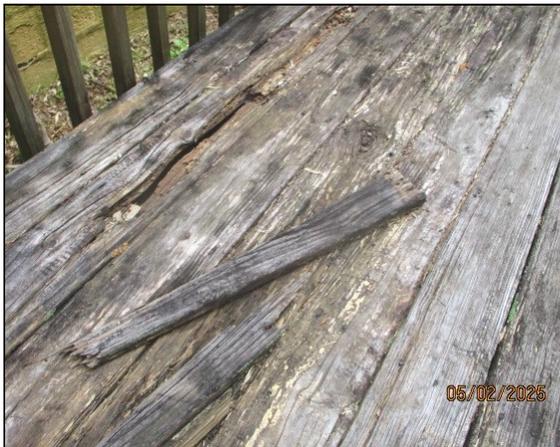
1.2 Item 12(Picture)

(6) More than 75% of the decking has failed from water damage and delayed maintenance.

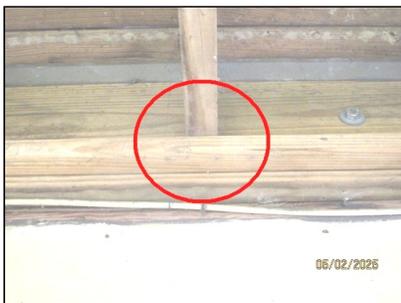
1.2 Item 13(Picture)

(7) Ledger strip is not appear to be adequately nailed. Local building code requires three nails on the ledger strip underneath each joist.

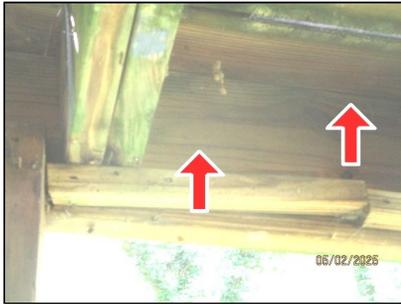
1.2 Item 14(Picture)

(8) Damaged ledger strip . Not secured as recommended.

Note: Removing ledger strip and adding sized joist hangers could be beneficial.

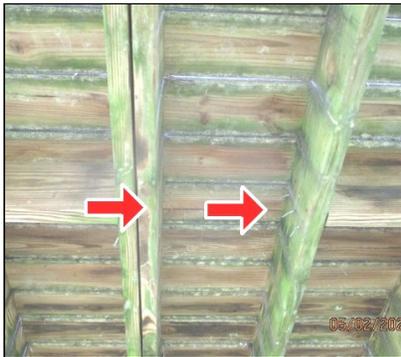
1.2 Item 15(Picture)

Missing in two sections minimum

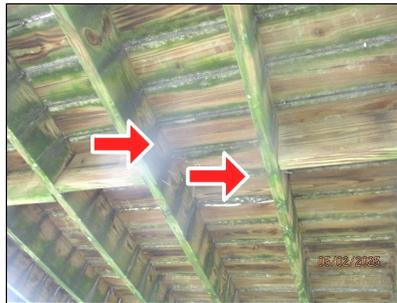
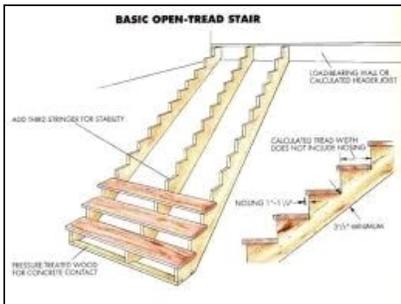
(10) Stair stringers should generally be spaced no more than 16-18 inches on center (OC). Risers should also be filled

Consult the Ga. Deck Perscriptive.

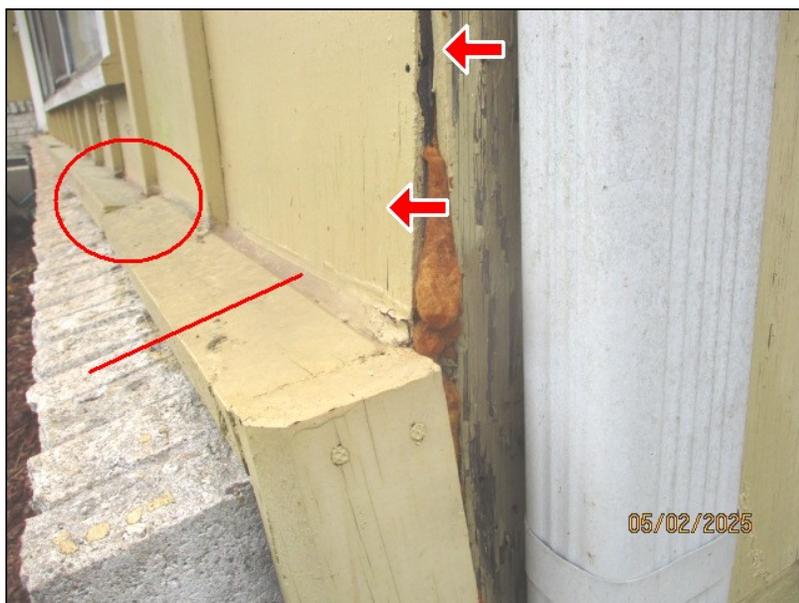
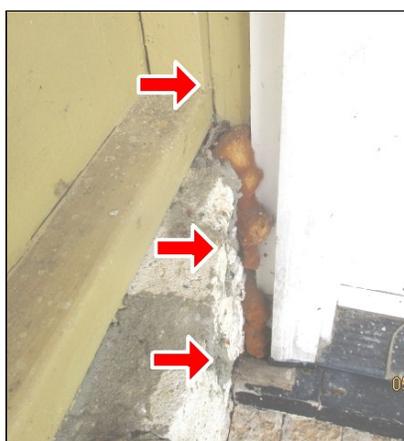
- (3) Wasp nest noted on the interior track of the front corner guest room.
- (4) Settlement of masonry wall at front entry. Expansion foam is failing.

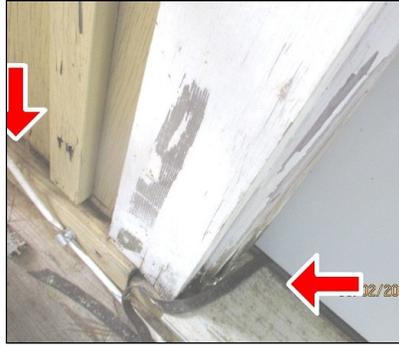
1.5 Item 8(Picture)

(5) Deck door frame threshold. Contributing factors missing caulk and paint coat.

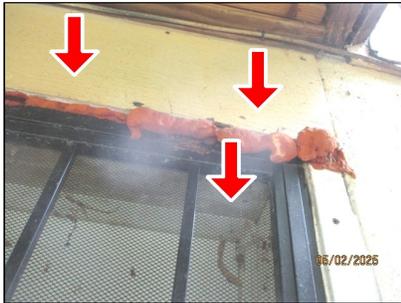
1.5 Item 9(Picture)

(6) Basement door appears to have been added. Header over the door is undersized for this application.

Expansion foam is not rated.

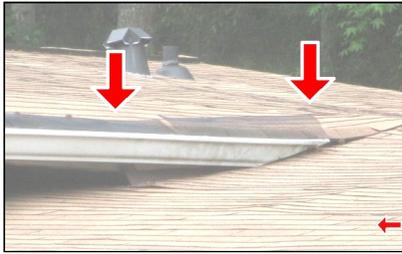
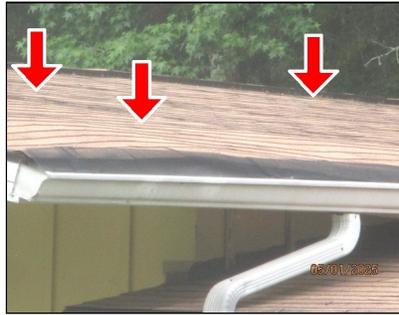
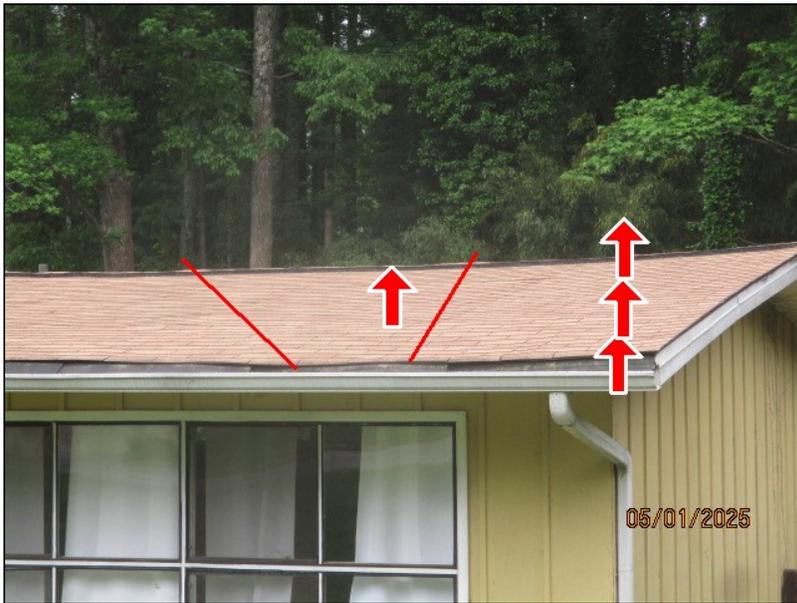
Multiple repairs. Curling and cupping of existing shingles. Replacement should be expected.

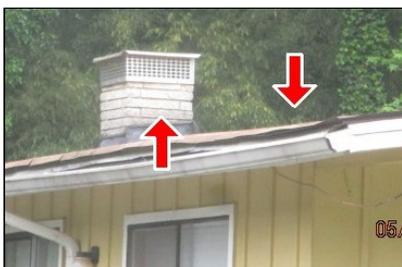
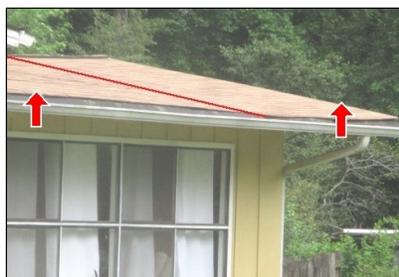
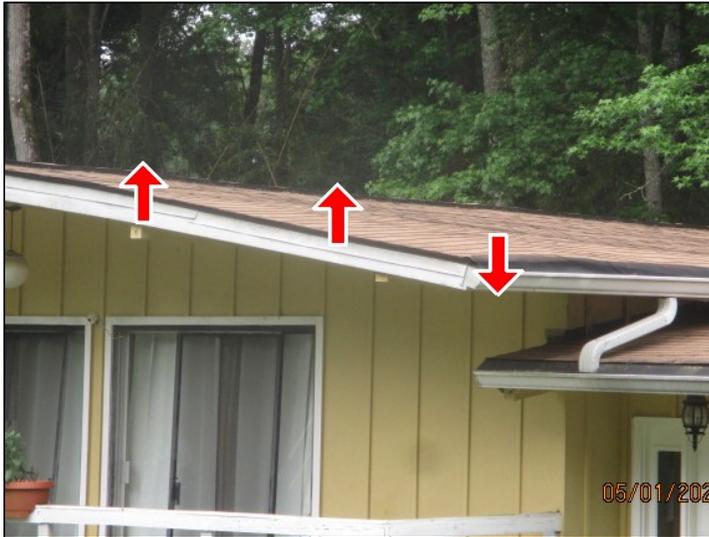
(2) Deflection in roof joists refers to the bending or sagging of the joists under a load, like a roof's weight and the weight of people or snow. It's essentially how much a joist bends when it's supporting a load, and it's a critical factor in ensuring the structural integrity and longevity of a roofing material.

Further evaluation by a licensed roofing contractor is recommended.

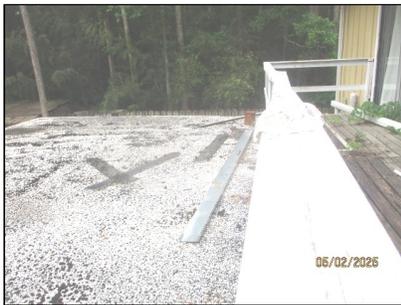
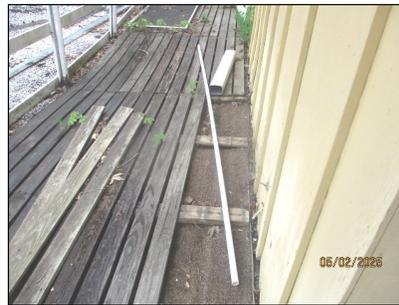
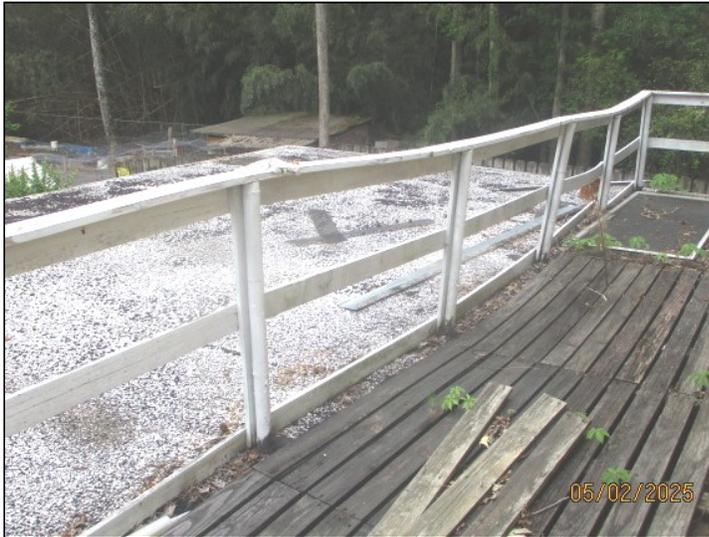
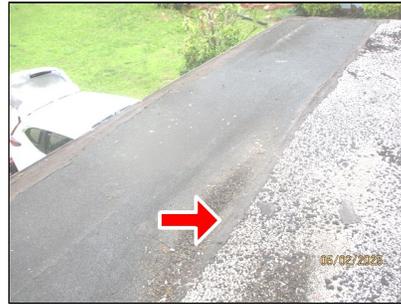
(3) Built Up roof system has failed. Numerous areas are ponding water. Multiple repairs exist.

Evaluation and replacement by a licensed roofer recommended.

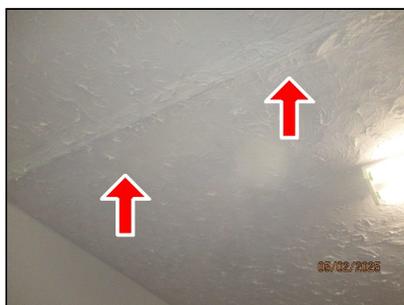
3.3 Item 1(Picture)

(1) Three types of ceiling material in use.

Note: Sheet rock in basement appears DIY.

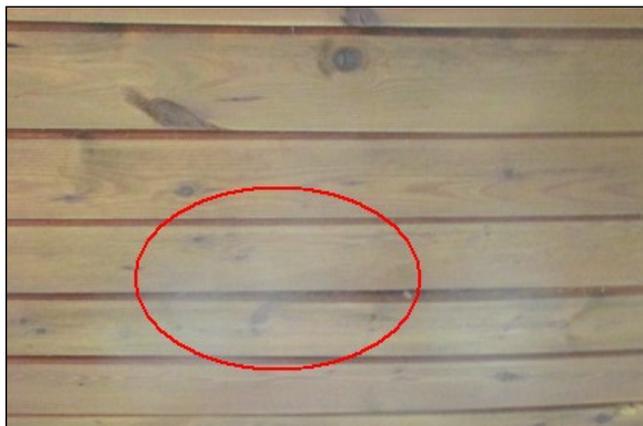
3.3 Item 4(Picture)

(3) Tongue and grooved ceiling material is original to construction. More than 6 areas present with water damage. Due to height restrictions brittle or damaged material could not be determined.

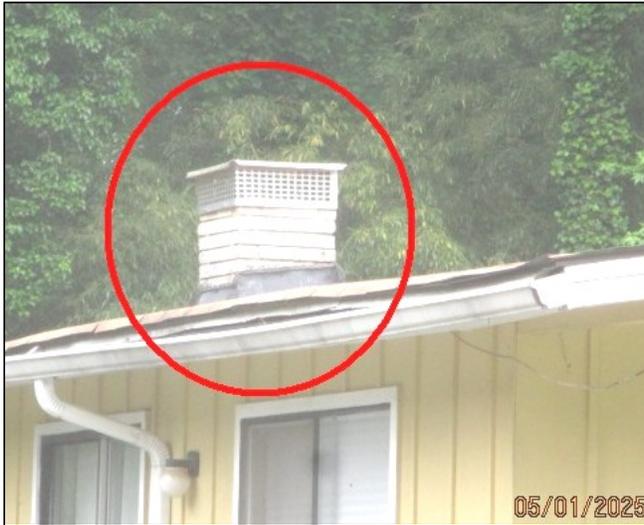
4.0 Item 1(Picture)

(1) Vent us unlined with approved venting material.

Note: Fireplace chimney flu draft has been closed.

Recommended prior to use of combustible materials and or gas appliance.

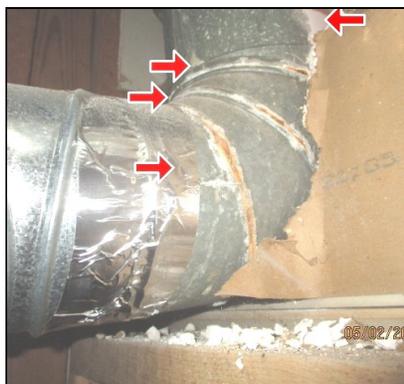
6.1 Item 1(Picture) Closet/
Laundry

Corrosion at the elbow joint. Replacement recommended.

This vent is responsible for discharging carbon monoxide (lethal gas) created by a gas flame to the exterior of the dwelling.

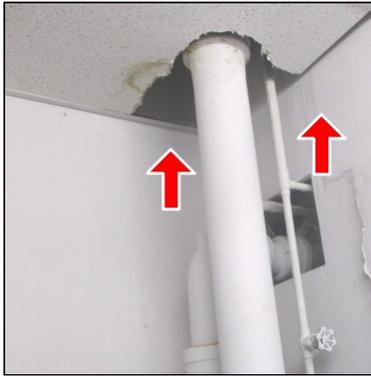
6.3 Item 1(Picture) Exterior corner of basement

No evidence of fire blocking was identified.

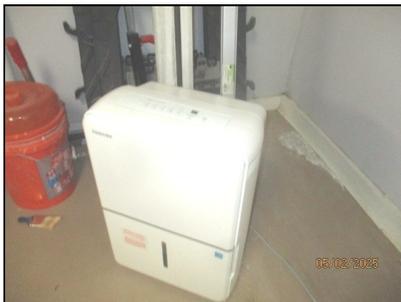
7.0 Item 2(Picture)

(2) Dehumidifier has been in use right front of basement.

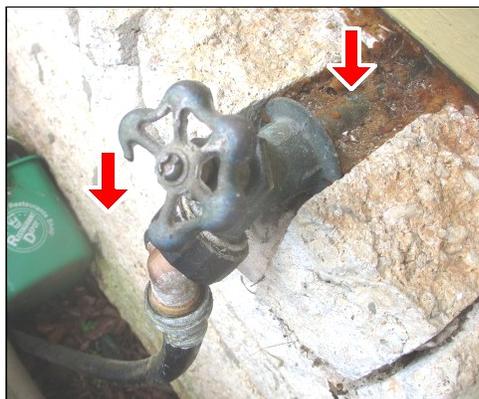
8.1 Item 1(Picture)

Front faucet control knob is damaged.

Note: Expansion foam is failing. This material is not rated for UV exposure.

Note: Water intrusion behind the masonry wall is likely.

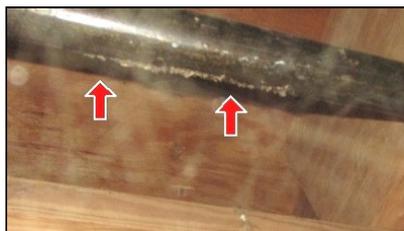
8.4 Item 1(Picture) Hall Closet/
Utility Room

- (1) Use water efficiently : Average indoor water use in the typical single-family home is almost 70 gallons per person per day. Dripping faucets can waste about 2,000 gallons of water each year. Leaky toilets can waste as much as 200 gallons each day
- (2) Due to the age of the dwelling and extensive root systems in the front yard it could be beneficial to have a licensed lumber scope the main waste line from the house to the street
- (3) Waste line in the basement closet is failing along the bottom of the cast iron material.

Note: Clean out plug next to the washer has been painted.

Evaluation and repair by a licensed plumber is recommended.

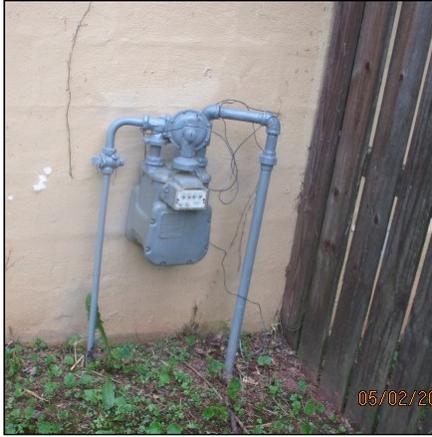
8.5 Item 1(Picture)

Gas Cutoff: The outdoor emergency cut-off valve for the main gas supply was found along the back wall. The location for this valve must be known so it can be closed in the event of a damaged pipe or small leak. **Additional tool is required to perform this function.**

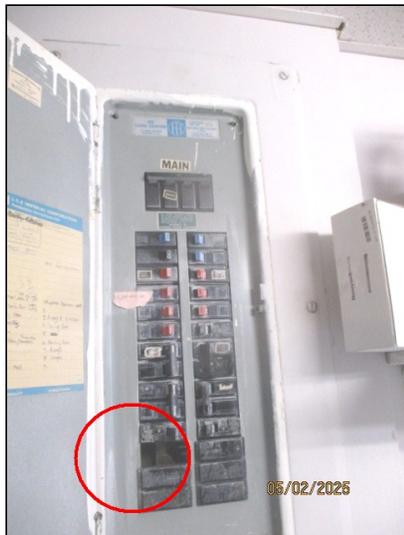
11.0 Item 1(Picture) Missing Spacer

Note: that application of cleaners or abrasives is not permitted. This essentially means that, per the NEC, over spray panel interiors must be replaced or evaluated by a licensed electrician for safety.

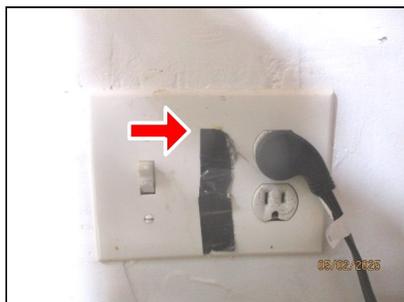
11.4 Item 1(Picture)

(1) Receptacle next to refrigerator has black tape over the receptacle. Source unknown

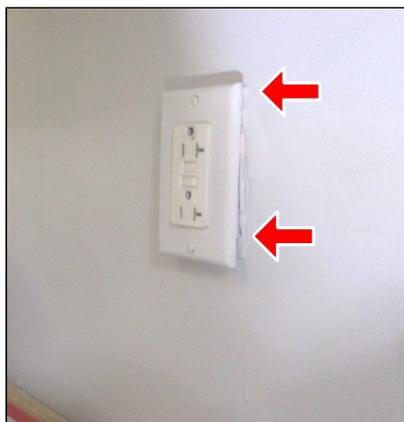
11.4 Item 2(Picture)

(2) Outlets in the basement right rear corner are not functioning.

Electrical box is not secured to the wall.

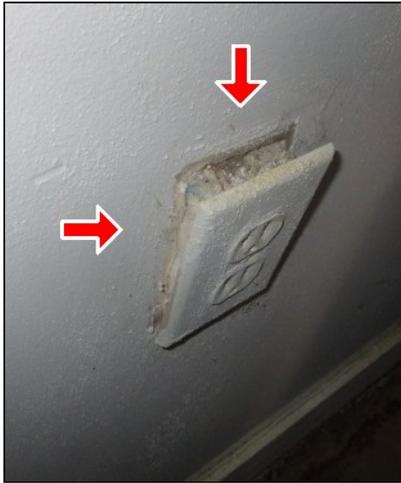
11.4 Item 3(Picture)

(3) Electrical box is not secure along the front wall of the basement.

Note: Numerous outlets are loose or not secure through out the dwelling.
