Inspection Report

Modified DIY - Mid Century Modern
Stone Mountain GA 30083

Common Cents Home Inspection Services Inc

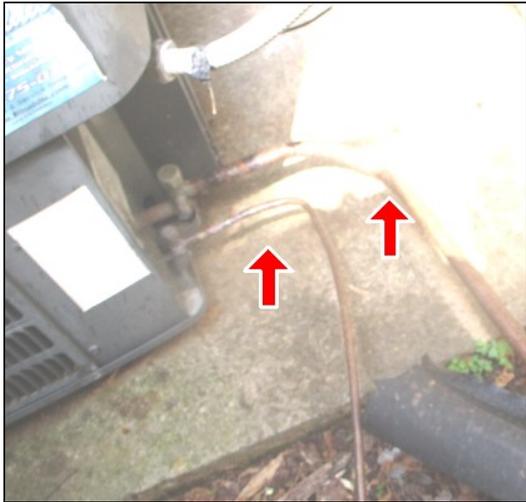
12.2 Item 1(Picture)

(1) The foam sleeve on suction line is missing foam sleeve in area(s) at outside unit. Missing foam on suction line can cause heat gain and energy loss and condensation.

Piping and fittings for refrigerant vapor (suction) lines shall be insulated with insulation having a thermal resistivity of at least R-4. (Armor Flex- trade name)

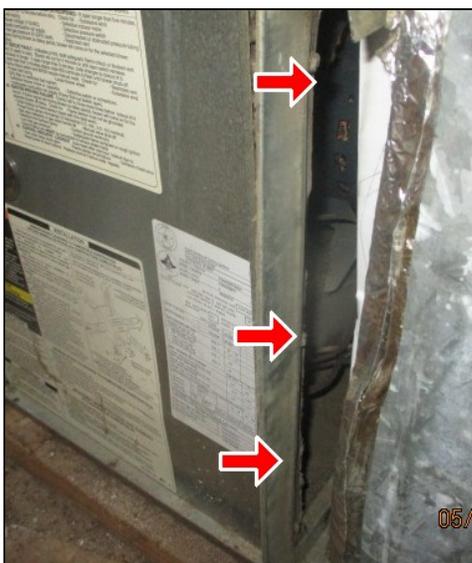
13.3 Item 1(Picture)

(1) A better quality improves performance and quality of air cleaning. Good choices include a one inch pleated filter or larger media filter that provide more surface area. Look for filters with a higher micro particle performance rating.(800 and up.)

(2) Filter is undersized for the plenum opening.
