Inspection Report

Life Event 55+

Property Address:
Full Brick Drive
Stone Mountain GA 30030

Date: 2/10/2025	Time: 02:00 PM	Report ID: Sample Condominium Inspection Review
Property: Full Brick Drive Stone Mountain GA 30030	Customer: Life Event 55+	Real Estate Professional: Supper Agent

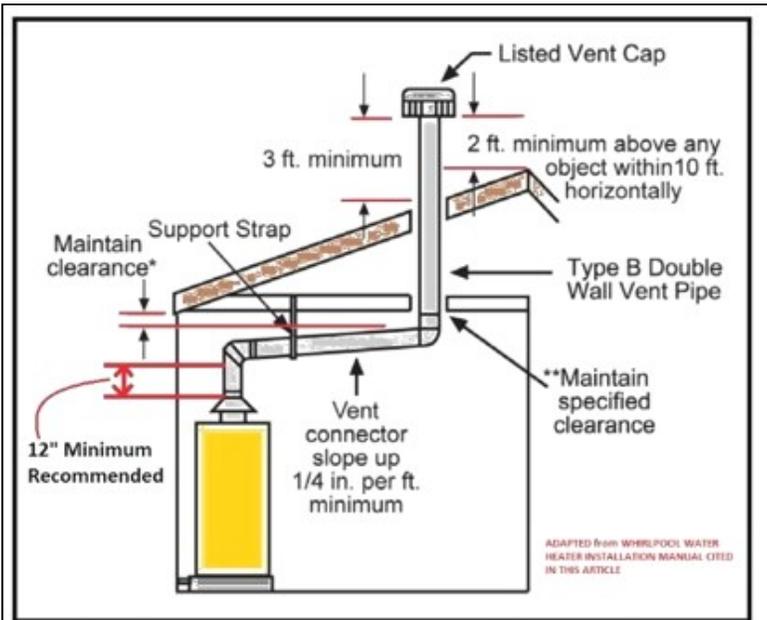
6.1 Item 1(Picture) Example

6.1 Utilizing the natural principle of hot air rising, where the hot exhaust gases from the water heater combustion chamber are expelled upwards through a vertical or slightly upward-sloping pipe, typically made of metal, to the outside of the home, essentially creating a "draft" that pulls the fumes out; this is called atmospheric venting and is the most common type for standard water heaters.

Vertical gas vent system with type B double wall vent pipe

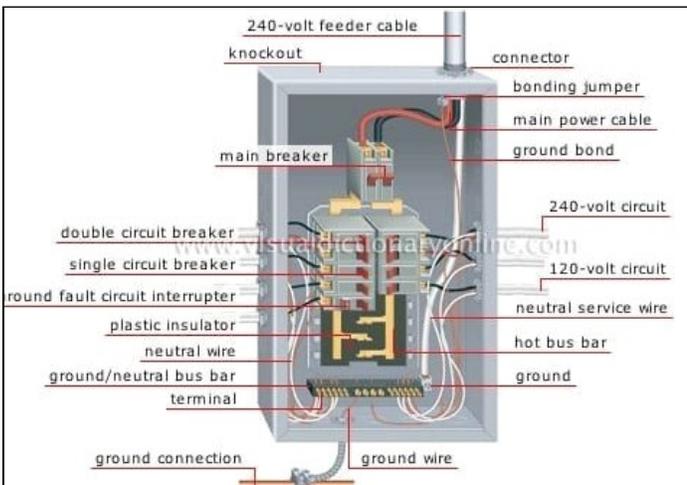
11.0 Item 3(Picture) Example:

11.2 Exterior service disconnect.

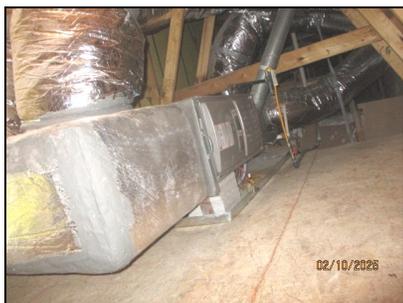
13.0 Item 1(Picture)

80,000 btu

13.1 Average useful life is 15 - 20 years. Regular service and evaluation by a licensed HVAC technician is recommended.
