Inspection Report

First Time Home Buyers Massive Structure

Property Address:
Popular Upscal Neighborhood
Atlanta GA 30328

Common Cents Home Inspection Services Inc

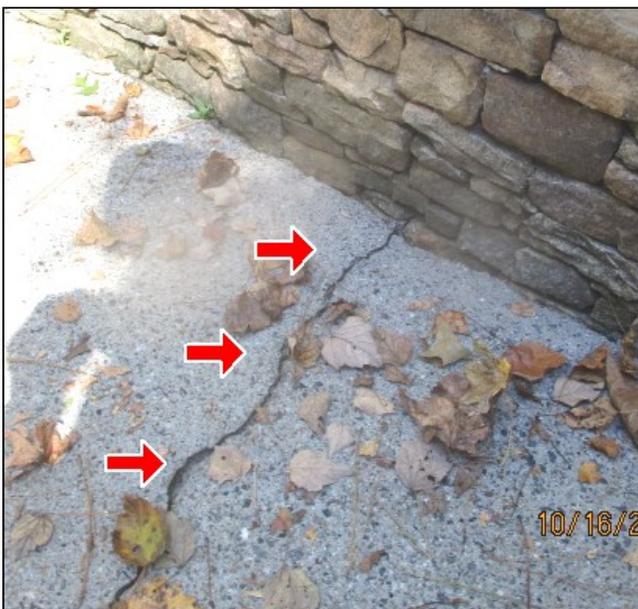
1.0 Item 3(Picture)

1.0 (6) Back Patio area along the retaining wall.

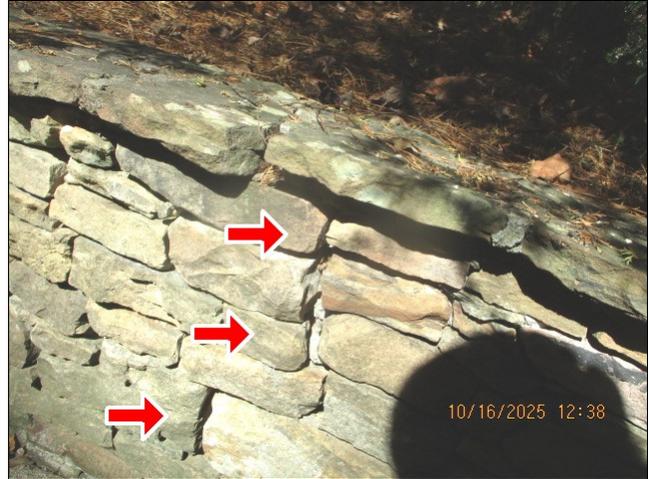
1.3 Item 3(Picture)

1.3 (4) Back elevation retaining wall has two cracks. Suggest the back fill may be to high.

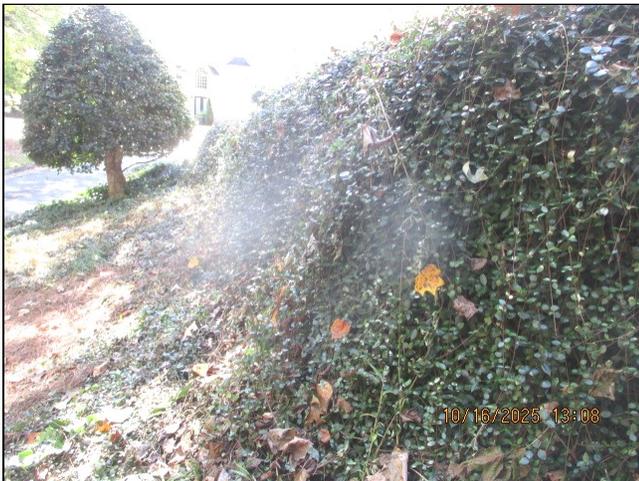
1.3 Item 4(Picture)

1.3 (5) Retaining wall right side of lot. Not accessible for review. Appears to be stone/brick

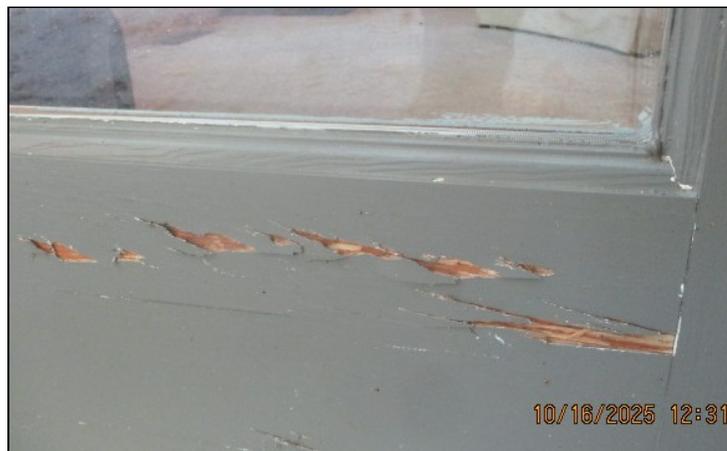
1.5 Item 1(Picture)

1.5 (3) Back entry door off living room

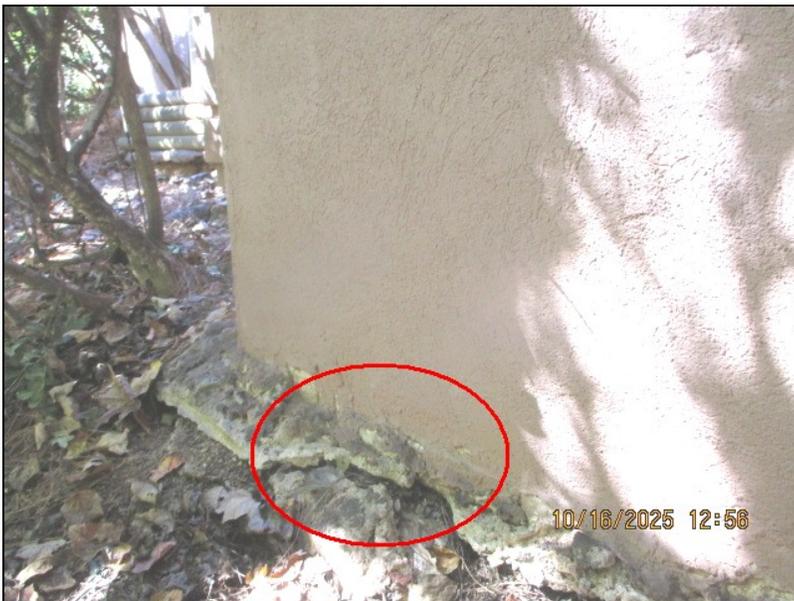
1.8 Item 2(Picture) Right Side Wall

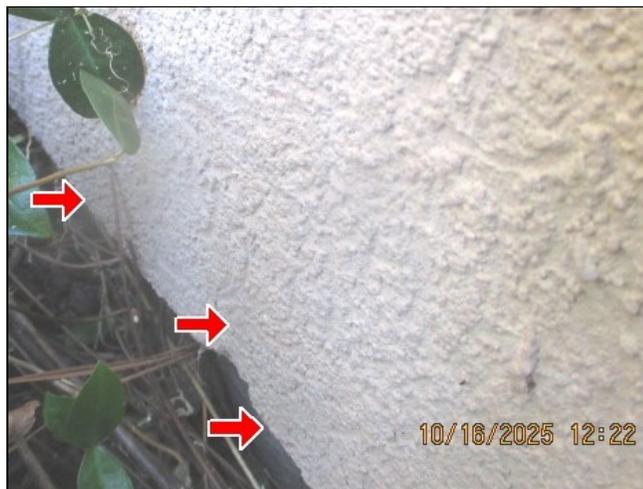
1.8 Item 3(Picture) Left front corner garage

Given the number of items on this system further evaluation by a licensed stucco professional is highly recommended.

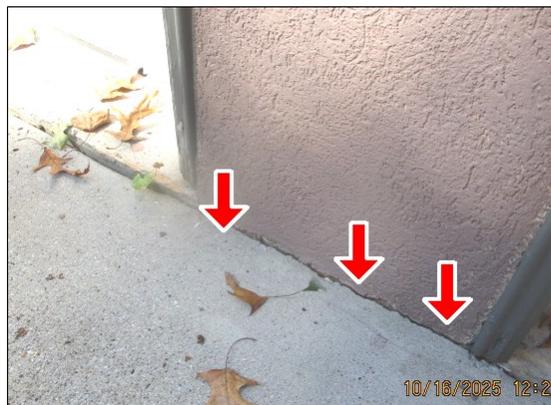
1.8 Item 4(Picture) Terminated below concrete (garage)

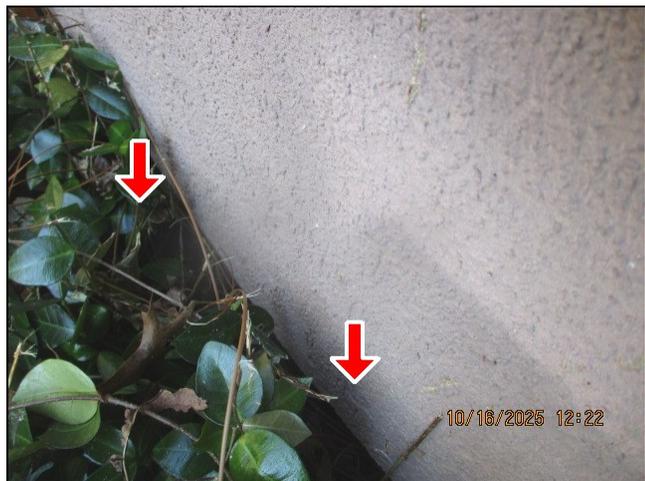
1.8 Item 5(Picture) Terminated below grade

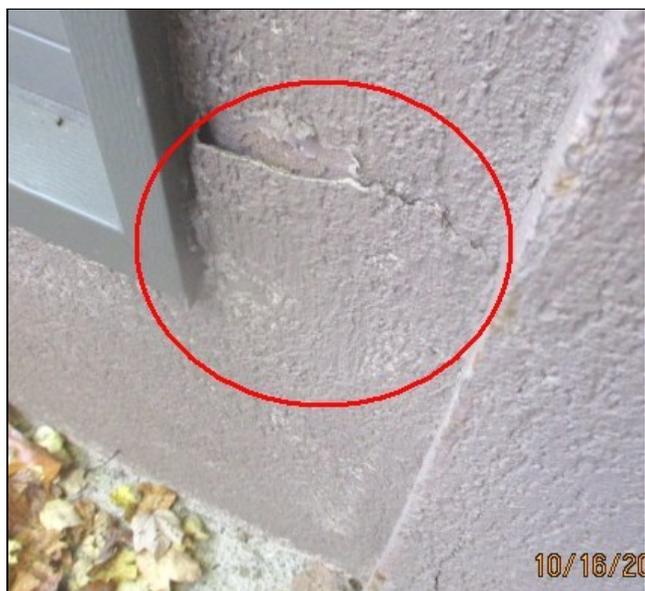
1.8 Item 7(Picture)

1.8 (5) Deck windows both side

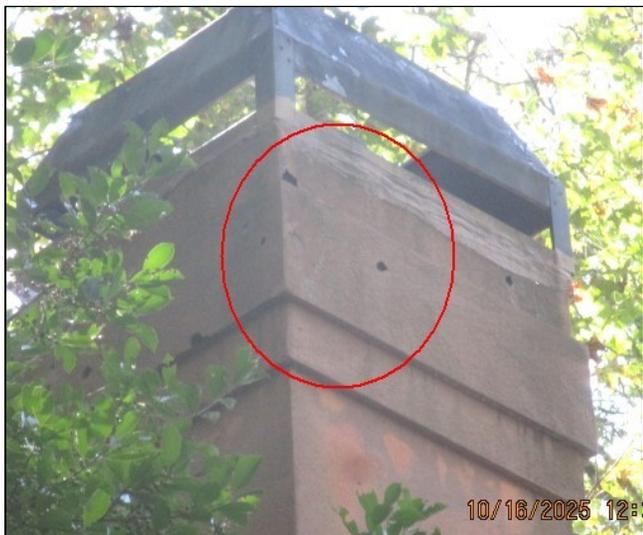
1.8 (6) Bird pecking is contributing to this damage.

1.8 Item 9(Picture) Chimney Cap

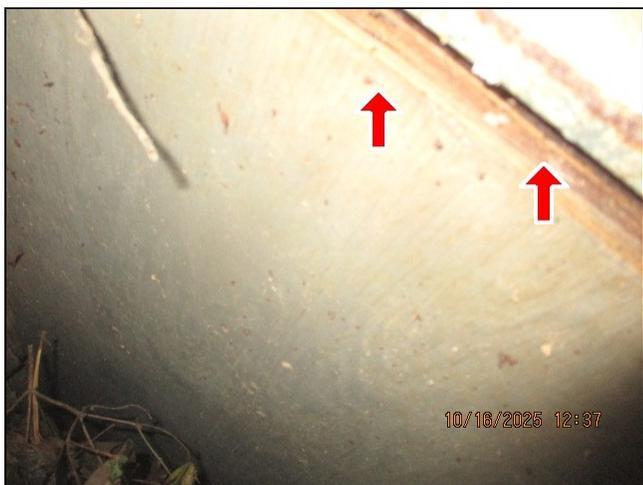
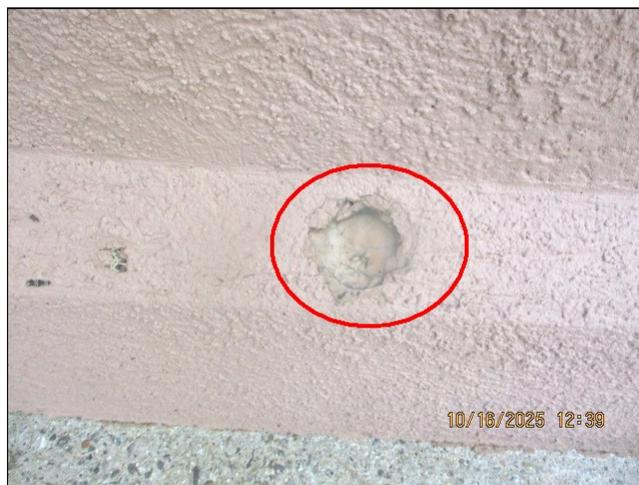
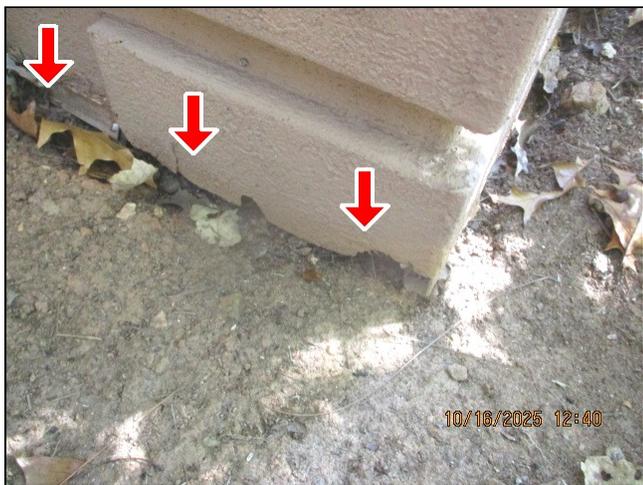
1.8 (7) Under side of stucco material. Gap exist in numerous areas.

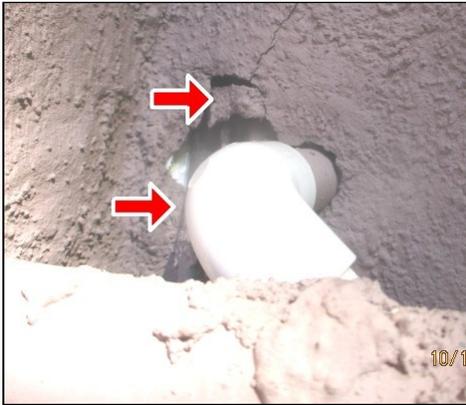
1.8 (8) Wall penetration

1.8 Item 13(Picture) Interior Corner at compressors

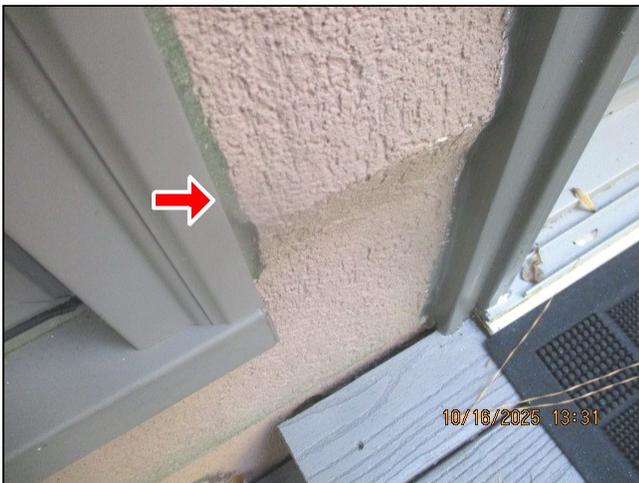
1.8 (9) System is buckling. This normally occurs with out expansion joints for the material to expand and contract.

1.8 Item 14(Picture) Patio

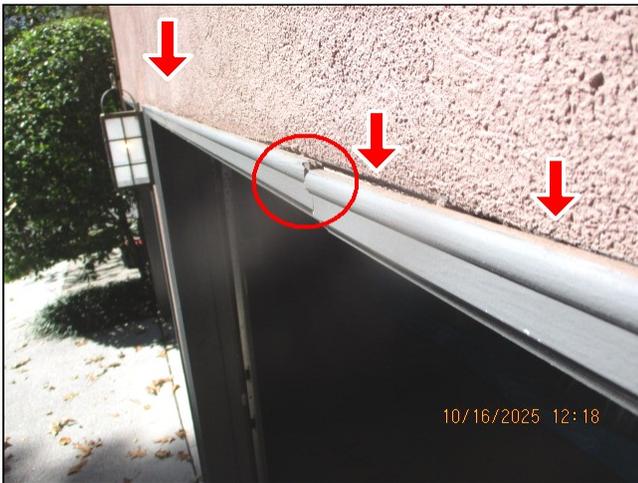
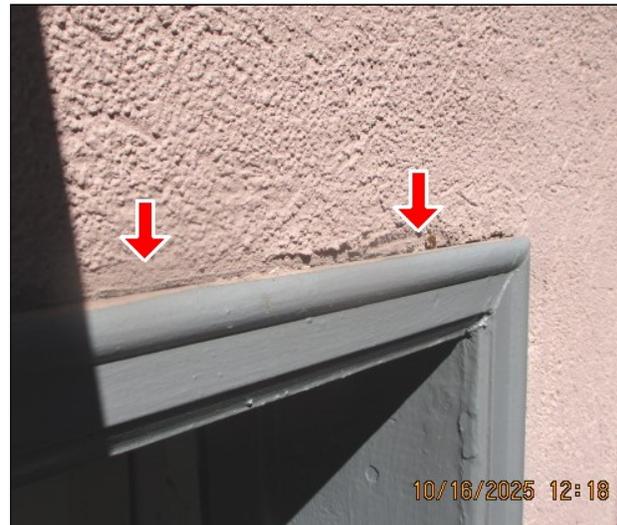
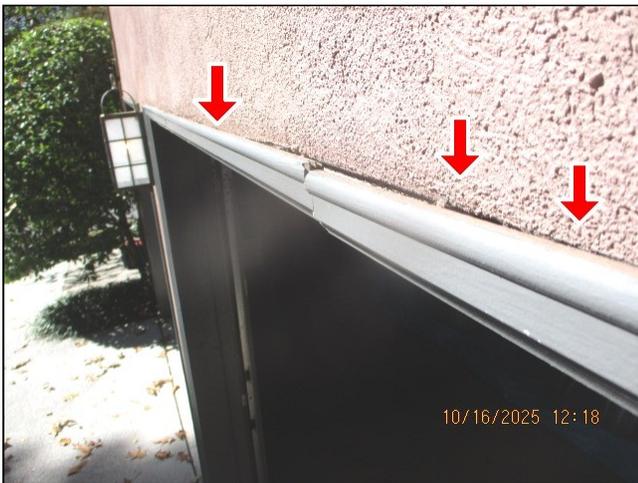
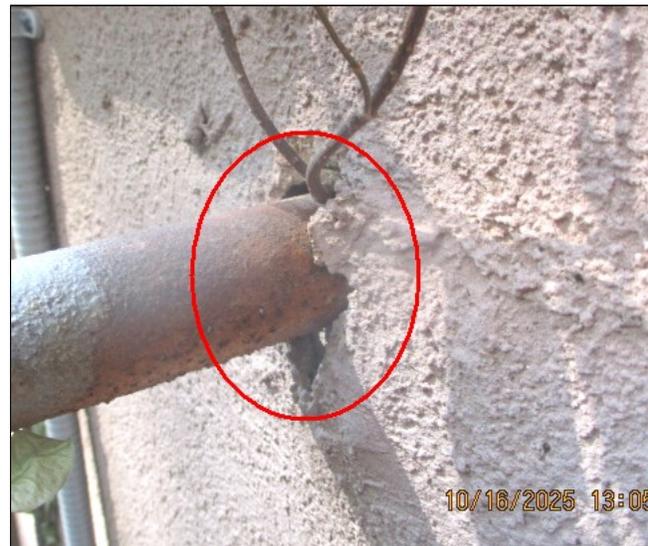
1.9 Item 3(Picture) Top of garage door frame.trim

1.9 (1) Seal all dissimilar material.

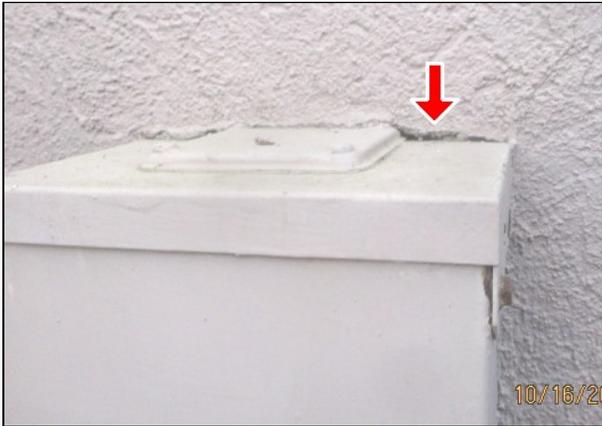
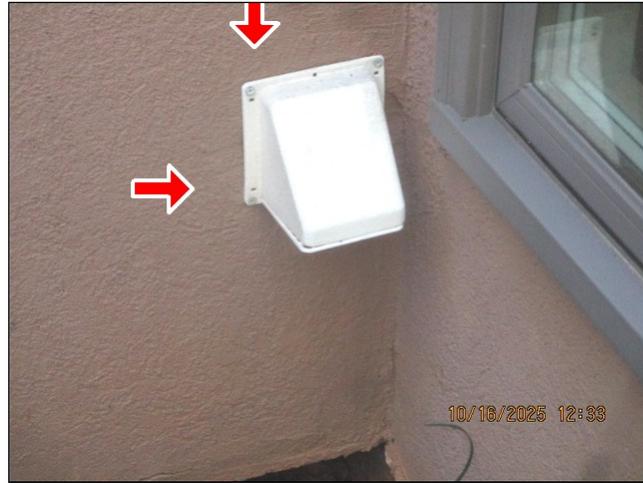
1.9 (2) Fireplace exhaust air.

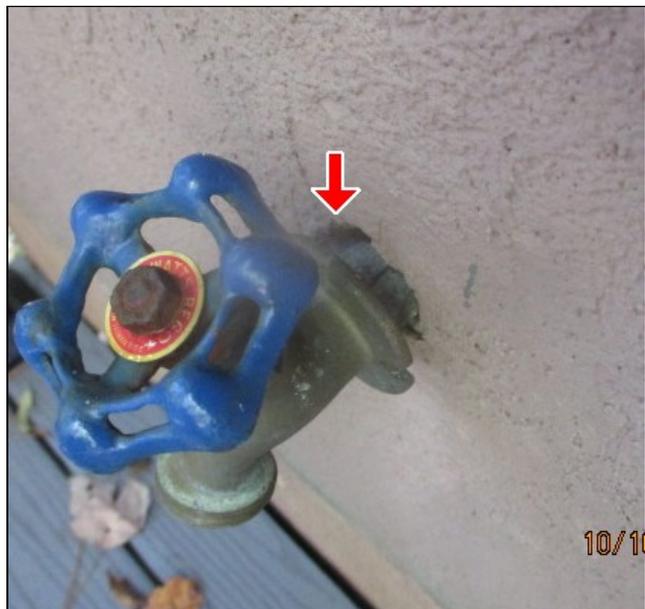
1.9 (3) All dissimilar material has failing sealant or is missing sealant.

1.9 (4) Back right corner

1.9 Item 8(Picture) Side of Deck

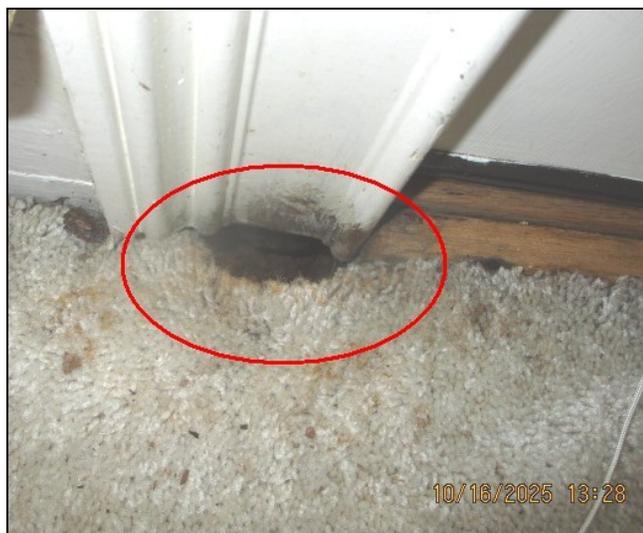
3.0 Item 1(Picture)

3.0 (2) Hole from the living room floor to the crawl space area.

Bottom of door trim.

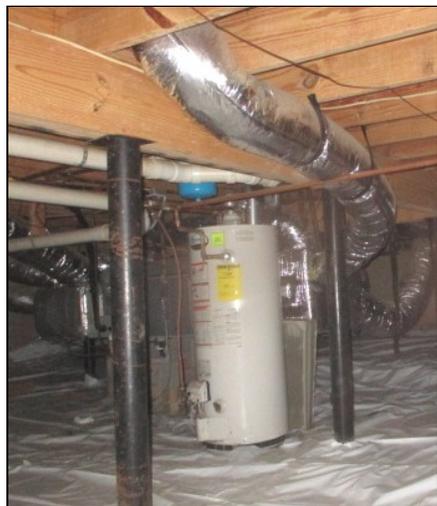
6.2 Item 1(Picture)

6.2 (1) Collar ring at flu vent connection is not secured.(A)

EVALUATION AND REPAIR BY A LICENSED HVAC TECHNICIAN.

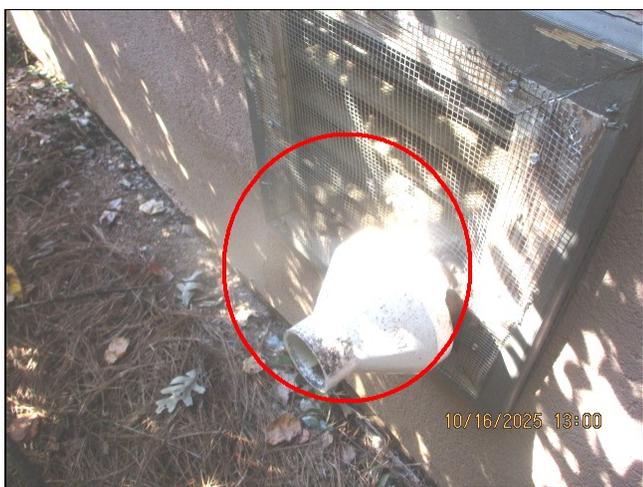
6.2 Item 3(Picture)

6.2 (4) This exhaust suggest a 90% efficiency furnace is in use.

The exhaust is terminated in the crawl view.

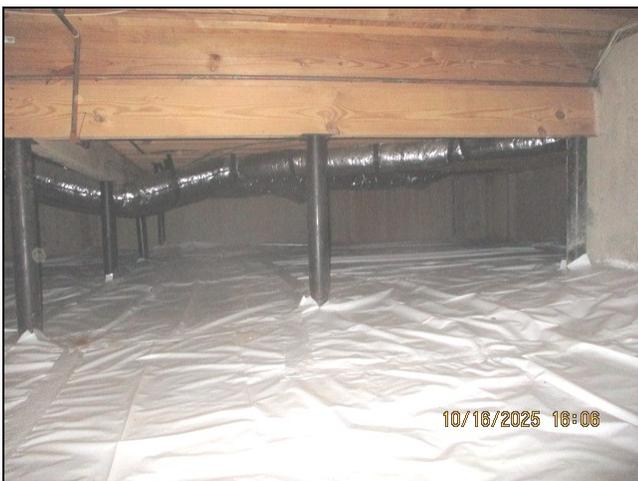
7.0 Item 1(Picture)

7.0 (1) Functioning as designed. Dry.

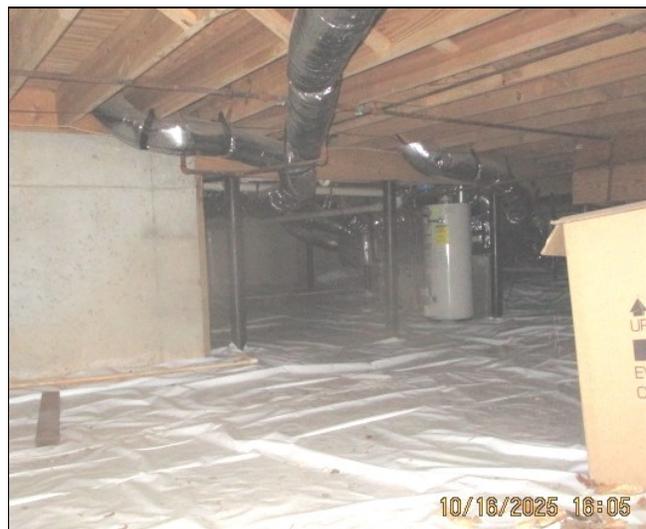
7.0 Item 2(Picture)

7.0 (2) Under Deck View

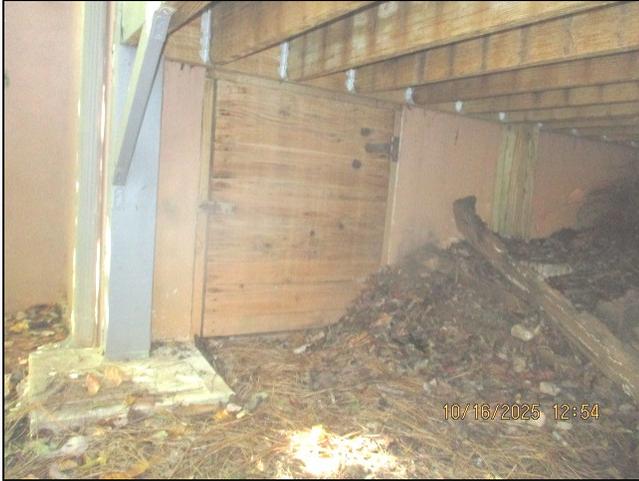
7.0 Item 3(Picture) Crawl Space Access.

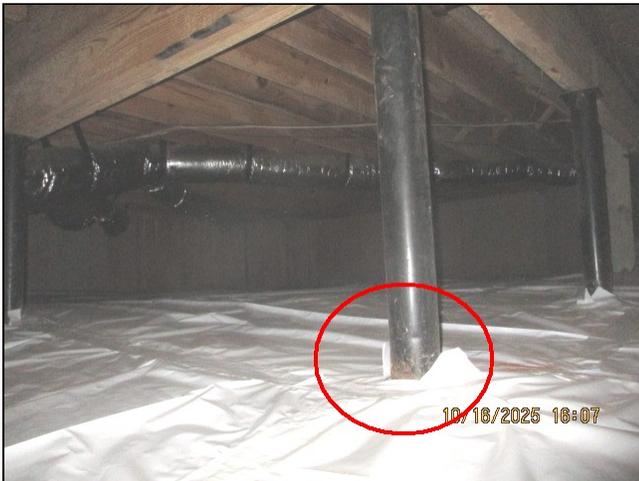
7.1 Metal support post are covered by vapor barrier.

7.1 Item 1(Picture) Limited View

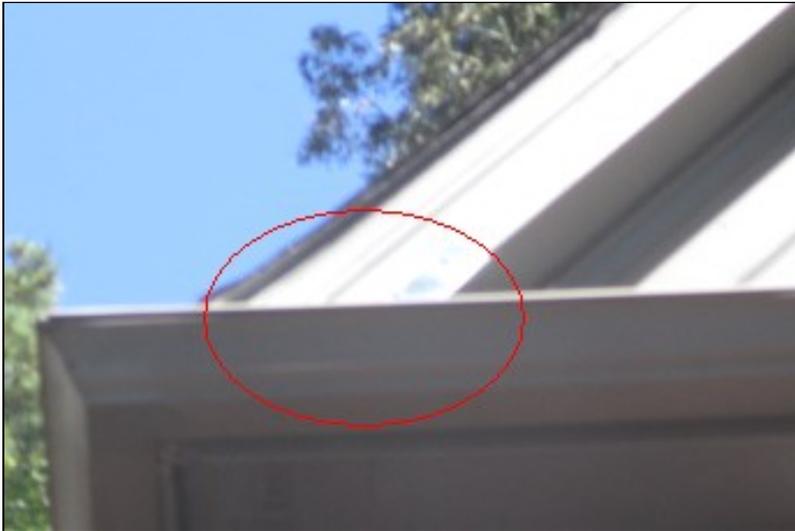
7.2 Item 1(Picture)

7.2 (1) Full attic over main area of the dwelling.

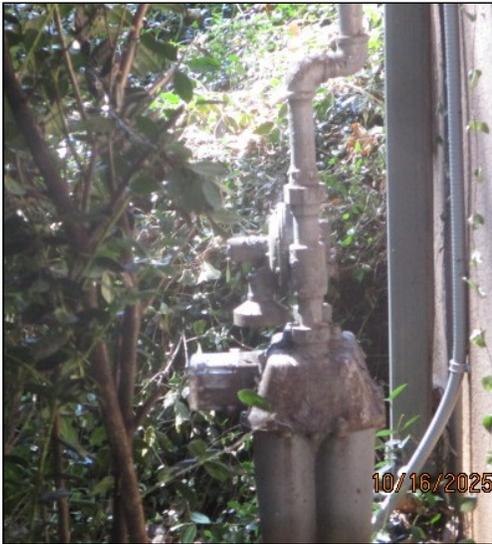
8.6 Gas Cutoff: The outdoor emergency cut-off valve for the main gas supply was found along the right front corner wall. The location for this valve must be known so it can be closed in the event of a damaged pipe or small leak.

8.6 Item 1(Picture) Right Front Corner.

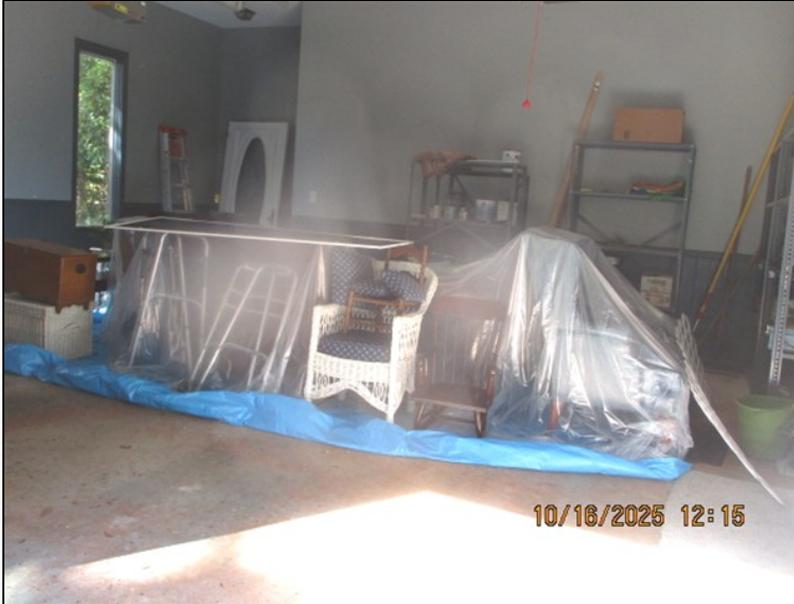
10.1 Item 1(Picture)

10.1 Limited access for review due to personal belonging. No visual access to components.

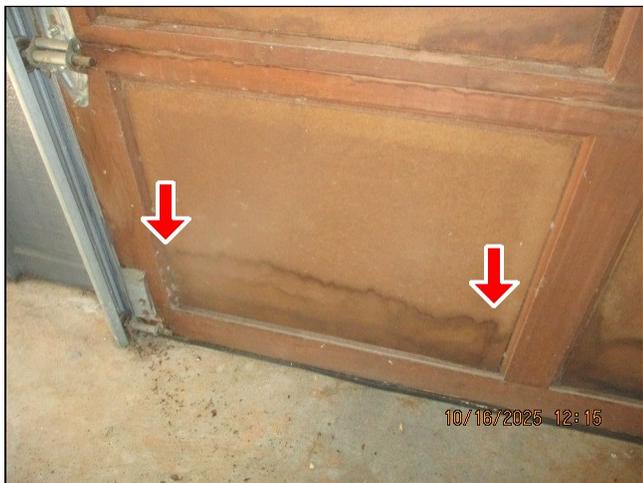
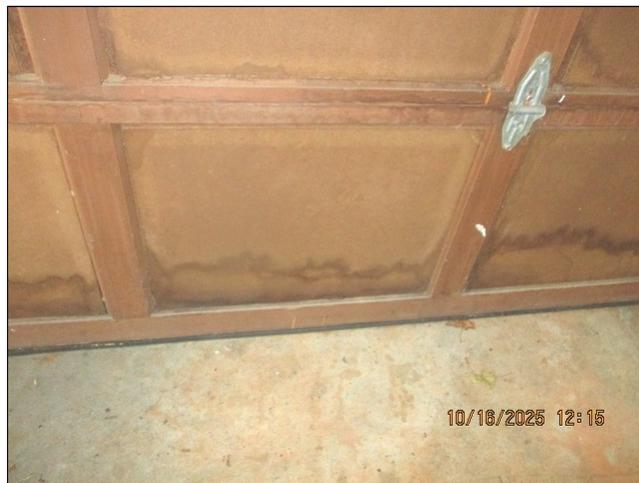
10.2 Original to construction

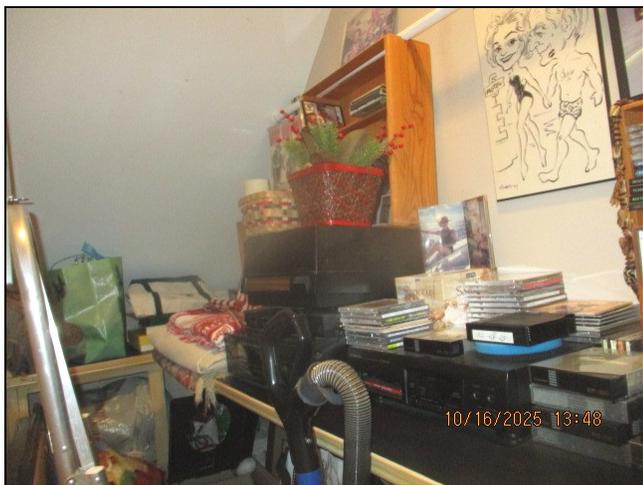
10.4 Item 1(Picture)

10.4 Back wall of garage.

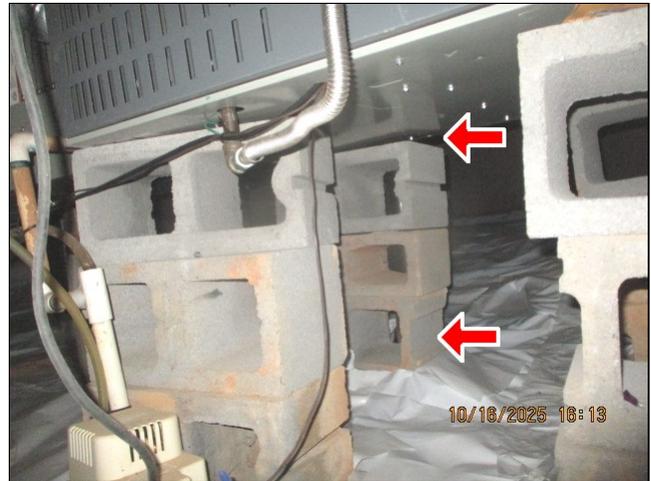
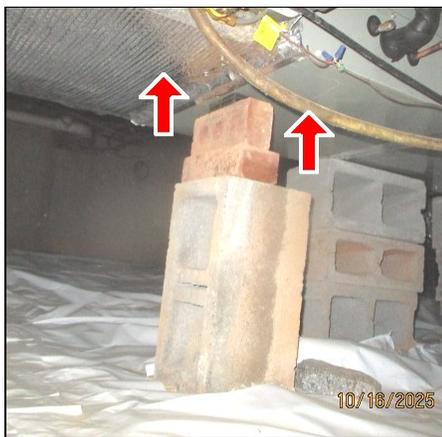
13.0 Item 1(Picture) Material is not stable

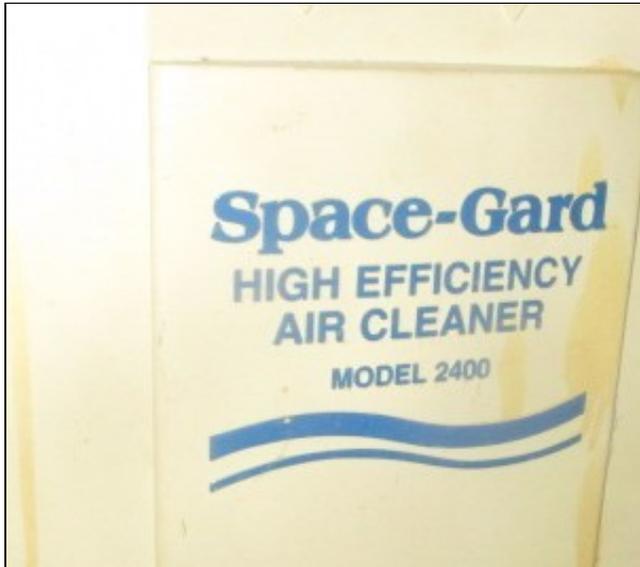
13.3 Item 1(Picture)

13.3 (1) A media box filter works by trapping airborne particles and contaminants as air passes through it. It is typically installed in the return duct of an HVAC system, where its dense and thick design allows it to capture a wider range of pollutants compared to standard filters, improving indoor air quality significantly.

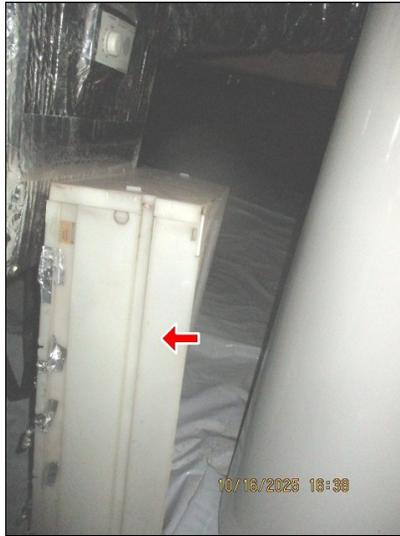
13.3 Item 3(Picture) Abandoned Unit

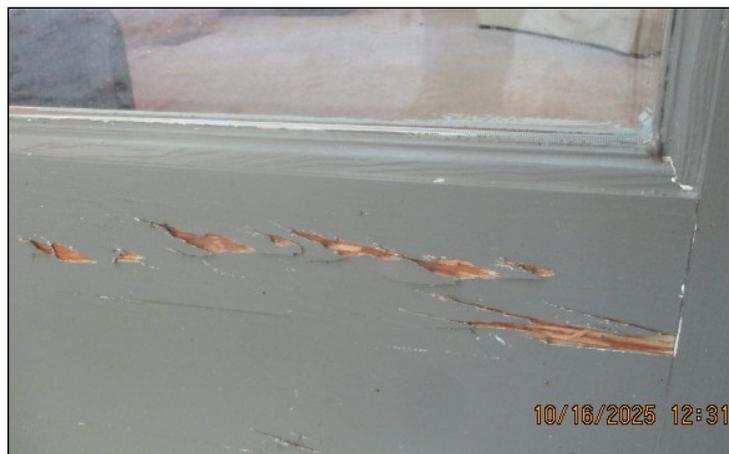
1.5 Item 1(Picture)

- (1) For improved safety rekeying all the entry doors and changing any garage door codes should be considered.
- (2) Exterior door entering the kitchen was not accessible.
- (3) Back entry door off living room

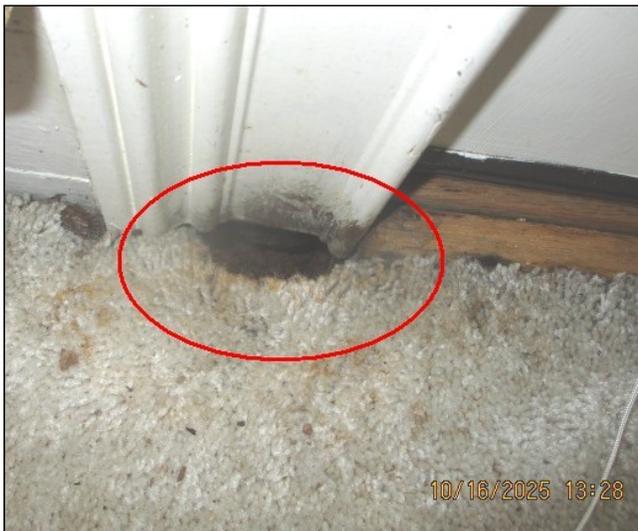
3.0 Item 1(Picture)

- (1) Sunken living room step up to the dining room and entry hall. Caution
- (2) Hole from the living room floor to the crawl space area.

Bottom of door trim.

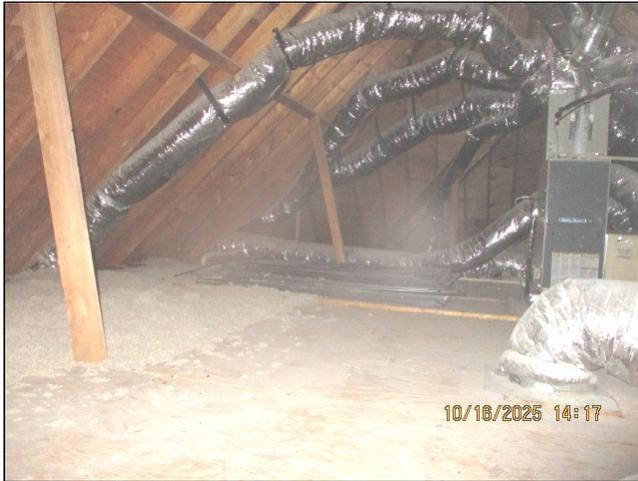
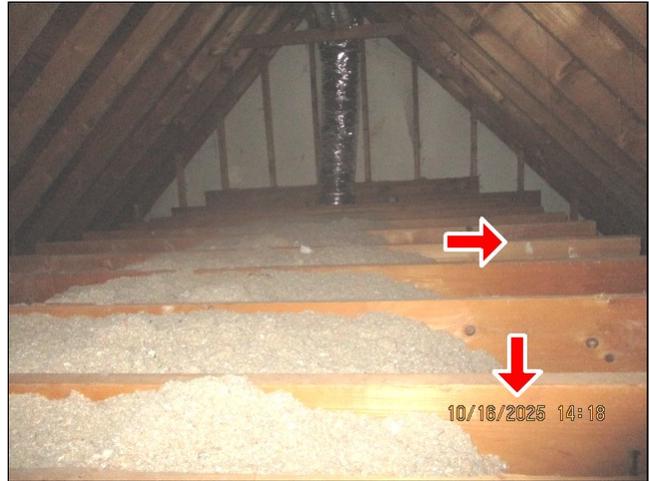
This information was not in place at the time of construction.

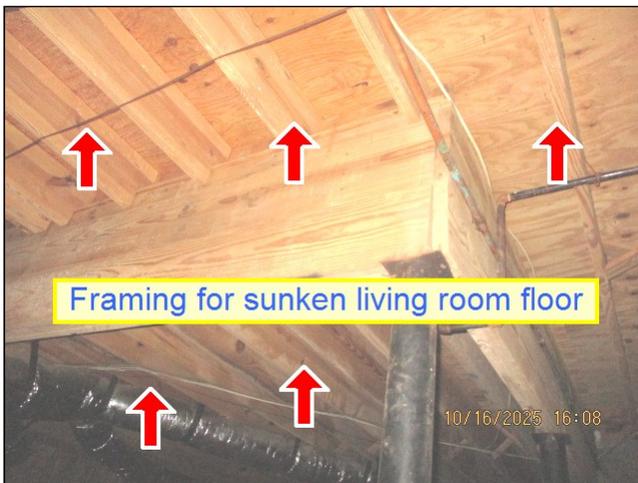
6.0 Item 3(Picture)

(2) For improved thermal envelope a minimum is R-19 between joist could be beneficial.

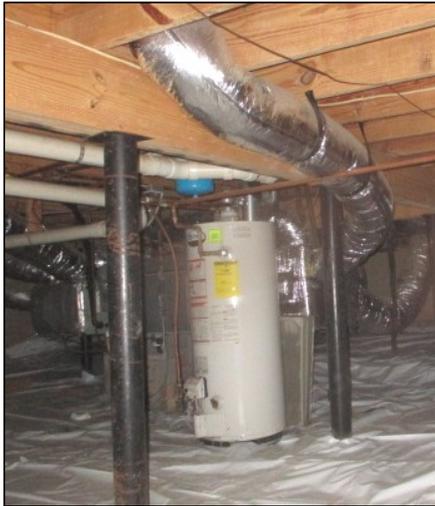
6.2 Item 1(Picture)

Unit installation in 2012

EVALUATION AND REPAIR BY A LICENSED HVAC TECHNICAN.

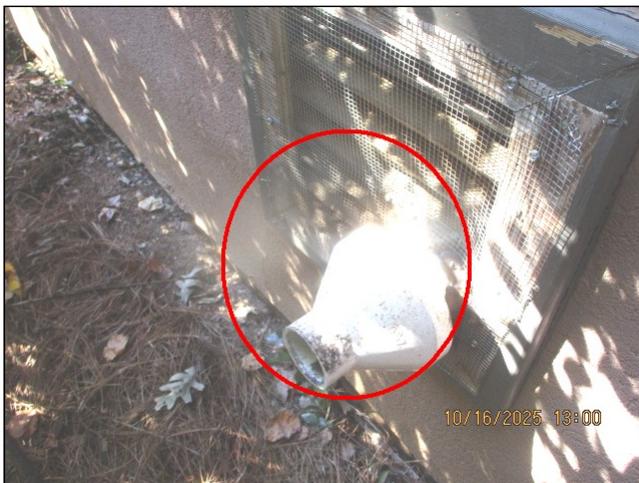
6.2 Item 3(Picture)

(4) This exhaust suggest a 90% efficiency furnace is in use.

The exhaust is terminated in the crawl view.

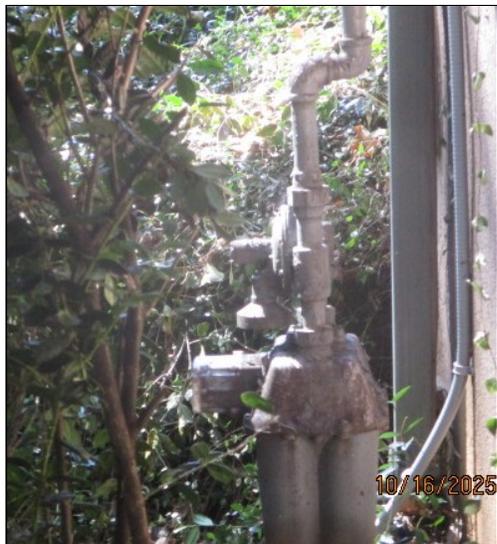
Gas Cutoff: The outdoor emergency cut-off valve for the main gas supply was found along the right front corner wall. The location for this valve must be known so it can be closed in the event of a damaged pipe or small leak.

8.6 Item 1(Picture) Right Front Corner.

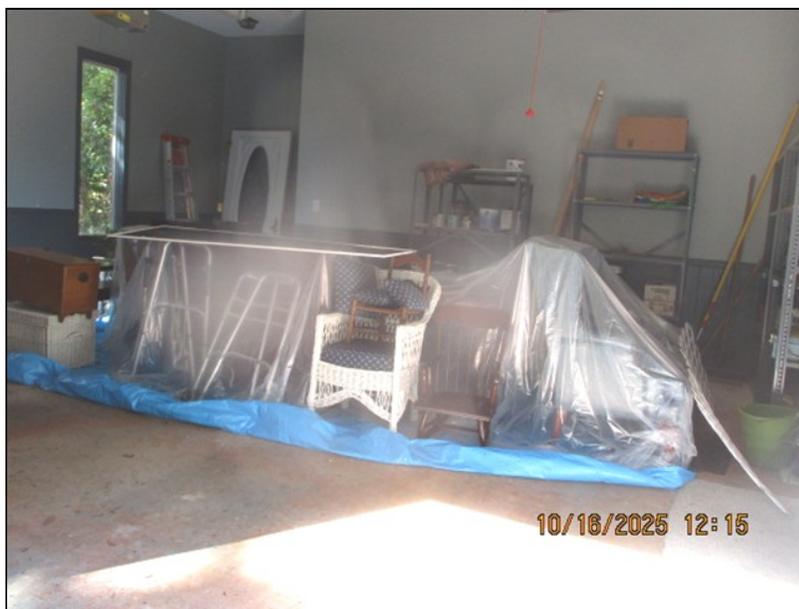
10.1 Item 1(Picture)

Limited access for review due to personal belonging. No visual access to components.

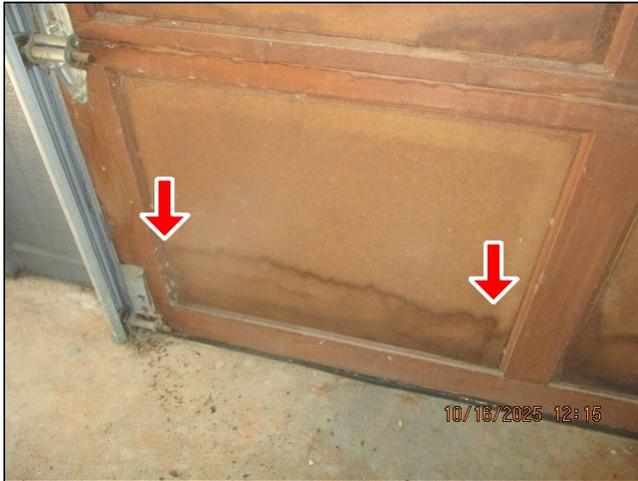
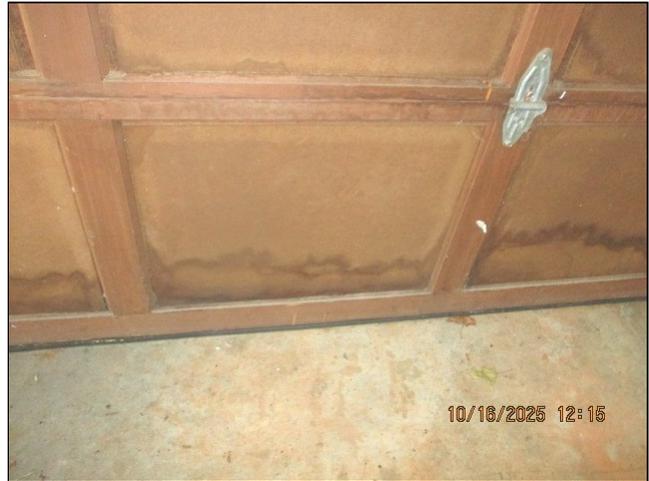
Original to construction

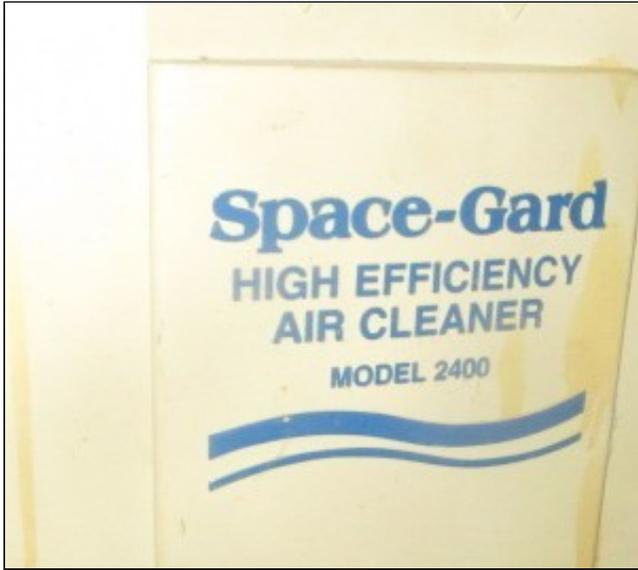
13.3 Item 1(Picture)

(1) A media box filter works by trapping airborne particles and contaminants as air passes through it. It is typically installed in the return duct of an HVAC system, where its dense and thick design allows it to capture a wider range of pollutants compared to standard filters, improving indoor air quality significantly.

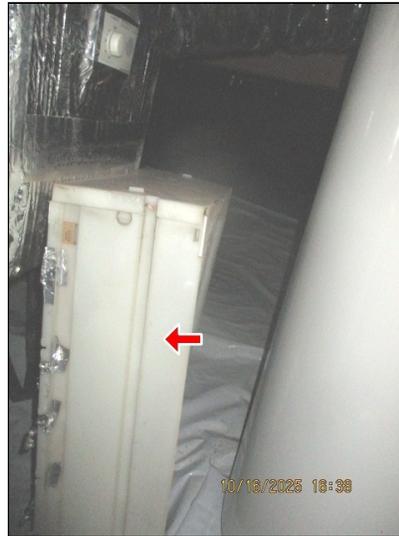
13.3 Item 3(Picture) Abandoned Unit
